HAZARDOUS MATERIALS SURVEY AND 2022 REASSESSMENT LEBLANC RESIDENCE, OTTAWA, ON

Project No.: Z2021102HZ / CCC-230252-00

REASSESSMENT SURVEY 2022

Re: 45 Louis-Pasteur Private, Ottawa, ON
Hazardous Materials Survey
McIntosh Perry Limited Reference No. Z2021102HZ / CCC-230252-00

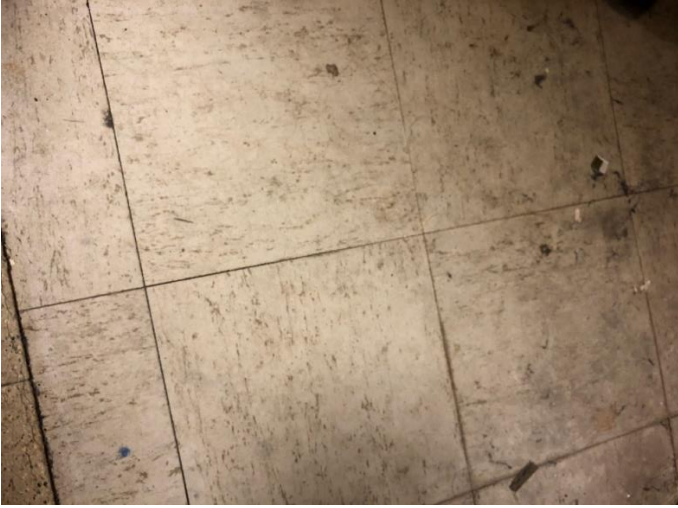
- Vinyl floor tiles (9"x9" – White with Grey Streaks) were observed and sampled in Rooms 231, 331, and 441. This material **contains 3% Chrysotile asbestos** and is considered to be non-friable. This material was observed to be in good condition. The associated mastic (black) was found not to contain asbestos.
- Vinyl floor tiles (12"x12" – Grey Marble) were observed and sampled in Room 327. The laboratory analytical results of the vinyl floor tile samples collected indicated that this material does not contain asbestos. The associated mastic (yellow) was found not to contain asbestos.
- Vinyl floor tiles (12"x12" – Green) were observed and sampled in Room 301 and 401. The laboratory analytical results of the vinyl floor tile samples collected indicate that this material does not contain asbestos.

Photo 4: View of asbestos-containing vinyl floor tiles (9"x9" - white with beige streaks observed in Room 101

- Materials identified to contain asbestos that are in good condition and do not pose a risk to workers or occupants can be managed in place. Prior to renovation/demolition activities that may disturb the ACMs, these materials must be removed following appropriate Type 1/2/3 asbestos abatement work procedures as detailed in O. Reg. 278/05 and disposed of as asbestos waste under O. Reg. 347;

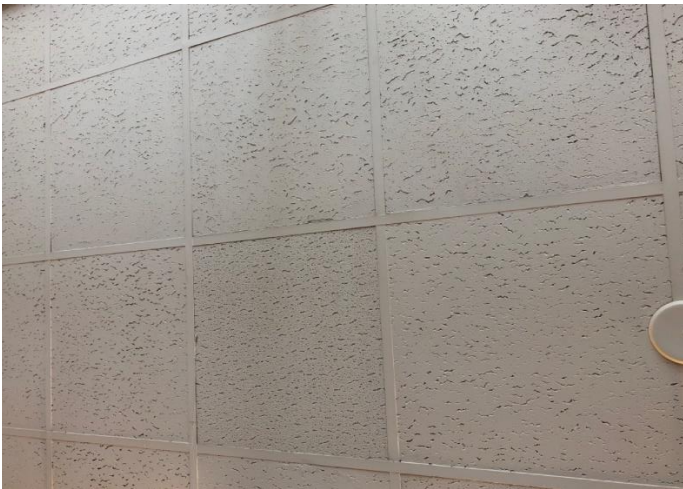
Previously identified ceiling tiles (2'x2' - white with dots and squiggle pattern) was observed within the subject building. The laboratory analytical results indicate that this material **contains 1% Amosite asbestos and 1% Chrysotile asbestos**. This material is considered to be friable and was observed to be good condition.

Photo 5: View of asbestos-containing suspended ceiling tiles (2'x2' - white with dots and squiggle pattern) observed in Room 140.

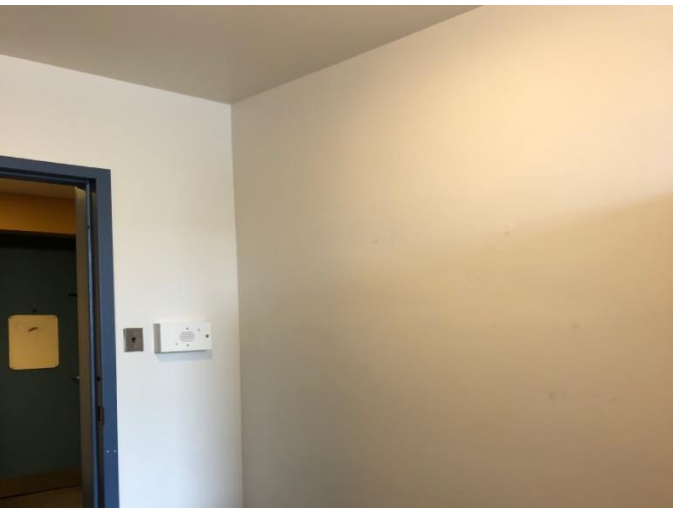
Drywall joint compound was observed throughout the subject building. The laboratory analytical results of drywall joint compound samples collected from Rooms 116A and 116X indicate that this material **contains 2% Chrysotile asbestos**. Since drywall joint compound is a homogeneous material, all areas must be treated as asbestos-containing unless additional bulk sampling and analysis proves otherwise. This material was observed in good condition.

Photo 6: View of asbestos-containing drywall joint compound observed throughout the subject building.

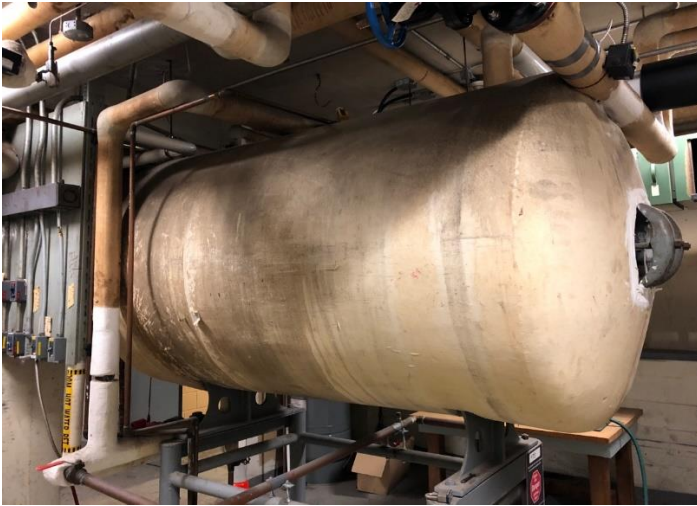
Previously identified tank insulation was observed in Room 014 within the subject building. The laboratory analytical results indicate that this material **contains 60% Chrysotile asbestos**. This material is considered to be friable and was observed to be good condition.

Photo 7: View of asbestos-containing tank insulation observed in Room 014.

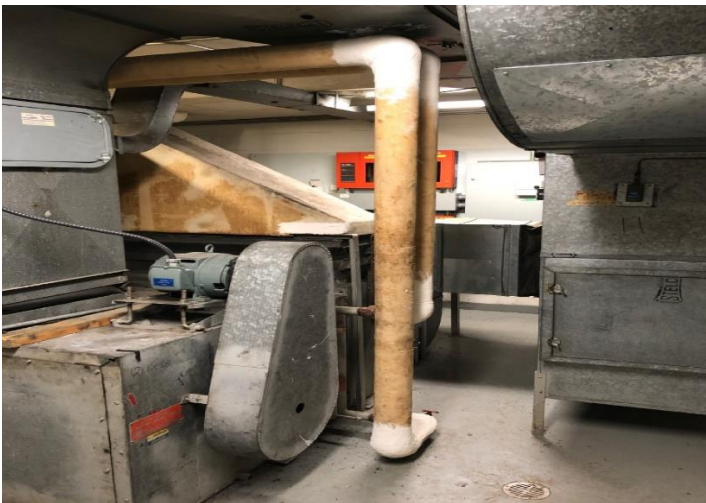
Previously identified mechanical pipe elbow/fitting insulation was observed within the basement of the subject building. The laboratory analytical results indicate that this material **contains 70% Chrysotile asbestos**. This material is considered to be friable and was observed to be good condition.

Photo 8: View of asbestos-containing pipe fitting insulation observed in Room 012.

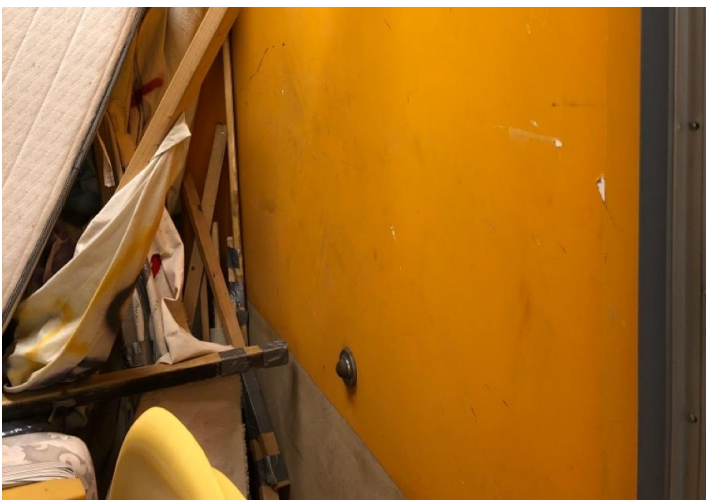
The paint finishes highlighted in pink in the above table are considered lead-containing paints or surface coatings with concentrations greater than 0.1% lead by weight. These paint finishes were observed to be in good condition with the exception of select areas that were observed in poor condition.

Photo 9: View of lead-containing orange paint observed in Room 055.

Paints identified to contain lead that are in poor condition must be immediately repaired and/or stabilized following a minimum Type 1/2 lead abatement procedures as per OMOL “Lead on Construction Project” dated April 2011.

Paints identified to contain lead that are in fair condition should be either repaired (where possible) and/or closely monitored for signs of further deterioration.

Paints identified to contain lead that are in good condition and do not pose a risk to workers or occupants can be managed in place.

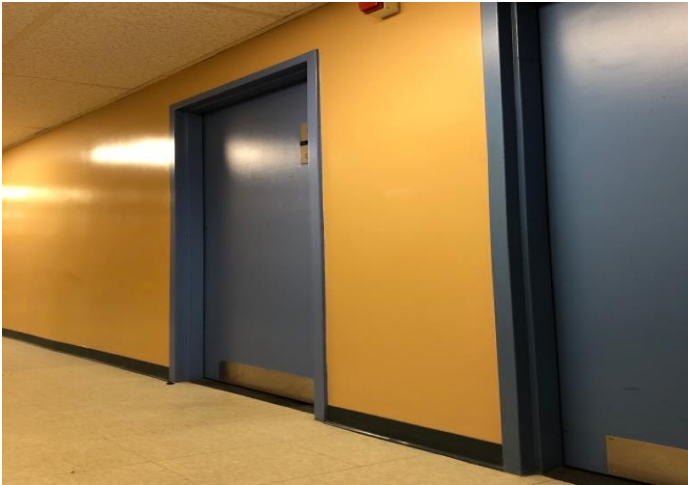
Photo 10: View of lead-containing blue paint observed in Room 145.

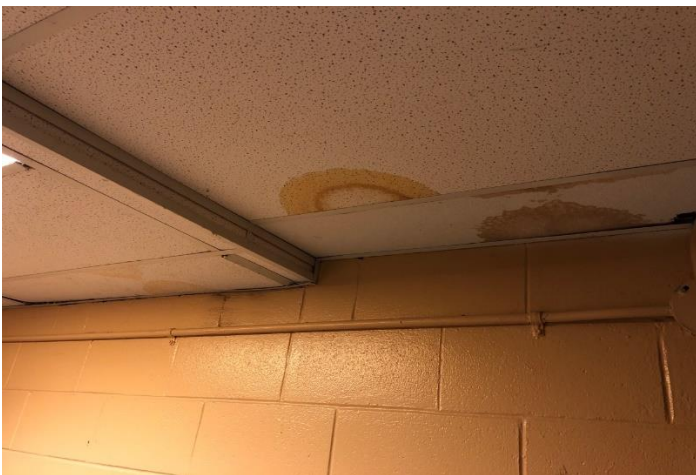
Photo 12: View of water damaged ceiling tiles observed in Room 046.

Water stained/damaged ceiling tiles observed throughout the subject building should be replaced as part of regular maintenance and the underlying cause of the water leakage should be identified and repaired.

Water stained/damaged ceiling tiles that are also determined to contain asbestos must be replaced following appropriate asbestos abatement procedures as outlined in O.Reg. 278/05.
