HAZARDOUS MATERIALS SURVEY AND 2022 REASSESSMENT 190 LAURIER AVENUE, OTTAWA, ONTARIO

Project No.: OZ2-021737-HZ

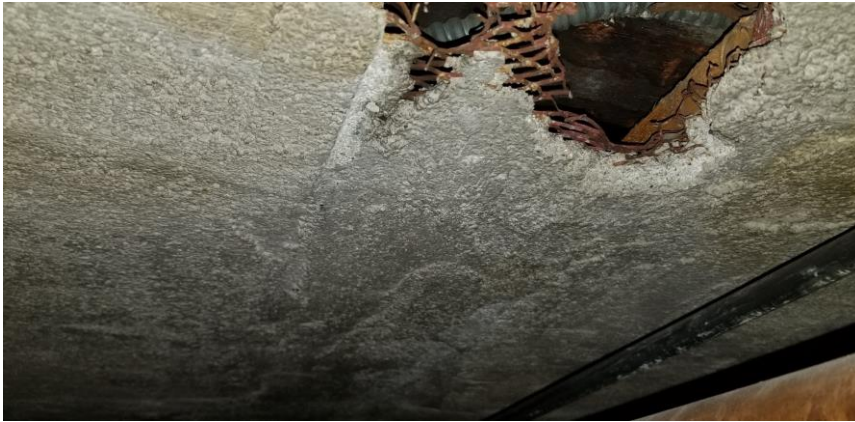
Photo 1: View of asbestos-containing plaster applied on to steel mesh observed to be in poor condition on the ceiling of the basement level boiler room.

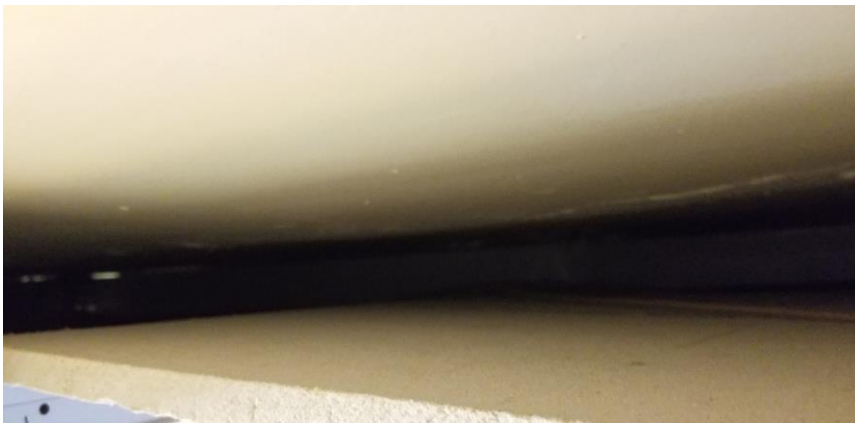
Photo 2: View of asbestos-containing ceiling plaster observed to be in good condition above the suspended ceiling tiles in Room 301.

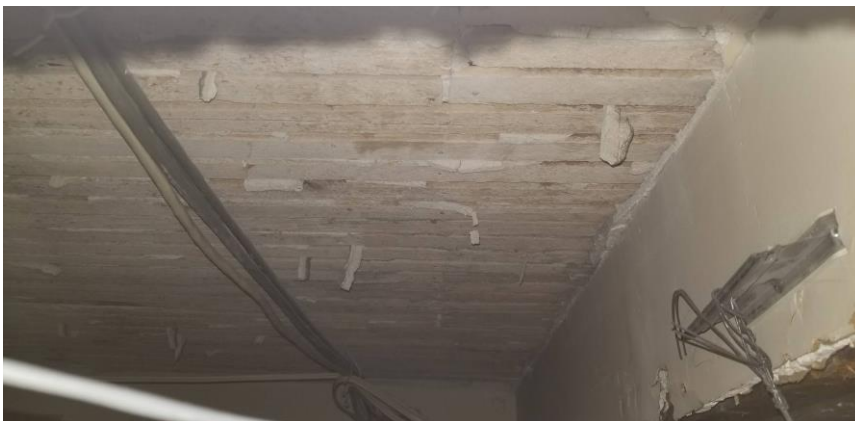
Photo 3: View of non-asbestos containing plaster on wood lathe observed above the suspended ceiling tiles in Room 204.

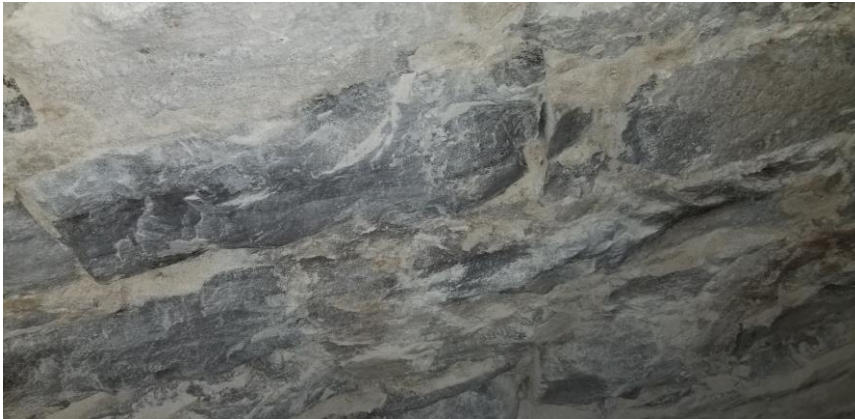
Photo 4: View of non-asbestos containing foundation block mortar observed in the basement level of the subject building.

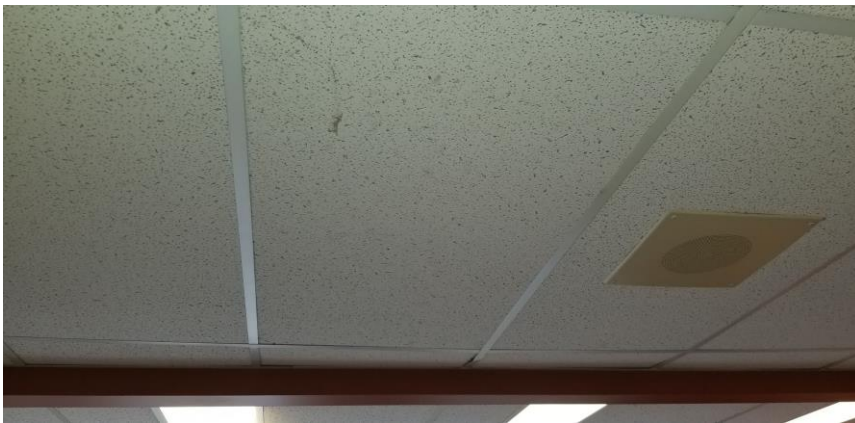
Photo 5: View of non-asbestos containing suspended ceiling tiles (2'x4'-Pinholes with small fissures) observed throughout the subject building.

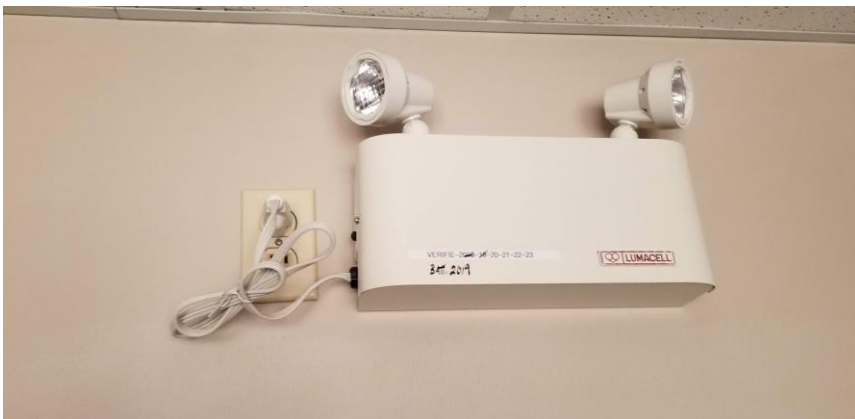
Photo 6: View of lead acid battery pack observed to be in good condition in Room 301.

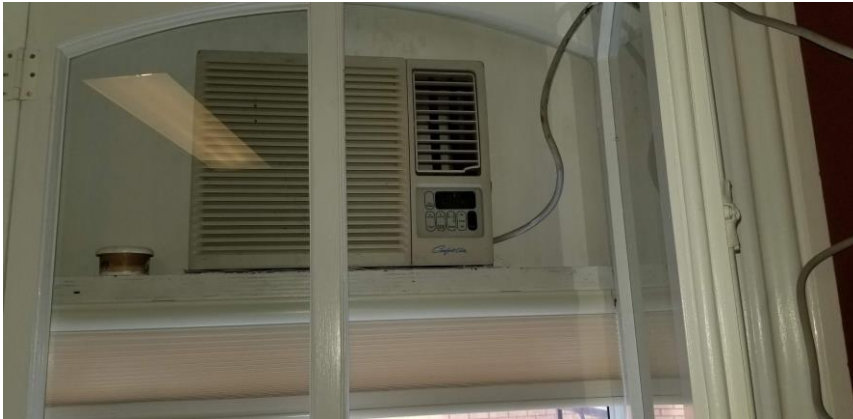
Photo 7: View of ODS-containing air condition unit observed to be in good condition in Room 204.

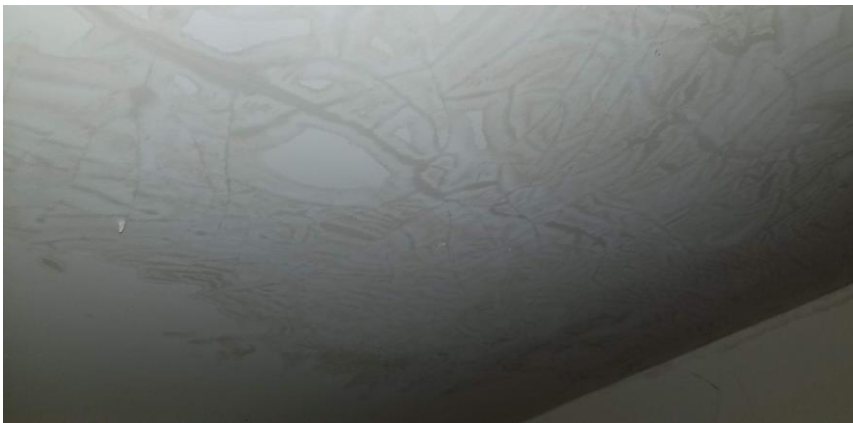
Photo 8: View of water-stained ceiling plaster observed to be in poor condition above the suspended ceiling tiles in Room 202.

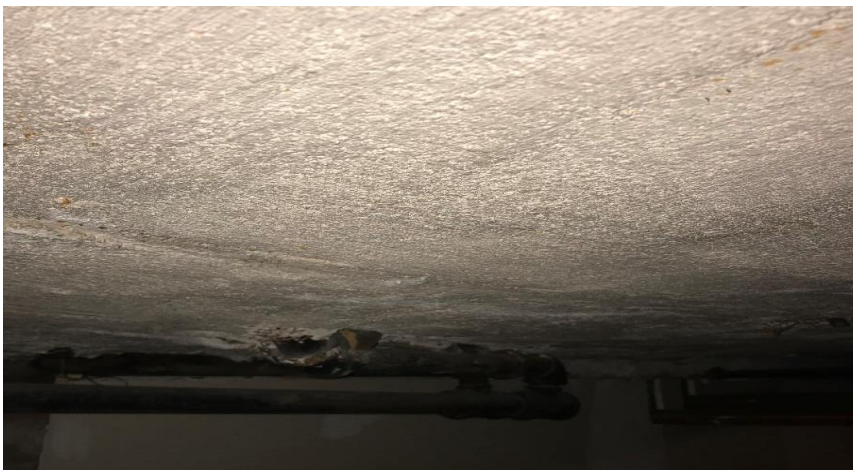
Photo 9: View of asbestos-containing textured plaster observed on the basement ceiling.

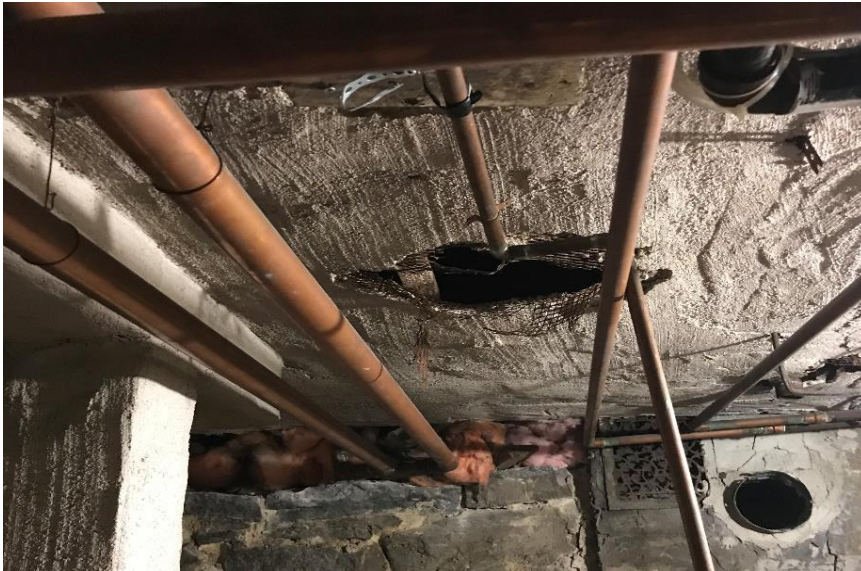
Photo 10: View of asbestos-containing textured plaster observed on the basement ceiling.

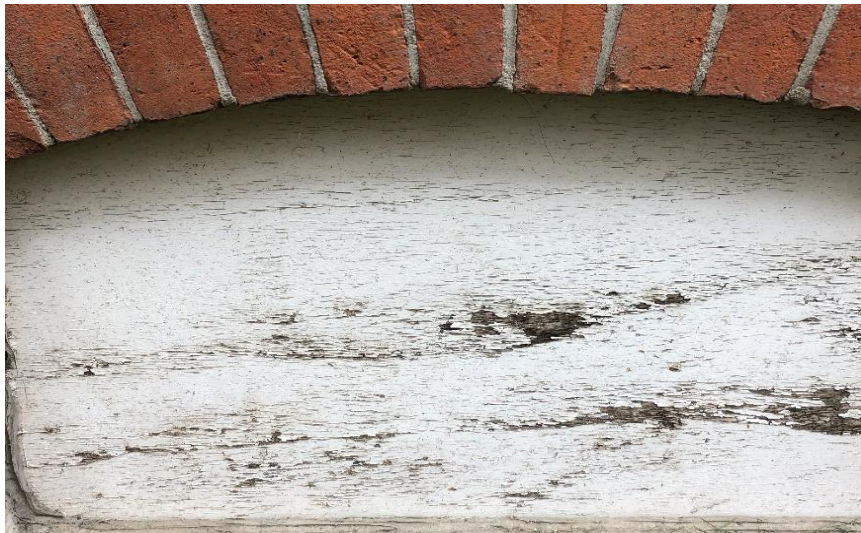
Photo 11: View of low-level lead paint (white) observed to be in poor condition on the exterior of the building.

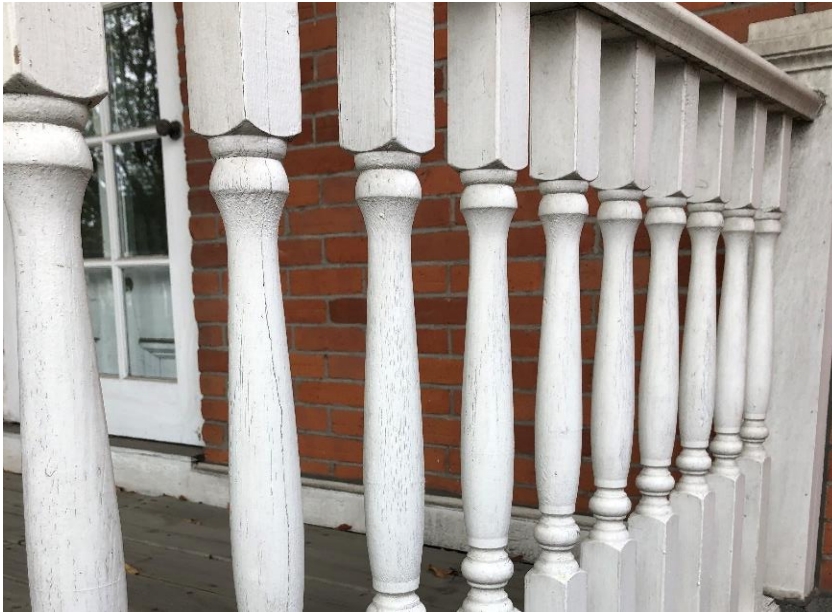
Photo 12: View of low-level lead paint (white) observed to be in poor condition on the exterior balcony/porch.

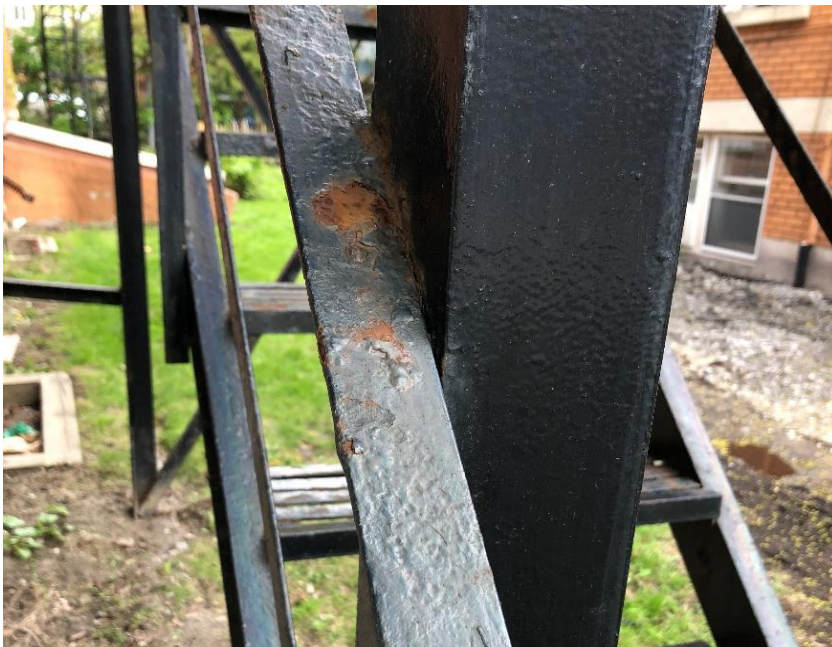
Photo 13: View of low-level lead paint (black) observed to be in poor condition on the exterior fire escapes
