HAZARDOUS MATERIALS SURVEY AND 2022 REASSESSMENT 100 LAURIER AVENUE, OTTAWA, ON

Project No.: Z1920014HZ / CCC-230252-00

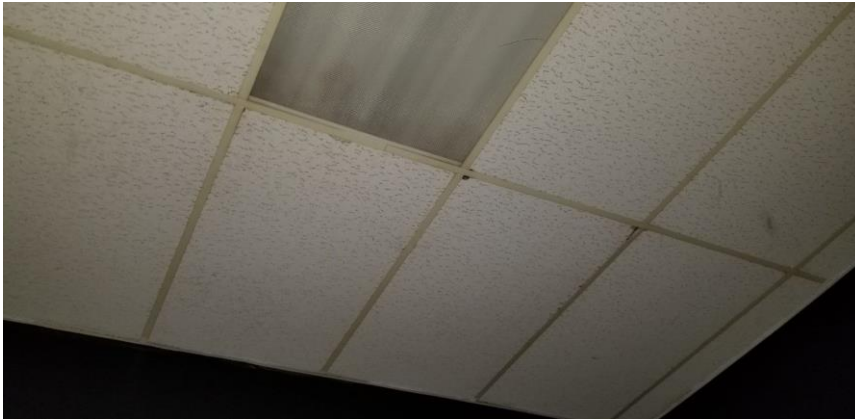
Photo 1: View of asbestos-containing ceiling tiles (2'x4'-Large fissures with pinholes) observed to be in fair condition in Room 321. Removed Summer, 2022.

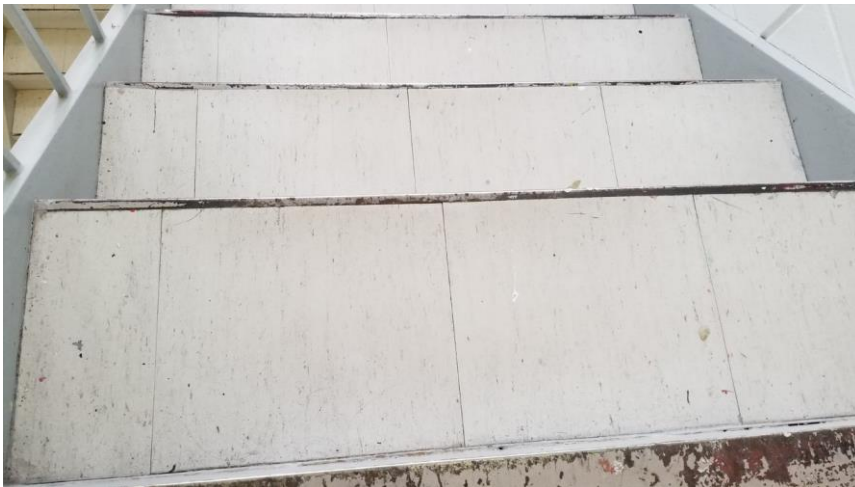
Photo 2: View of asbestos-containing vinyl floor tiles (12"X12"-Beige w/ Dark and Light flakes) observed to be in good condition in Room 323.

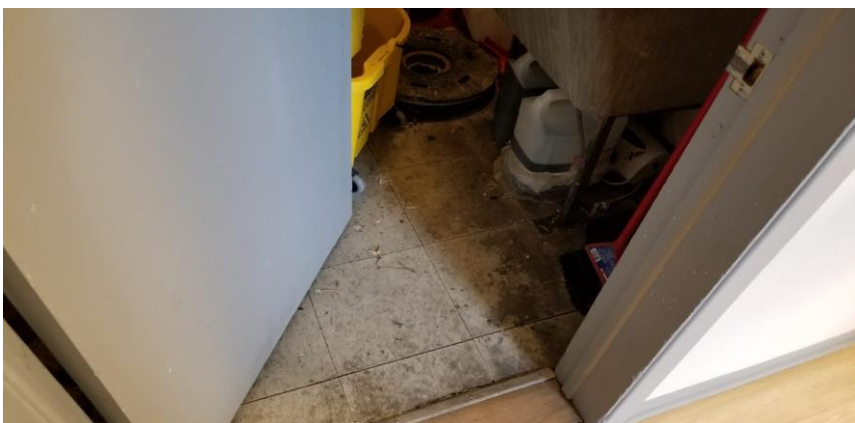
Photo 3: View of asbestos-containing vinyl floor tiles (12"x12"- Beige w/ Brown Flakes) observed to be in poor condition in Room 314. Removed September, 2020.

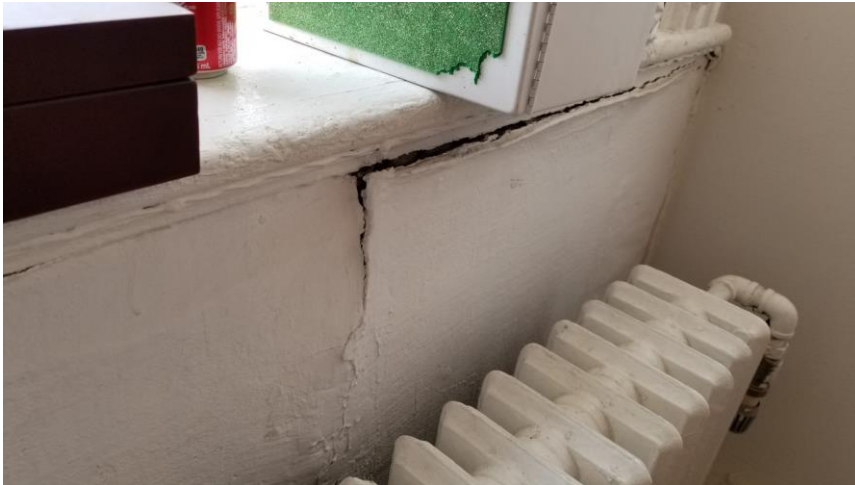
Photo 4: View of non-asbestos containing wall plaster observed in Room 310.

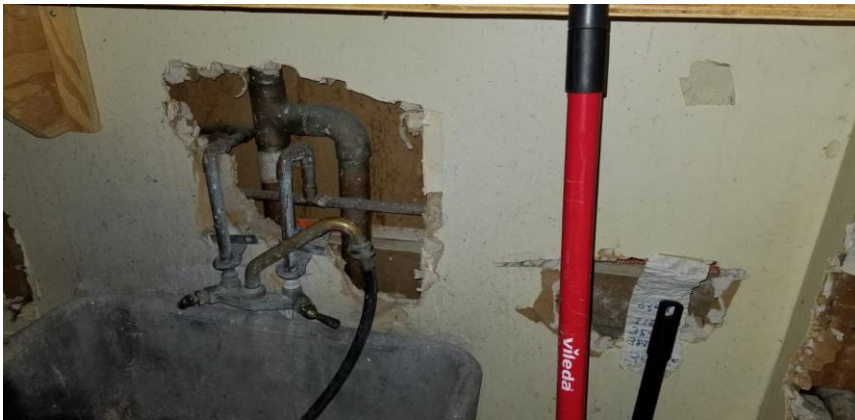
Photo 5: View of asbestos-containing drywall joint compound observed to be in poor condition in Room 314. Repaired September 2020.

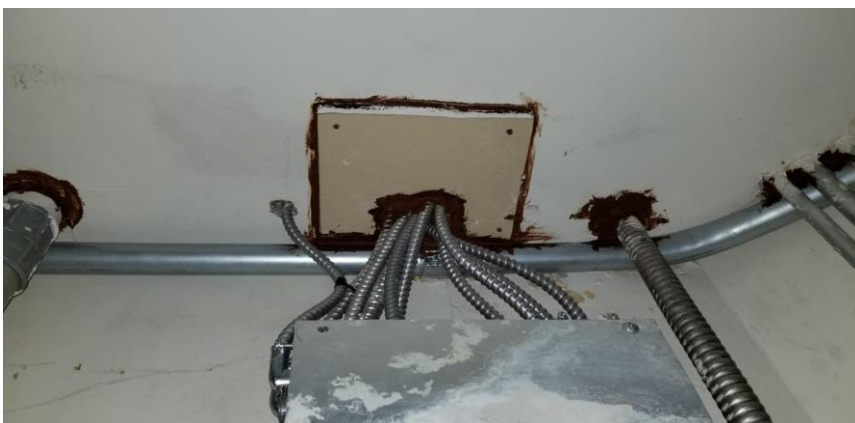
Photo 6: View of asbestos-containing firestop caulking (Red) observed to be in good condition in Room 105.

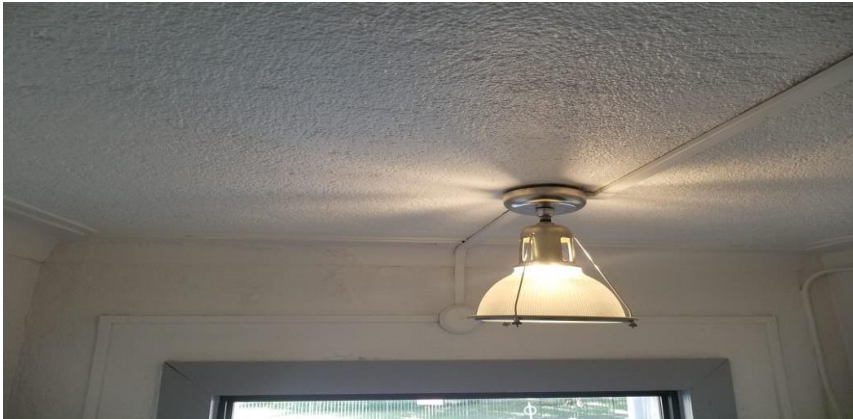
Photo 7: View of asbestos-containing ceiling texture coat observed to be in good condition adjacent to Rooms 120 and 120A.

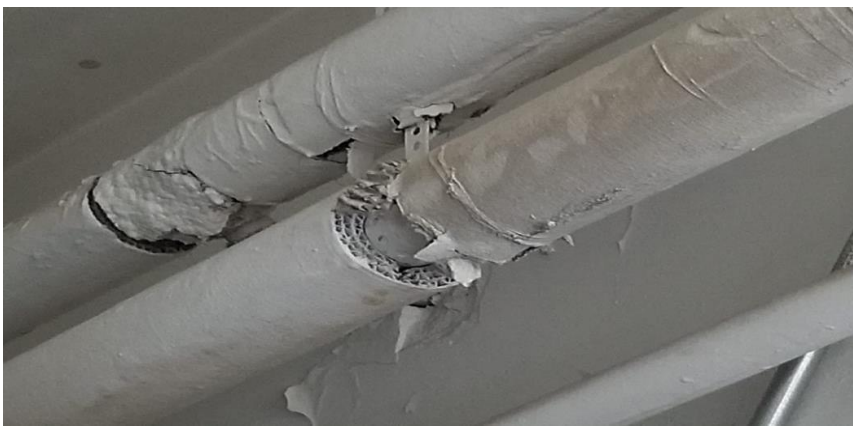
Photo 8: View of asbestos-containing pipe straight aircell insulation observed to be in poor condition in Room 010. Repaired September 2020.

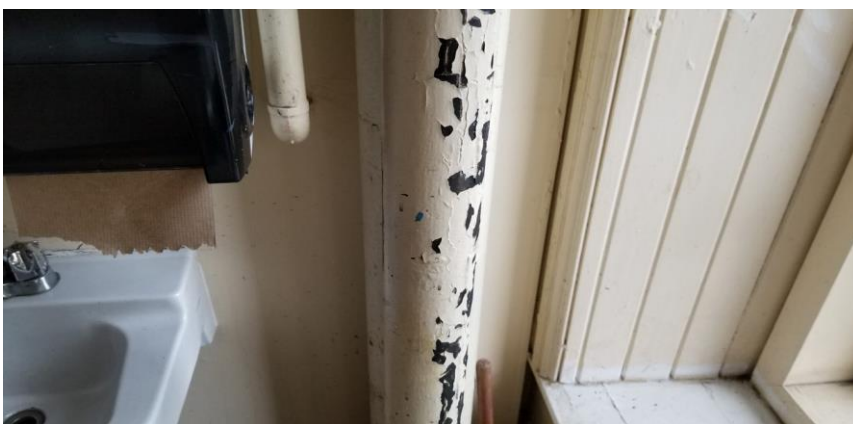
Photo 9: View of lead-containing beige paint observed to be in poor condition in Room 316A.

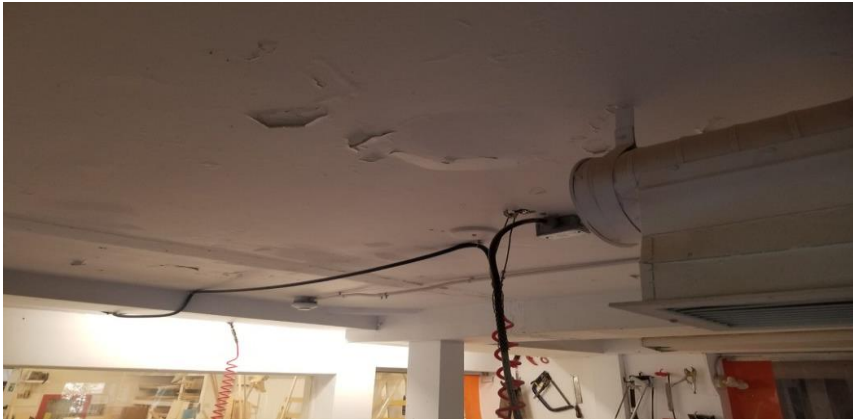
Photo 10: View of lead-containing white ceiling paint observed to be in poor condition in Room 100C.

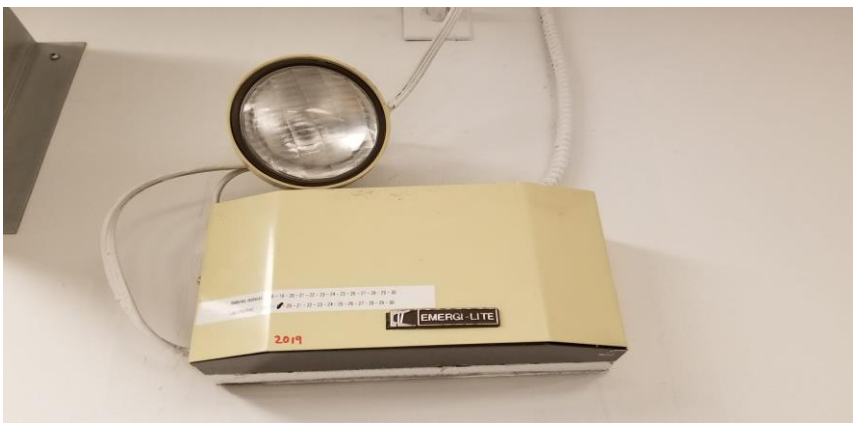
Photo 11: Typical view of lead-containing emergency battery packs observed to be in good condition throughout the surveyed building.

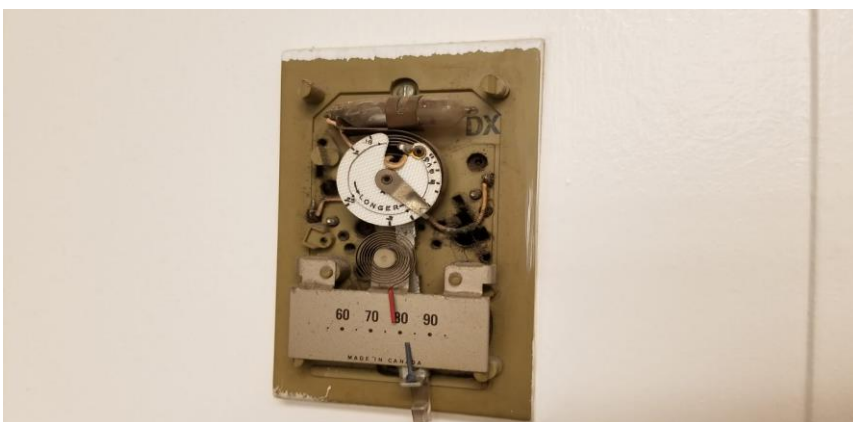
Photo 12: View of Honeywell thermostat containing one ampoule of liquid mercury observed to be in good condition in Room 013.

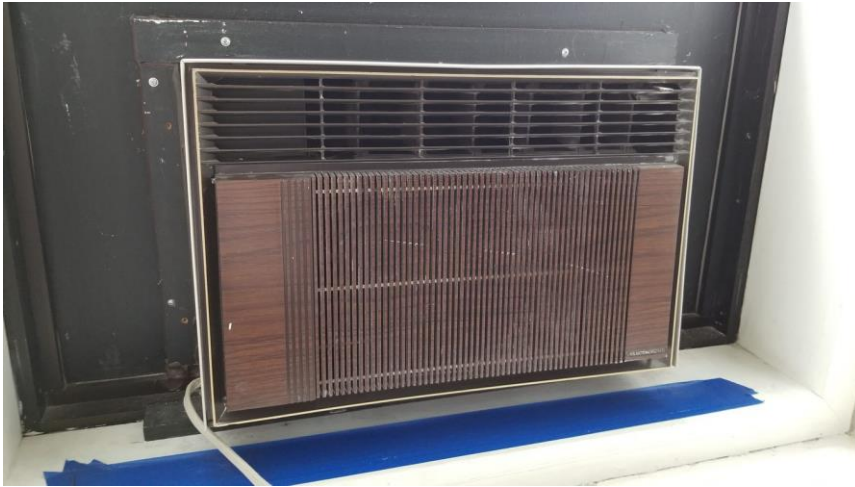
Photo 13: View of Electrohome-brand air conditioning unit observed to be in good condition in Room 216.

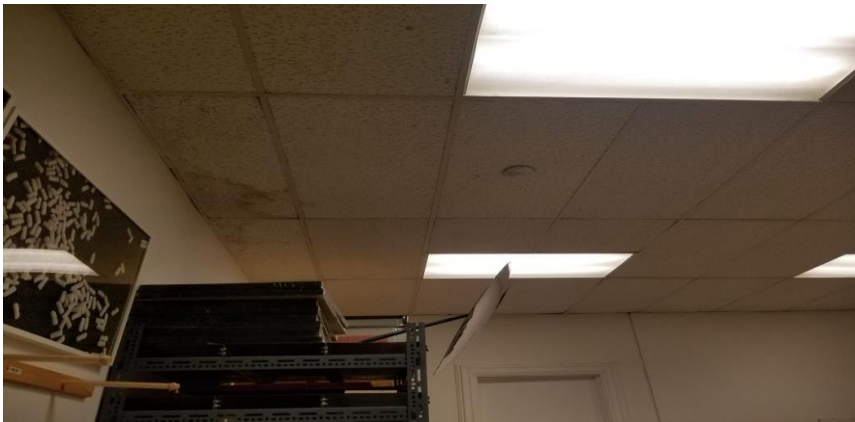
Photo 14: View of water-stained ceiling tiles observed in Room 113. Removed Summer, 2022.
