HAZARDOUS MATERIALS SURVEY

100 MARIE CURIE PRIVATE, OTTAWA, ON

Project No.: CCC-230252-00

December 20, 2022

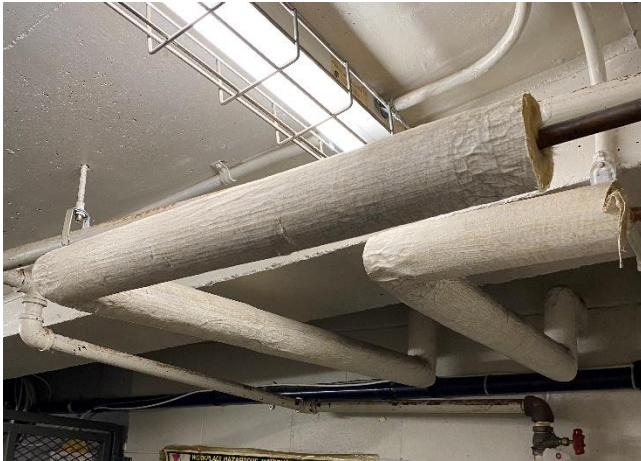
Mechanical pipe straight insulation was observed in the basement stairwell. MPL made several incisions throughout to investigate its composition, and it was visually identified as fiberglass, and therefore not suspected of containing asbestos.

Mechanical pipe elbows/fittings insulation was observed in the basement. MPL made several incisions throughout to investigate its composition, and it was visually identified as fiberglass, and therefore not suspected of containing asbestos.

Photo 1: View of fiberglass pipe insulation observed throughout the subject building.

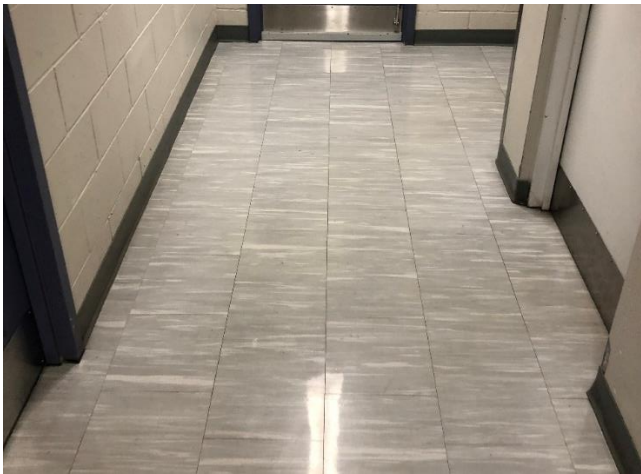
- Vinyl floor tiles (Grey with White Marble) were observed in Room 001. The laboratory analytical results of the vinyl floor tile samples collected from Room 001 indicate that this material does not contain asbestos.

Photo 2: View of non-asbestos containing vinyl floor tile (Grey with White Marble) observed in Room 001.

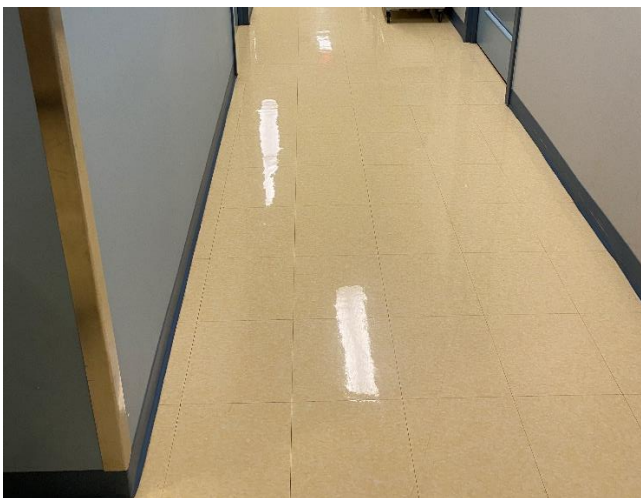
- Vinyl floor tiles (Yellow with White Specks) were observed in Room 200. The laboratory analytical results of the vinyl floor tile samples collected from Room 200 indicate that this material does not contain asbestos.

Photo 3: View of non-asbestos containing vinyl floor tiles (yellow with white specks) observed in Room 200.

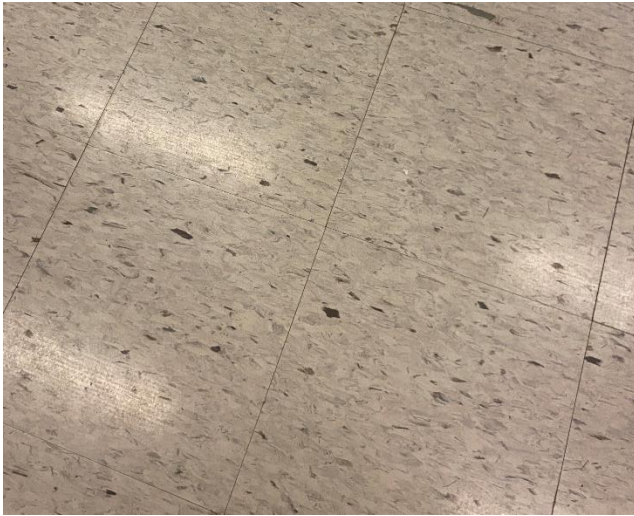
- Vinyl floor tiles (Cream with Black Streaks) were observed in Rooms 012 and 012(A-G). The laboratory analytical results of the vinyl floor tile samples collected from Room 012 indicate that this material does not contain asbestos. The associated mastic (Yellow) was also found not to contain asbestos.

Photo 4: View of non-asbestos containing vinyl floor tiles (cream with black specks) observed in Room 012.

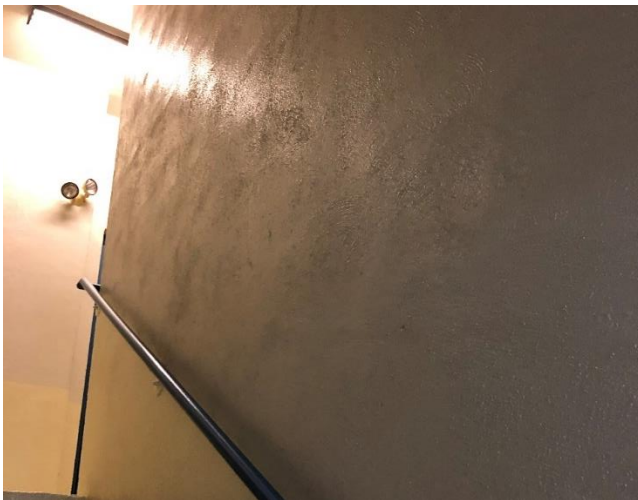
Photo 5: View of non-asbestos containing concrete skim coat observed on walls in stairwell.

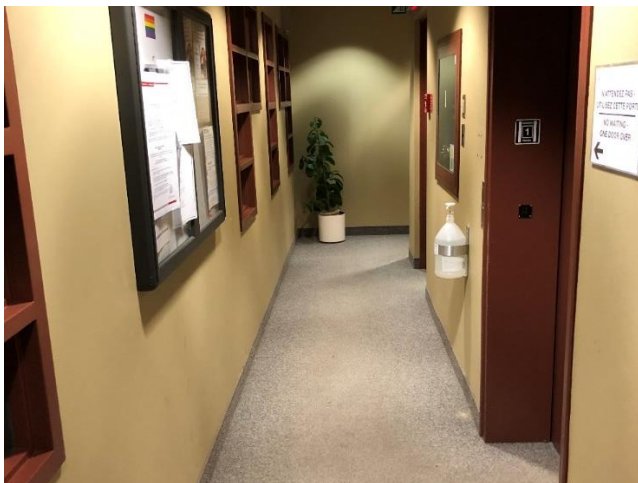
Drywall joint compound was observed throughout the subject building and previously sampled from Floors 1, 2, 3 and 4. The laboratory analytical results of drywall joint compound samples collected indicated that this material does not contain asbestos.

Photo 6: View of non-asbestos containing drywall joint compound observed throughout the subject building

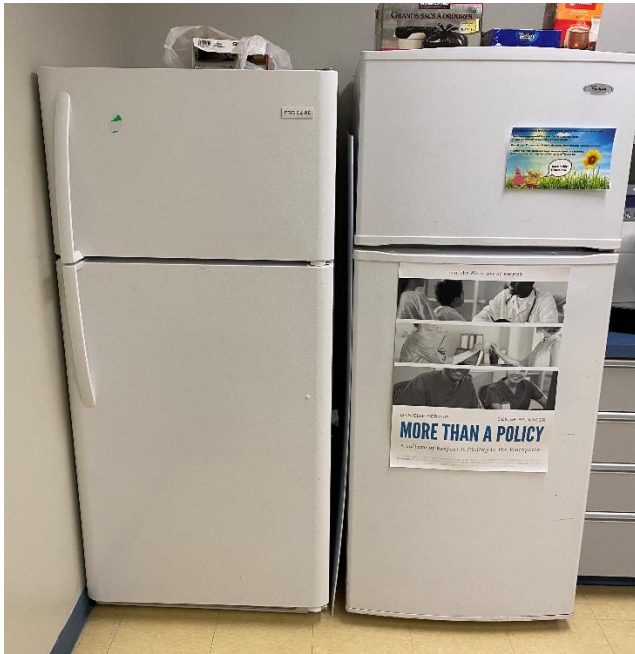
A visual assessment for equipment potentially containing ODSs and other halocarbons was conducted. MPL observed equipment such as refrigerators, water fountains, water coolers, freezers, etc. which contain or are suspected of containing ODSs or other halocarbons.

Photo 7: View of ODS containing refrigerators observed throughout the subject building

Please refer to Appendix F – Hazardous Materials Checklist for equipment conditions, quantities (where applicable), and recommended actions.

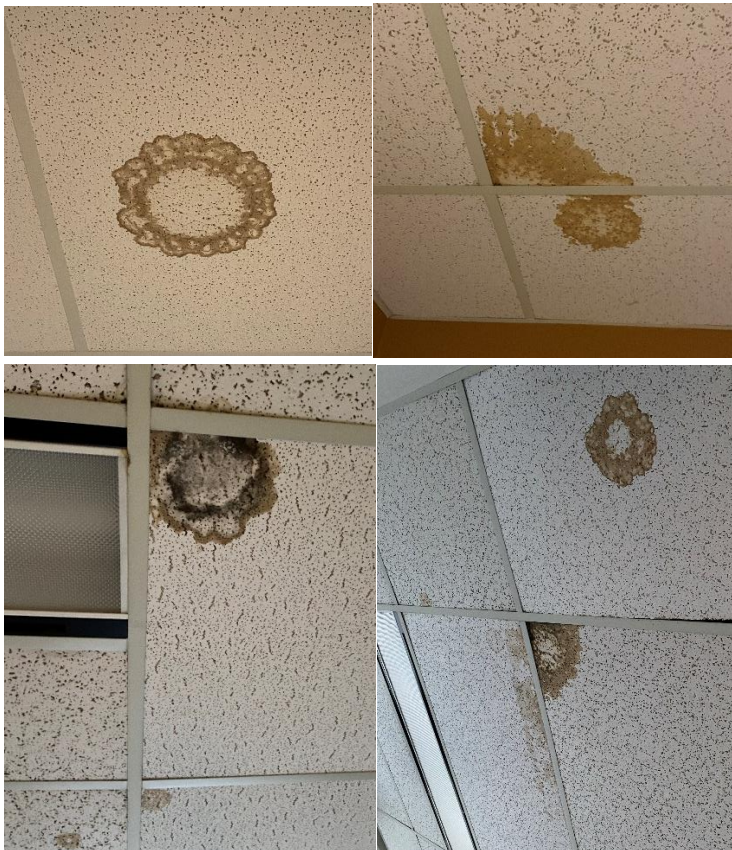
A visual survey of the subject building was conducted to determine if any water damaged was present. MPL identified select areas throughout the subject building where materials were affected by water damage.

Photo 8: View of water damaged ceiling tiles (non-asbestos containing) observed throughout the subject building.

Water stained/damaged ceiling tiles observed throughout the subject building should be replaced as part of regular maintenance and the underlying cause of the water leakage should be identified and repaired;

Water stained/damaged ceiling tiles that are also determined to contain asbestos must be replaced following appropriate asbestos abatement procedures as outlined in O.Reg. 278/05.
