HAZARDOUS MATERIALS SURVEY AND 2022 REASSESSMENT 100 THOMAS MORE AVENUE, OTTAWA, ON

Project No.: Z2021101HZ / CCC-230252-00

University of Ottawa

September 14, 2022

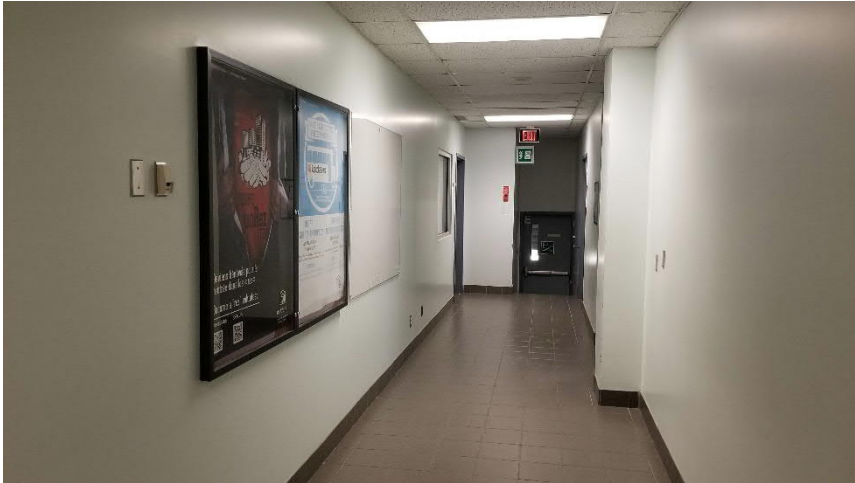
Photo 1: Representative view of the interior finishes observed in the subject building.

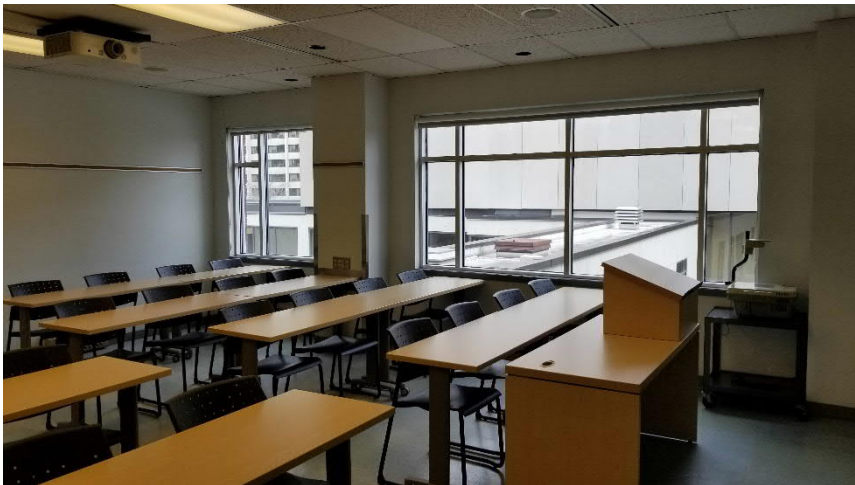
Photo 2: Representative view of the interior classroom finishes observed throughout the subject building.

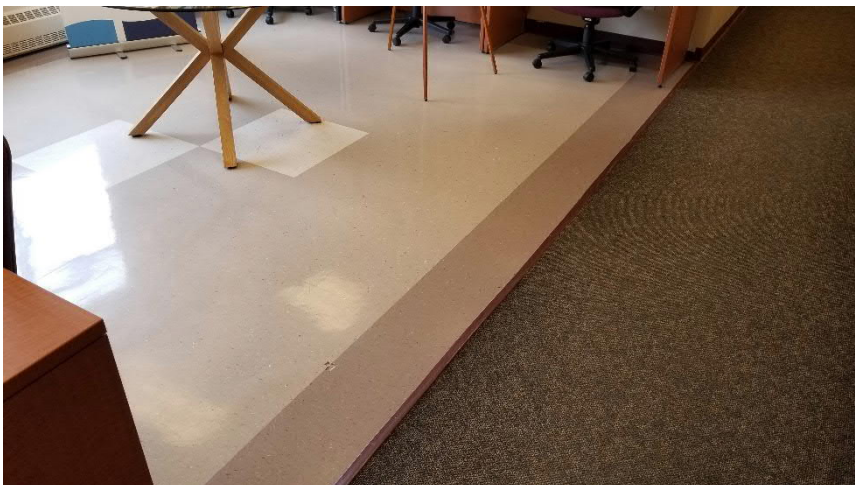
- Vinyl floor tiles (12" x 12"- Beige with White Flakes) were observed and sampled in Room 110. The laboratory analytical results indicate that this material does not contain asbestos. The associated mastic/levelling compound (Tan/Yellow/Grey) was also found not to contain asbestos.

Carpet mastic (Yellow) was observed and sampled in Room 327 and 333. The laboratory analytical results indicate that this material does not contain asbestos.

Photo 3: Representative view of the non-asbestos vinyl floor tiles and carpet mastic observed in the subject building.

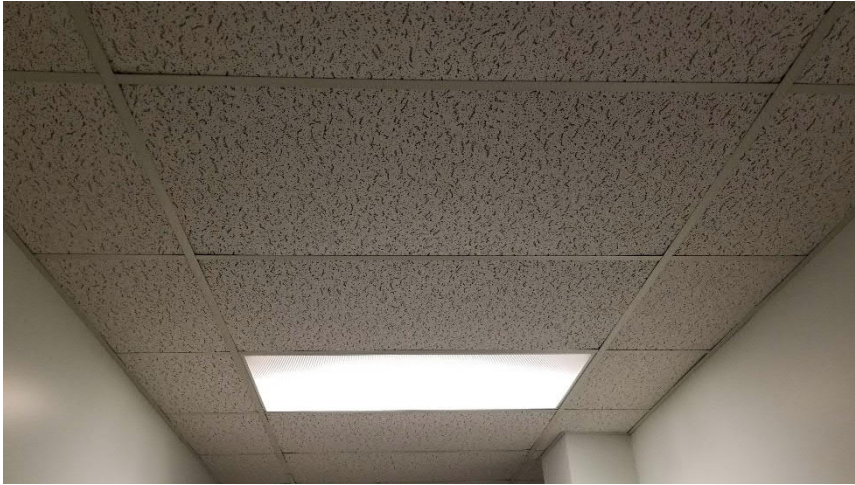
- Suspended ceiling tiles (2'x'4 – Pinholes and Small Fissures) were observed in Room 239. The date stamp on the back of these tiles indicated that they were manufactured in 2013 and therefore, this material is not considered to contain asbestos.

Photo 4: Representative view of the non-asbestos ceiling tiles identified throughout the subject building.

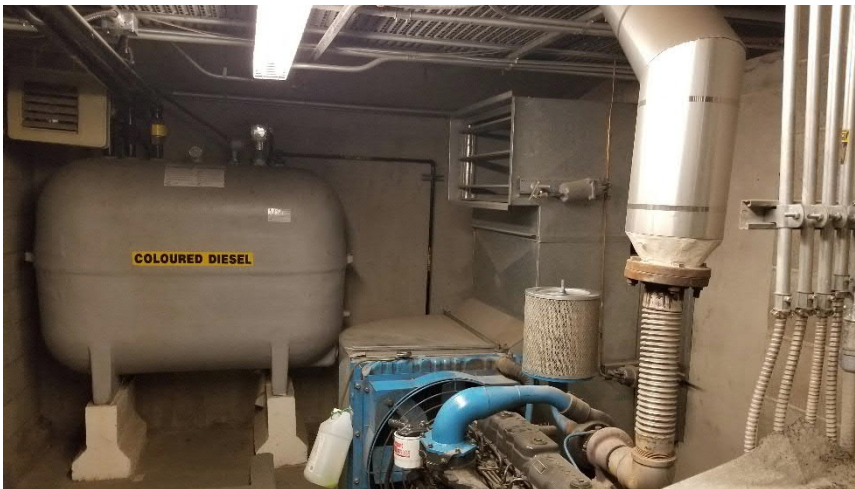
Photo 5: View of the above ground diesel storage tank identified in Room 005.

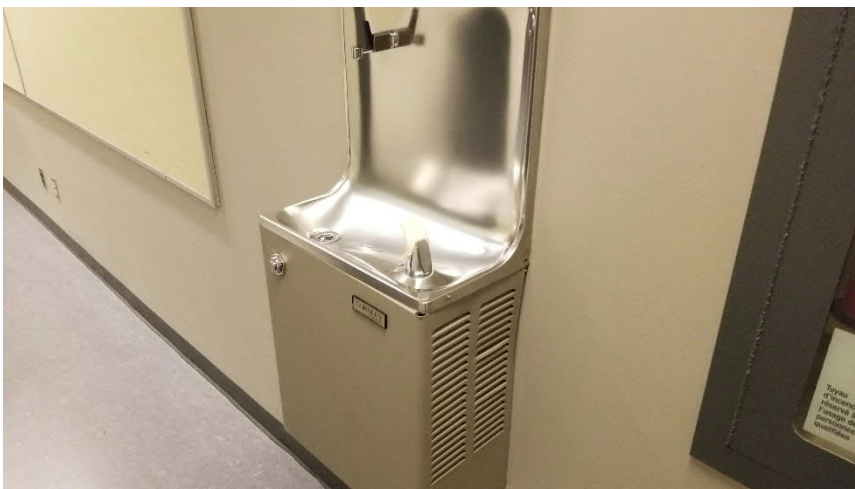
A visual assessment for equipment potentially containing ODSs and other halocarbons was conducted. Equipment containing ODSs or other halocarbons was observed in the subject building.

Photo 6: Representative view of the equipment containing ODSs identified throughout the subject building.

Please refer to Appendix F – Hazardous Materials Checklist for equipment conditions, approximate quantities (where applicable), and recommended actions.

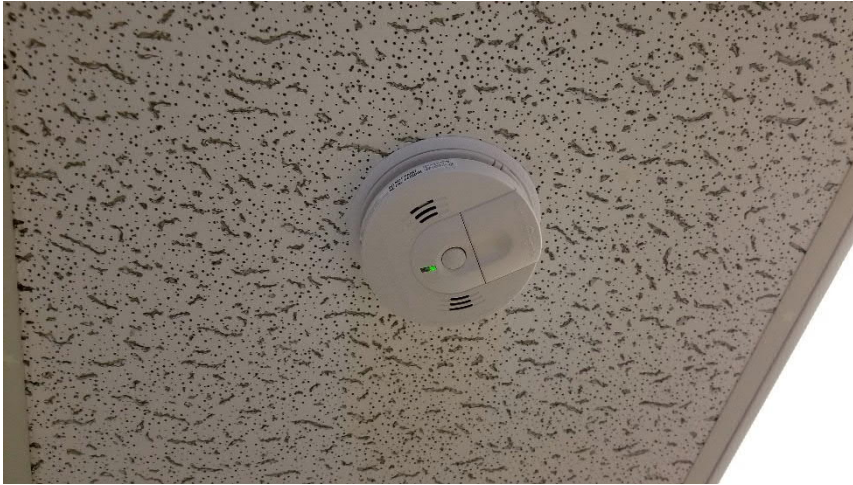
A visual assessment of the subject building was conducted to determine if any electrical components containing radioactive materials were present. MPL observed Kiddie brand smoke detectors, which contains small quantities of radioactive material.

Photo 7: Representative view of the smoke detectors containing radioactive materials observed in the subject building.

The radioactive sources in smoke alarms are sealed and contained within a metal case inside the smoke detector and must not be damaged or tampered with. These materials do not pose a hazard as long as they remain contained and properly disposed at the time of removal or replacement.

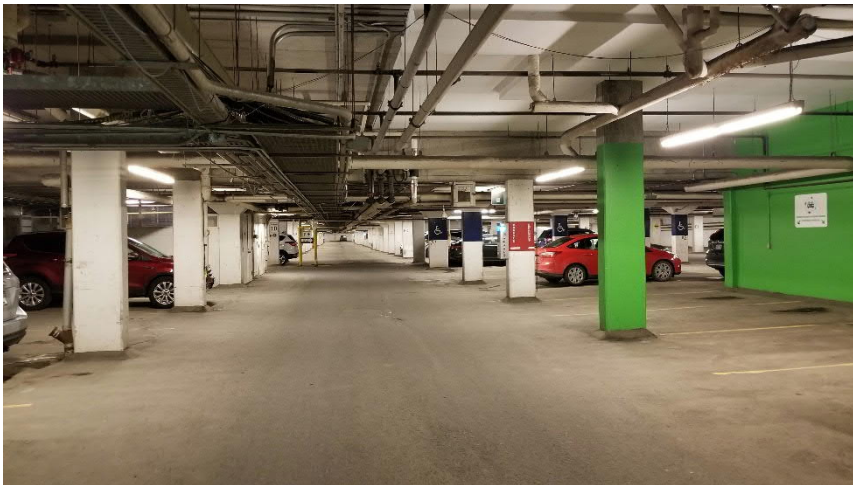
Photo 8: Representative view of the interior finishes observed throughout the subject building.

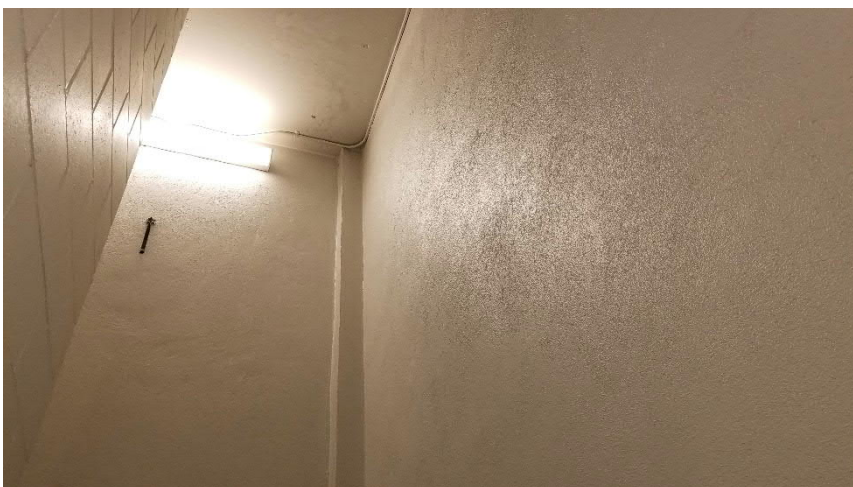
- ACM Cementous Coating was observed to be in Good Condition in Room 007.
- Suspected ACM in Floor Tile Grout, Concrete Block Mortar and Roofing Material were observed to be in Good Condition throughout the subject building.
- No mould or water damaged materials were observed during the site survey

- Cementitious wall coating (White) was observed and sampled in Room 007. The laboratory analytical results of the cementitious coating samples collected from Room 007 indicate that this material **contains 0.75% Chrysotile asbestos**. Since texture coat is a homogeneous material, all areas must be treated as asbestos-containing unless additional bulk sampling and analysis proves otherwise. This material was observed in good condition.
- Cementitious wall and ceiling coating (Grey) was observed and sampled in Room 019A. The laboratory analytical results indicate that this material does not contain asbestos.

Photo 9: View of the asbestos-containing cementitious coating (White) identified in Room 007.

- Materials identified to contain asbestos that are in good condition and do not pose a risk to workers or occupants can be managed in place. Prior to renovation/demolition activities that may disturb the ACMs, these materials must be removed following appropriate Type 1/2/3 asbestos abatement work procedures as detailed in O. Reg. 278/05 and disposed of as asbestos waste under O. Reg. 347;
- Please refer to Appendix E – Asbestos-Containing Materials Checklist for material conditions, quantities (where applicable), and recommended actions;

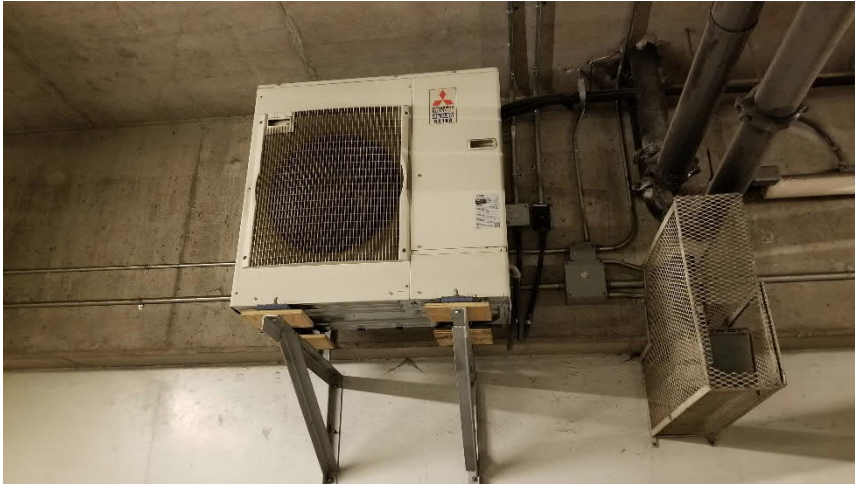
Photo 10: Representative view of the ODS containing air conditioning units observed throughout the subject building.

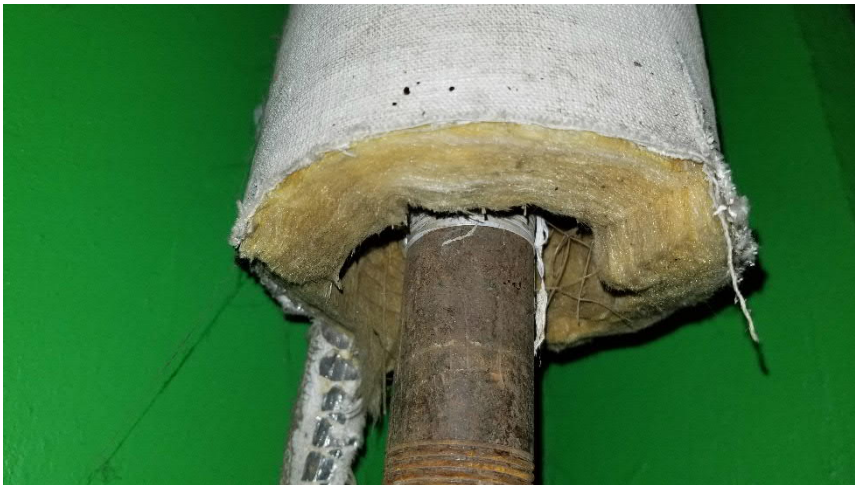
Mechanical pipe straight insulation was observed throughout the subject building. MPL made several incisions throughout to investigate its composition, and it was visually identified as fiberglass, and therefore not suspected of containing asbestos.

Photo 11: Representative view of the non-asbestos pipe straight insulation observed throughout the subject building.

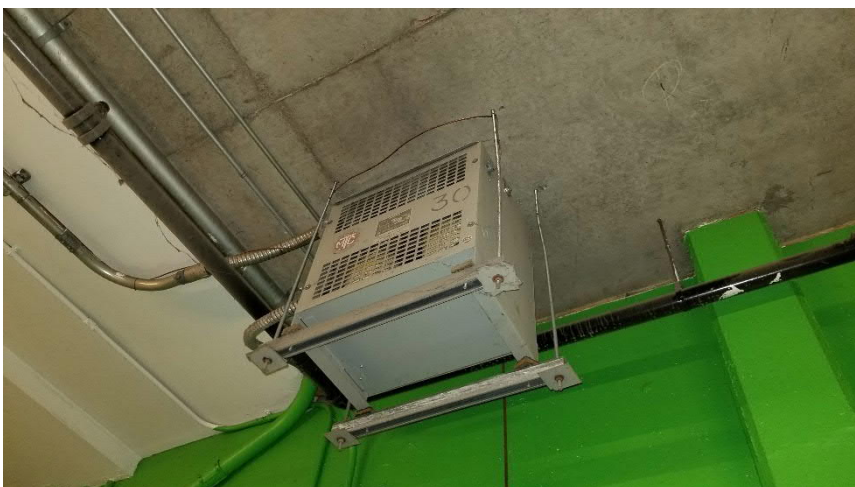
MPL did not observe any PCBs containing electrical transformers within the subject building. Transformers that could be assessed were observed to be dry-type.

Photo 12: View of the non-PCB dry-type transformers observed throughout the subject building.

Since no PCB-containing equipment was observed or suspected to be present during the site survey, no further action is required.

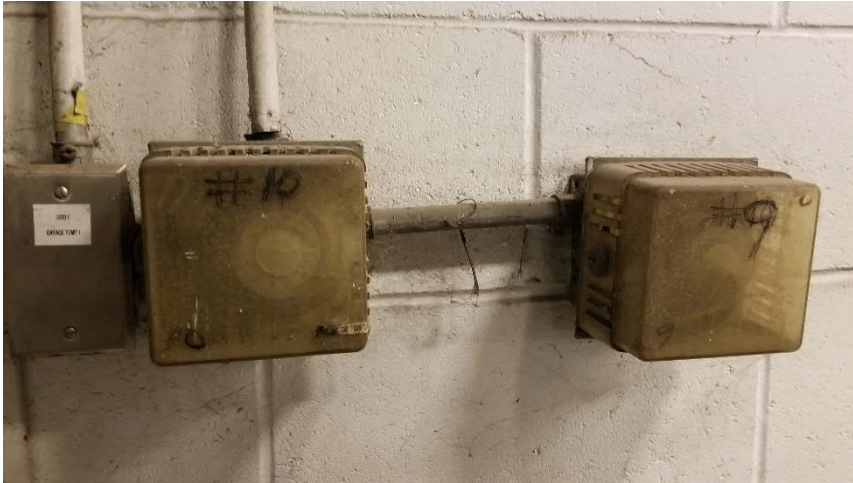
MPL observed thermostats containing liquid mercury within the subject building.

Photo 13: Representative view of the mercury-containing thermostat switches identified in Room 019.

Please refer to Appendix F – Hazardous Materials Checklist for equipment conditions, quantities (where applicable), and recommended actions.

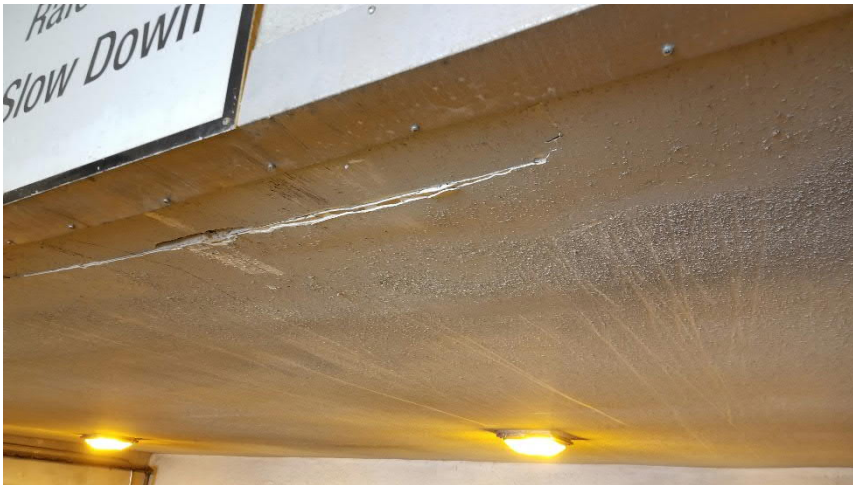
Photo 14: Representative view of the non-asbestos cementitious coating observed in Room 007.

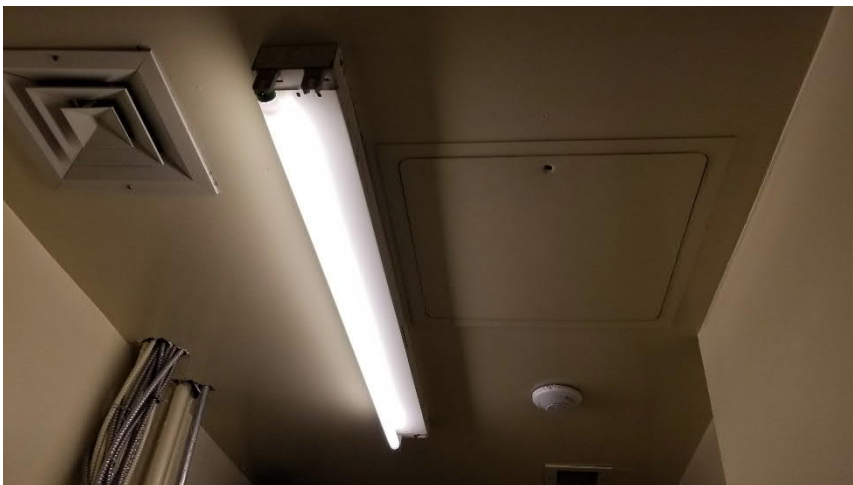
Photo 15: Representative view of the fluorescent light fixtures containing mercury vapour, observed throughout the subject building.
