HAZARDOUS MATERIALS SURVEY AND 2022 REASSESSMENT 113 OSGOODE STREET, OTTAWA, ON

Project No.: 0Z2021101HZ / CCC-230252-00

University of Ottawa

McIntosh Perry Limited (MPL)

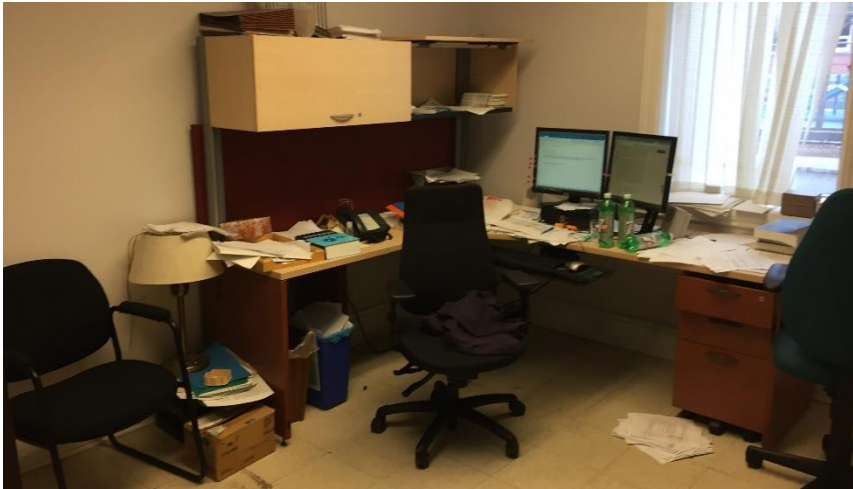
Photo 1: View of the interior finishes observed throughout the subject building.

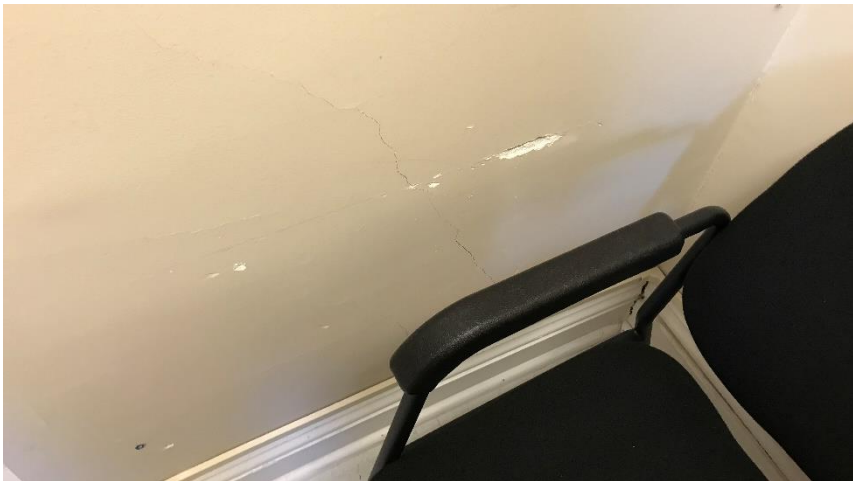
- Wall plaster (White) was observed and sampled in Room B1. The laboratory analytical results indicate that this material does not contain asbestos.
- Ceiling plaster (White) was observed and sampled in Room 101. The laboratory analytical results indicated that this material does not contain asbestos.

Photo 2: View of the non-asbestos containing wall plaster observed throughout the subject building.

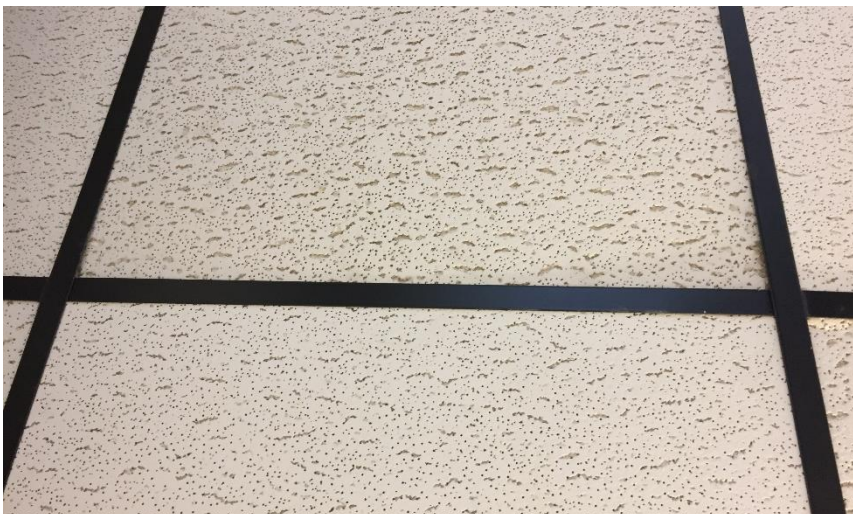
Ceiling tiles (2'x4' - Pinholes w/ Wide Fissures) were observed and sampled in Room 102. The laboratory analytical results indicated that this material does not contain asbestos.

Photo 3: View of the non-asbestos containing ceiling tiles identified throughout the subject building.

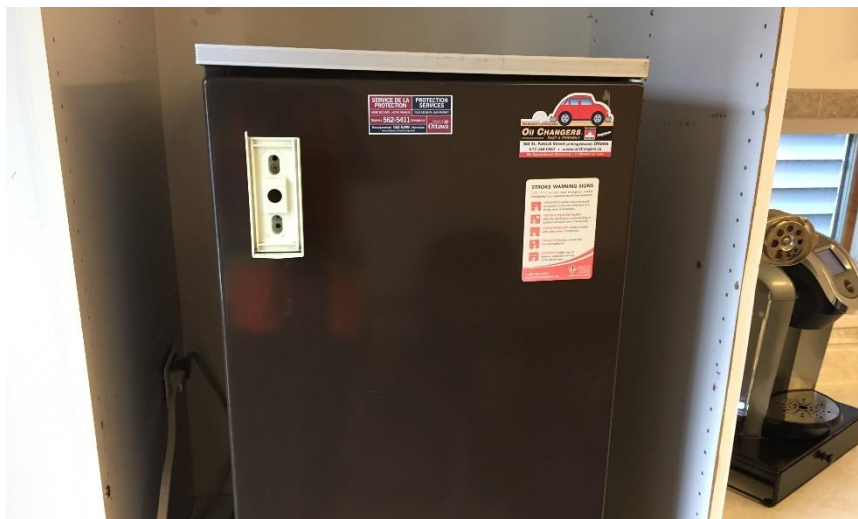
A visual assessment for equipment potentially containing ODSs and other halocarbons was conducted. Equipment containing ODSs or other halocarbons was observed in the subject building.

Photo 4: View of the ODS-containing equipment observed in the subject building.

Please refer to Appendix F – Hazardous Materials Checklist for equipment conditions, approximate quantities (where applicable), and recommended actions.

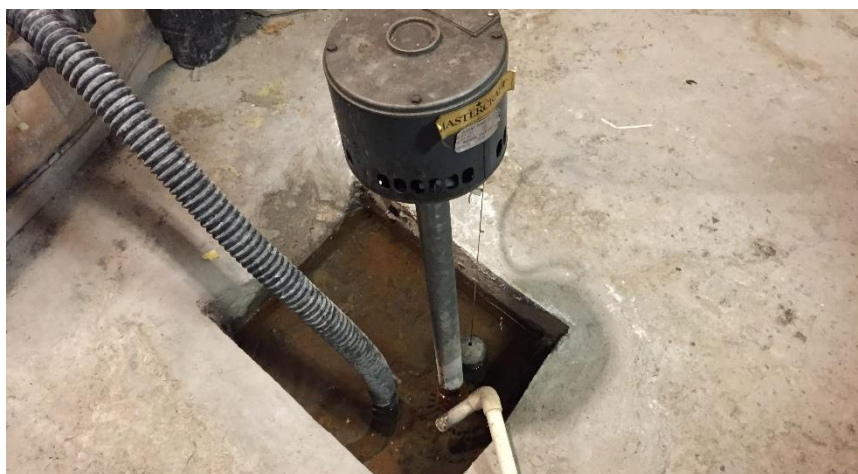
Photo 5: View of the sump pump containing a mercury float switch observed in Room B1.

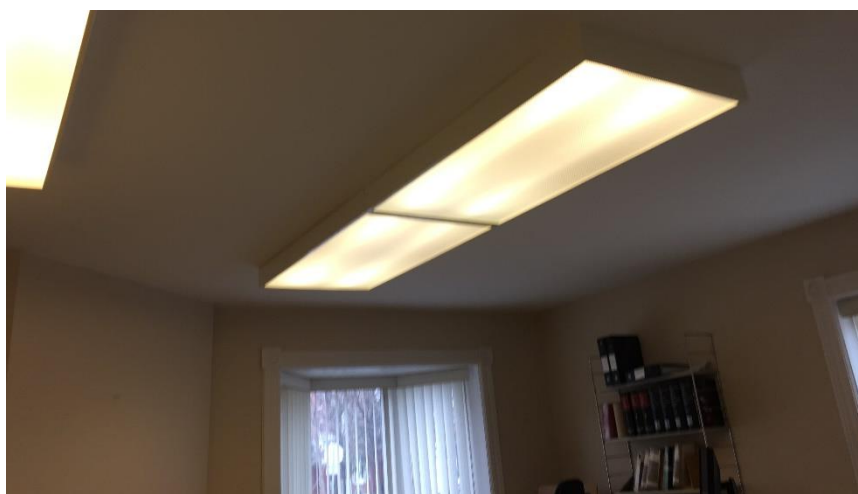
Photo 6: View of the mercury vapour containing fluorescent light fixtures observed throughout the subject building.
