# HAZARDOUS MATERIALS SURVEY AND 2022 REASSESSMENT 120 OSGOODE STREET, OTTAWA, ON

Project No.: Z2021101HZ / CCC-230252-00

University of Ottawa

October 25, 2022

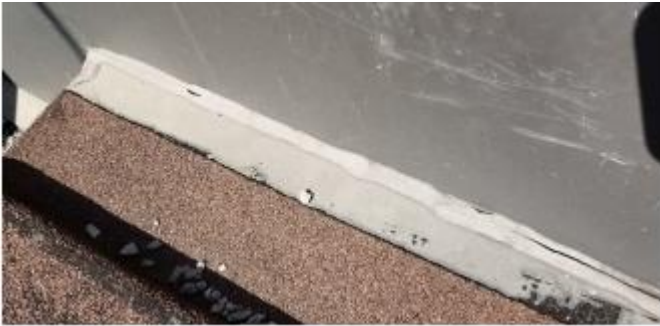
Roofing materials were previously observed and sampled in the subject building. The laboratory analytical results of roofing material samples collected indicate that this material contains up to 10% Chrysotile asbestos in the tar and caulking of the roof. This material was observed to be in good condition.

Photo 1: View of asbestos-containing caulking (Light Grey) on the roof.

- Materials identified to contain asbestos that are in good condition and do not pose a risk to workers or occupants can be managed in place. Prior to renovation/demolition activities that may disturb the ACMs, these materials must be removed following appropriate Type 1/2/3 asbestos abatement work procedures as detailed in O. Reg. 278/05 and disposed of as asbestos waste under O. Reg. 347;

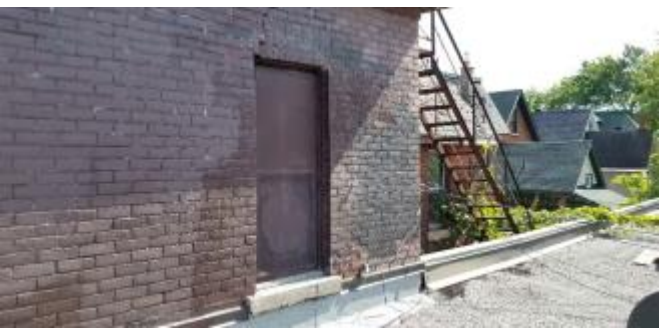
The paint finishes highlighted in pink in the above table are considered lead-containing paints or surface coatings with concentrations greater than 0.1% lead by weight. These paint finishes were observed to be in good condition.

Photo 2: View of lead-containing dark brown paint observed on the roof.

Paints identified to contain lead that are in good condition and do not pose a risk to workers or occupants can be managed in place.

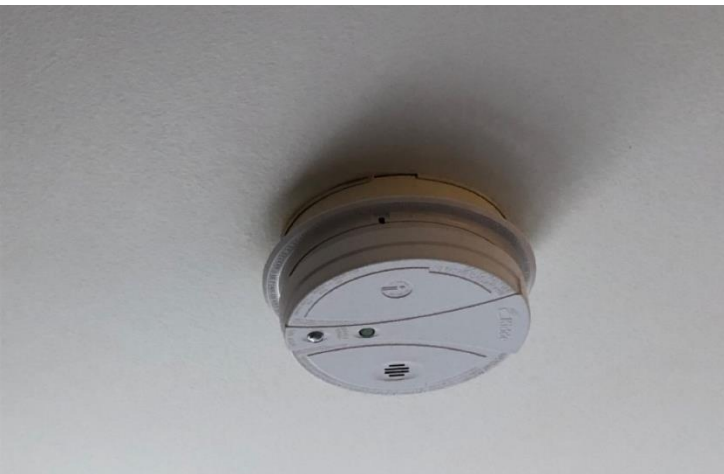
A visual assessment of the subject building was conducted to determine if any electrical components containing radioactive materials were present. MPL observed smoke detectors within the subject building which contain small quantities of radioactive material.

Photo 3: Typical view of smoke detectors containing radioactive materials.

The radioactive sources in smoke alarms are sealed and contained within a metal case inside the smoke detector and must not be damaged or tampered with. These materials do not pose a hazard as long as they remain contained and properly disposed at the time of removal or replacement.

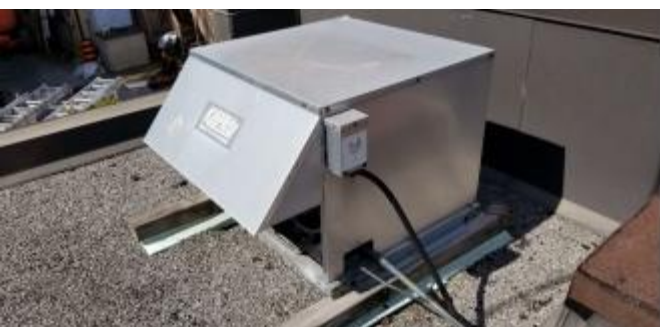
A visual assessment for equipment potentially containing ODSs and other halocarbons was conducted. MPL observed equipment such as refrigerators which contain or are suspected of containing ODSs or other halocarbons.

Photo 4: View of ODS containing air-handling unit observed on the roof.
