HAZARDOUS MATERIALS SURVEY AND 2022 REASSESSMENT 120 UNIVERSITY PRIVATE, OTTAWA, ON

Project No.: Z2021101HZ / CCC-230252-00

University of Ottawa

McIntosh Perry Limited (MPL)

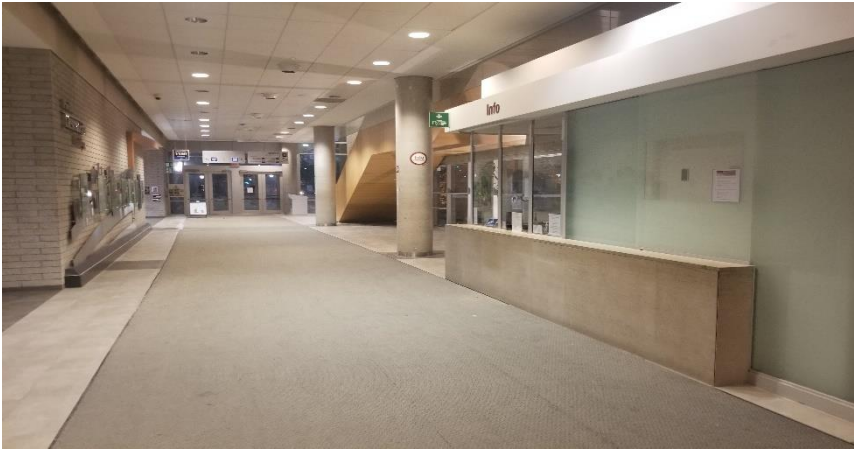
Photo 1: View of typical building finishes.

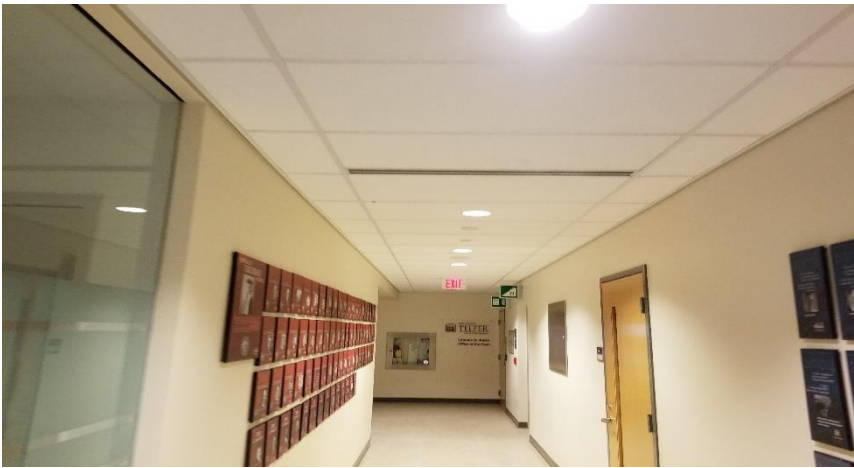
Photo 2: View of typical hallway finishes.

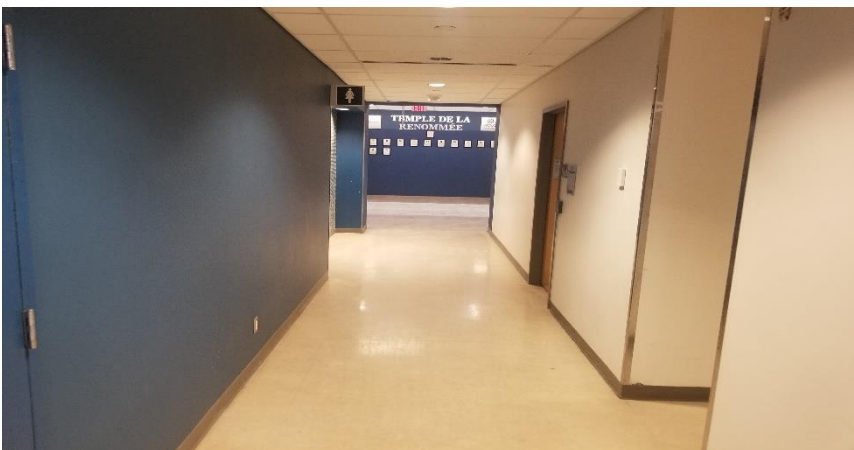
MPL identified lead-containing acid battery packs throughout the subject building. These battery packs were observed on walls and above exits throughout the subject building.

Photo 3: View of typical hallway finishes with lead-acid batteries present in emergency lights.

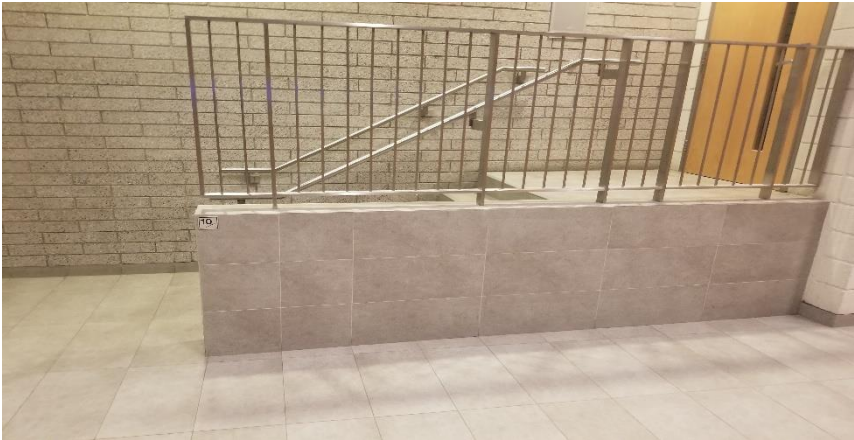
Silica is expected to be present in building materials such as concrete, brick, mortar and ceramic tiles located throughout the structures. Free crystalline silica (α -Quartz) may be a component in ceiling tiles and gypsum board. Silica (including free crystalline silica) may also be a component of concrete and brick surfaces noted in the building.

Photo 4: Typical silica containing brick, mortar, concrete and ceramic tile finishes.

Please refer to Appendix D – Designated Substances Checklist for equipment conditions, quantities (where applicable), and recommended actions.

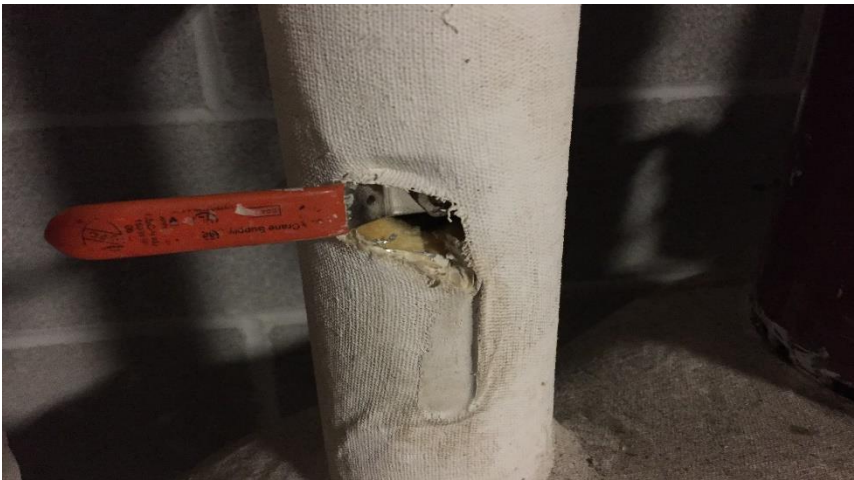
Photo 5: Typical view of fibreglass mechanical insulation.
