# HAZARDOUS MATERIALS SURVEY AND 2022 REASSESSMENT 129 - 141 LOUIS-PASTEUR PRIVATE, OTTAWA, ON

Project No.: Z2021101HZ / CCC-230252-00

University of Ottawa

McIntosh Perry Limited (MPL)

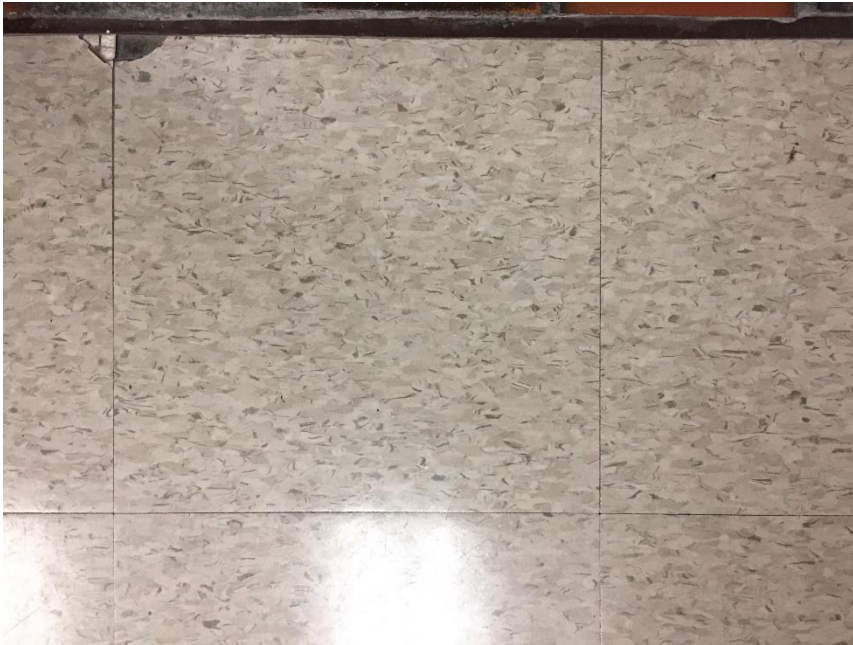
- Vinyl floor tiles (12" x 12"- Light and Dark Grey Smudge) were observed and sampled in Room 117. The laboratory analytical results indicate that this material contain 5% Chrysotile asbestos. The material was observed to be in good condition. The associated mastic (Black) was also found not to contain asbestos.
- Vinyl floor tiles (12" x 12"- White with Grey Streaks) were observed and sampled in Room 176. The laboratory analytical results indicate that this material contain 5% Chrysotile asbestos. The material was observed to be in good condition
- Vinyl floor tiles (12" x 12"- White w/Grey Mix) were observed and sampled in Room 281. The laboratory analytical results indicate that this material does not contain asbestos. The associated mastic (Beige) was also found not to contain asbestos.

Photo 1: View of asbestos containing VFT – 12"X12" Light and Dark Grey in Room 177

- Materials identified to contain asbestos that are in good condition and do not pose a risk to workers or occupants can be managed in place. Prior to renovation/demolition activities that may disturb the ACMs, these materials must be removed following appropriate Type 1/2/3 asbestos abatement work procedures as detailed in O. Reg. 278/05 and disposed of as asbestos waste under O. Reg. 347;

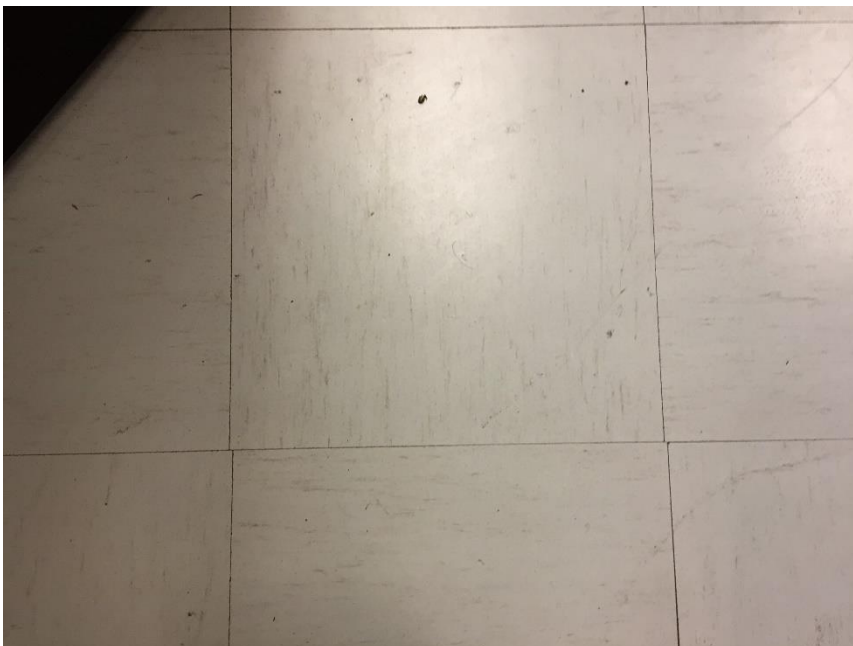
Photo 2: View of asbestos containing VFT – 12"X12" Beige in Room 176

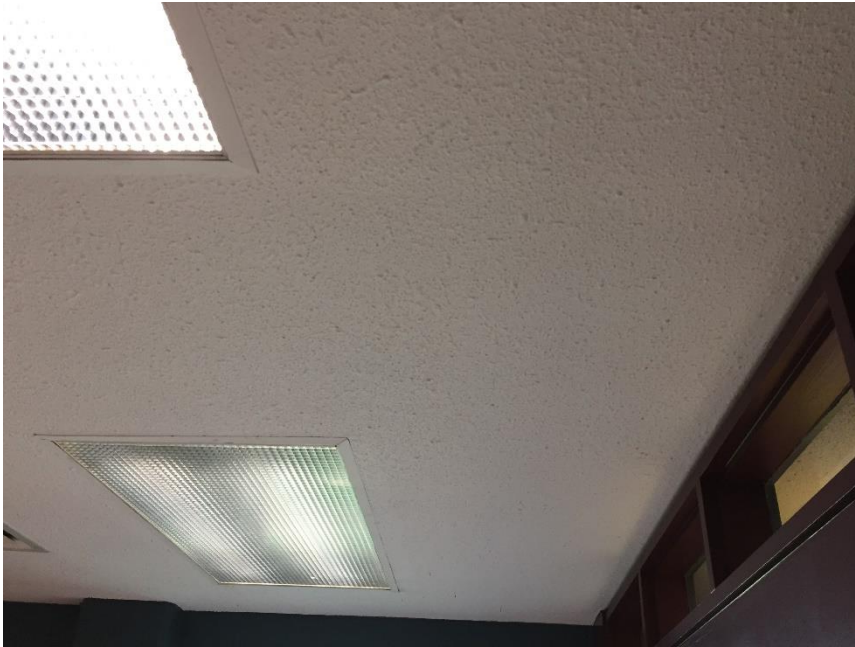
Ceiling texture coating was observed and sampled in Room 172. The laboratory analytical results of ceiling texture coat samples collected from Room 172 indicate that this material contains 4% Chrysotile asbestos. This material is considered to be friable and was observed in good condition.

Photo 3: View of asbestos containing texture coat (popcorn ceiling) in Room 172.

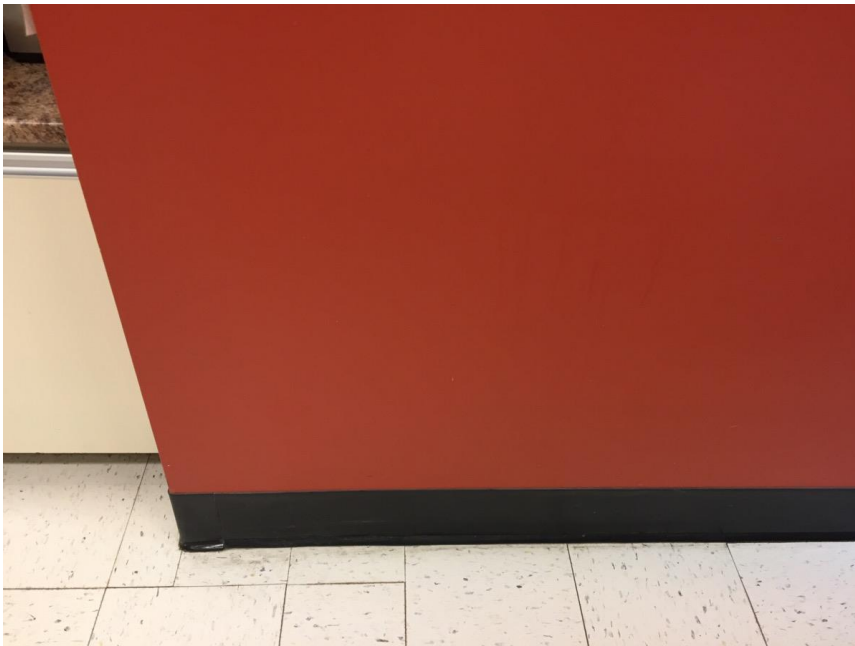
The paint finishes highlighted in pink in the above table are considered lead-containing paints or surface coatings with concentrations greater than 0.1% lead by weight. These paint finishes were observed to be in fair condition.

Photo 4: View of red lead containing paint in Room 179

Paints identified to contain lead that are in fair condition should be either repaired (where possible) and/or closely monitored for signs of further deterioration.

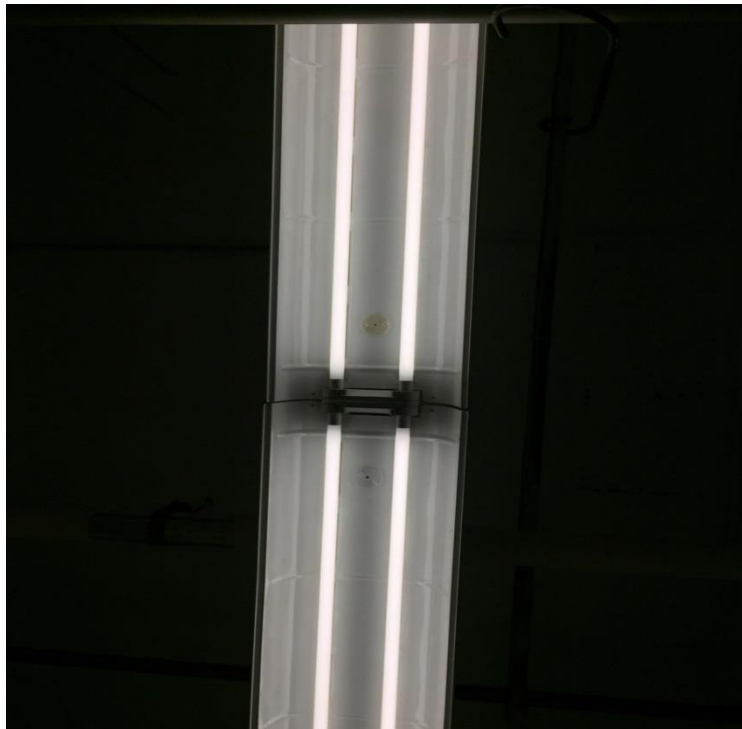
The subject building is illuminated by LED and fluorescent lights. MPL assessed representative ballasts in the building, and these ballasts were suspected to contain PCBs. These light ballasts were observed to be manufactured by Sylvania.

Photo 7 View of of flourscent bulb suspected to contain PCB

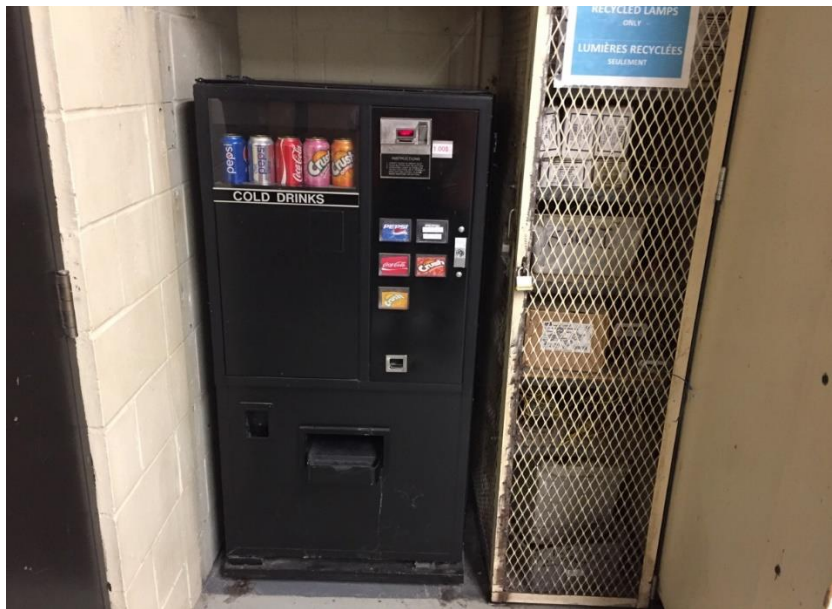
Photo 8 View of vending machine suspected to contain ODS in Room 100C

Please refer to Appendix F – Hazardous Materials Checklist for equipment conditions, approximate quantities (where applicable), and recommended actions.

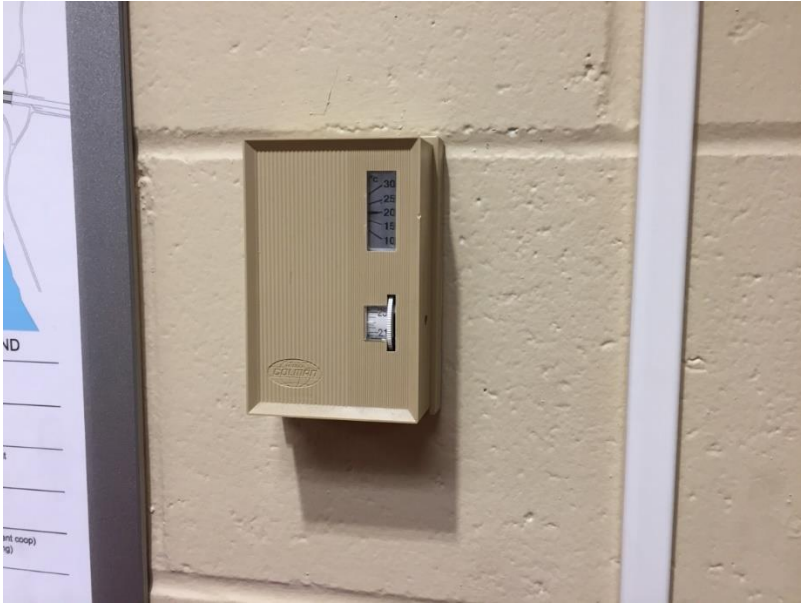
MPL observed thermostats containing liquid mercury within the subject building.

Photo 9 View of Thermostat suspected to contain mercury in Room 120A

Please refer to Appendix F – Hazardous Materials Checklist for equipment conditions, quantities (where applicable), and recommended actions.

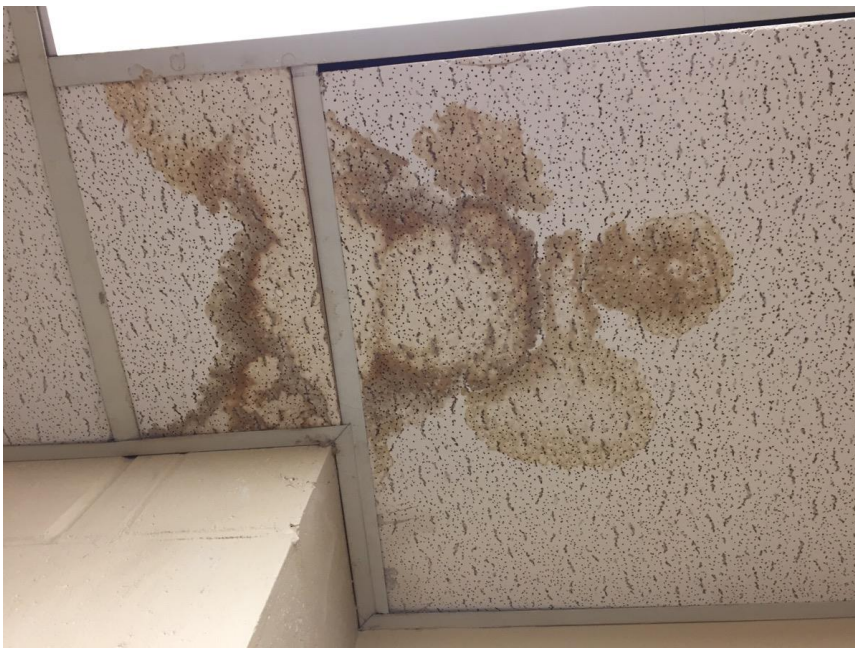
A visual survey of the subject building was conducted to determine if any water damaged was present. MPL identified select areas throughout the subject building, where materials were affected by water damage.

View of water damage ceiling tile in Room 100B

Water stained/damaged ceiling tiles observed throughout the subject building should be replaced as part of regular maintenance and the underlying cause of the water leakage should be identified and repaired.
