HAZARDOUS MATERIALS SURVEY AND 2022 REASSESSMENT 143 SERAPHIN-MARION PRIVATE, OTTAWA, ON

Project No.: Z2021101HZ / CCC-230252-00

University of Ottawa

October 26, 2022

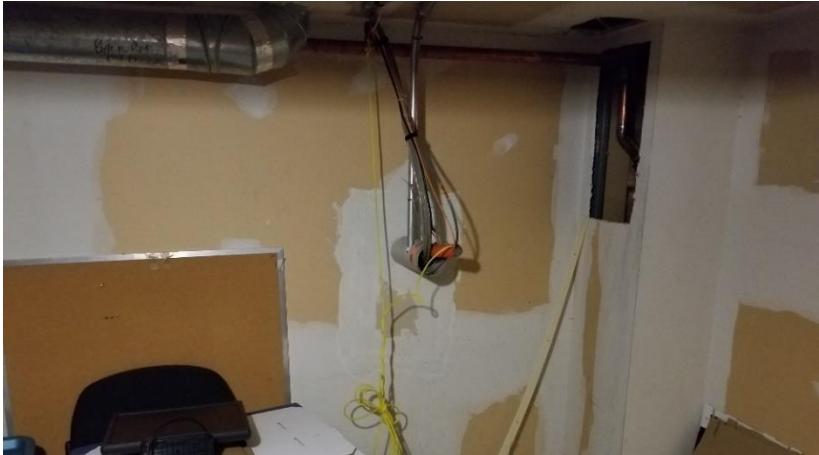
Drywall joint compound was observed throughout the subject building. The laboratory analytical results of the samples collected indicate that this material contains 1% Chrysotile asbestos. Since drywall joint compound is a homogeneous material, all areas must be treated as asbestos-containing unless additional bulk sampling and analysis proves otherwise. This material was observed in good condition.

Photo 1: Typical view of asbestos-containing drywall joint compound observed throughout the subject building.

- Materials identified to contain asbestos that are in good condition and do not pose a risk to workers or occupants can be managed in place. Prior to renovation/demolition activities that may disturb the ACMs, these materials must be removed following appropriate Type 1/2/3 asbestos abatement work procedures as detailed in O. Reg. 278/05 and disposed of as asbestos waste under O. Reg. 347;

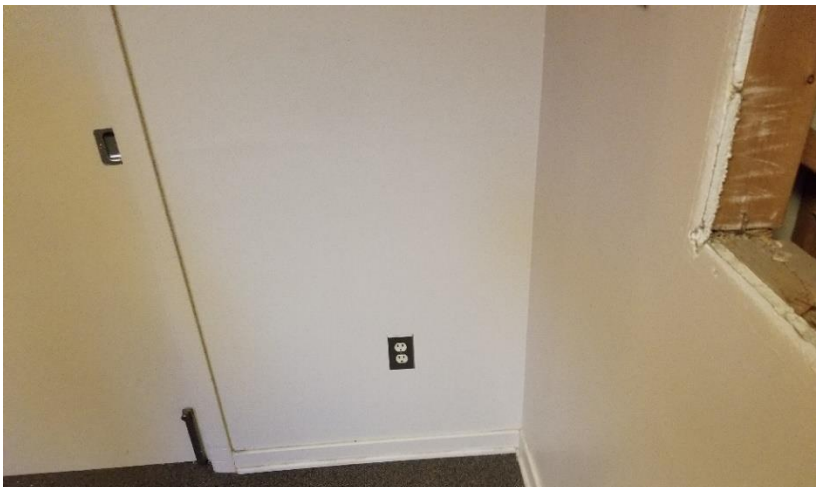
Photo 2: Typical view of asbestos-containing drywall joint compound observed throughout the subject building.

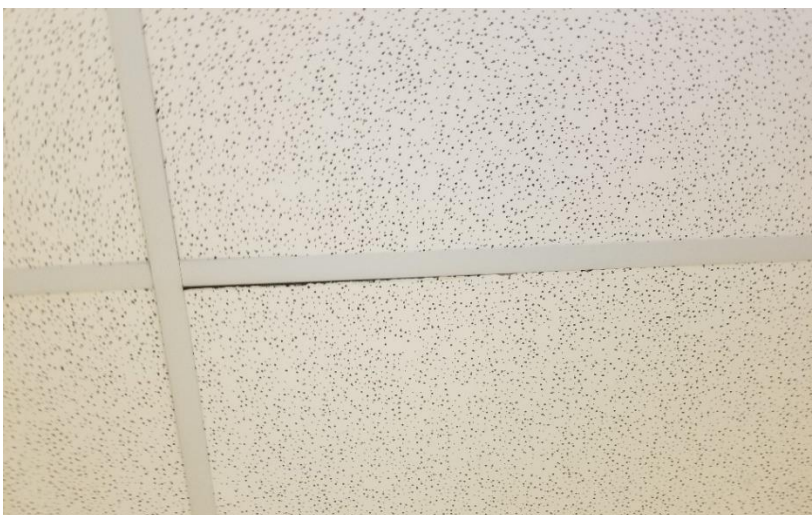
Suspended ceiling tiles (2'x4' – Varying Pinholes) were observed throughout the subject building. The laboratory analytical results of ceiling tile samples collected from Room 207 indicate that this material does not contain asbestos.

Photo 3: Typical view of non-asbestos-containing suspended ceiling tiles observed throughout the subject building.

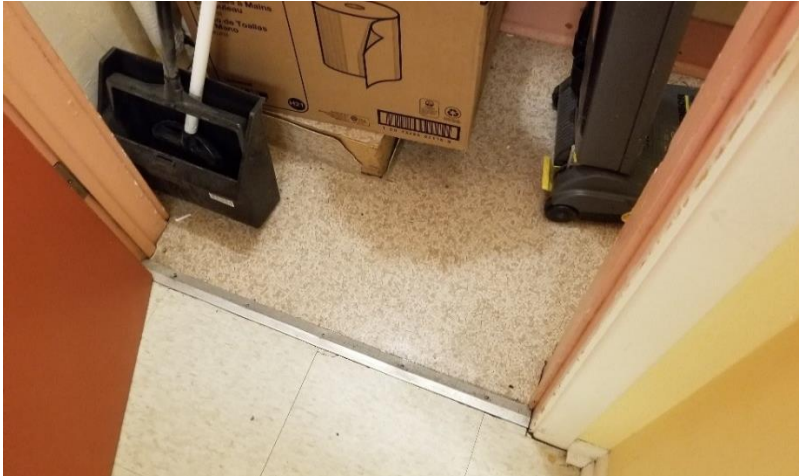
Vinyl floor tiles (12"x12" White w/ Grey Flakes) were observed throughout the subject building. The laboratory analytical results of the vinyl floor tile samples collected from Room 104 indicate that this material does not contain asbestos. The associated mastic/backing material (Yellow and Beige) was also found not to contain asbestos.

- Vinyl sheet flooring (Grey and White) was observed throughout the subject building. The laboratory analytical results of the vinyl sheet flooring samples collected from the Room 200/200A indicate that this material does not contain asbestos. The associated mastic/backing material (beige) was also found not to contain asbestos.
- Vinyl sheet flooring (Rubber Stair Cover) was observed and sampled in Rooms 106/203. The laboratory analytical results of the vinyl sheet flooring samples collected indicate that this material does not contain asbestos. The associated mastic/backing material (brown) was also found not to contain asbestos.

Photo 4: View of non-asbestos vinyl sheet flooring (Grey and White) and non-asbestos 12"x12" vinyl floor tiles (White w/ Grey Flakes).

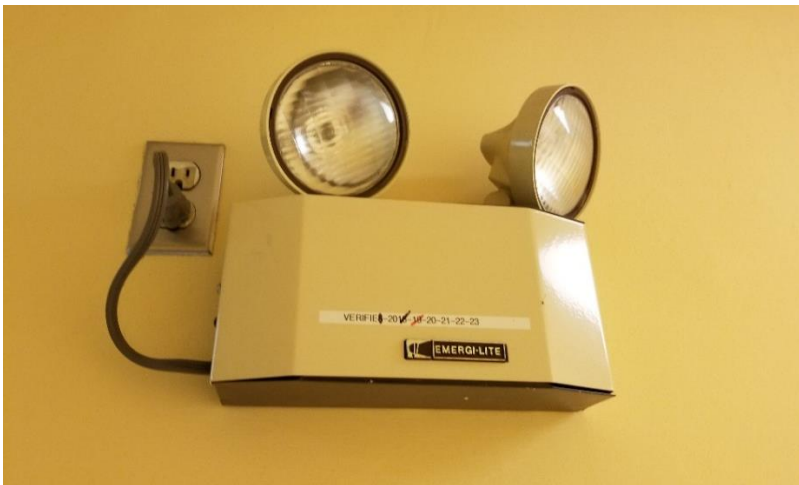
MPL identified lead-containing acid battery packs throughout the subject building. These battery packs were observed on the walls and above the exits throughout the subject building.

Photo 5: Typical view of lead-battery packs observed throughout the subject building.

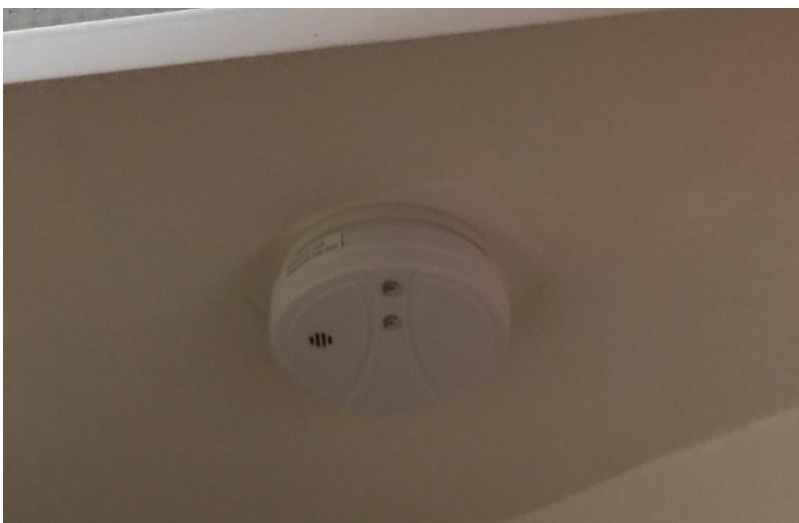
A visual assessment of the subject building was conducted to determine if any electrical components containing radioactive materials were present. MPL observed smoke detectors within the subject building which contain small quantities of radioactive material.

Photo 6: View of radioactive containing smoke detector observed in Room 300.

The radioactive sources in smoke alarms are sealed and contained within a metal case inside the smoke detector and must not be damaged or tampered with. These materials do not pose a hazard as long as they remain contained and properly disposed at the time of removal or replacement.
