HAZARDOUS MATERIALS SURVEY AND 2022 REASSESSMENT 145 SERAPHIN-MARION PRIVATE, OTTAWA, ON

Project No.: Z2021102HZ / CCC-230252-00

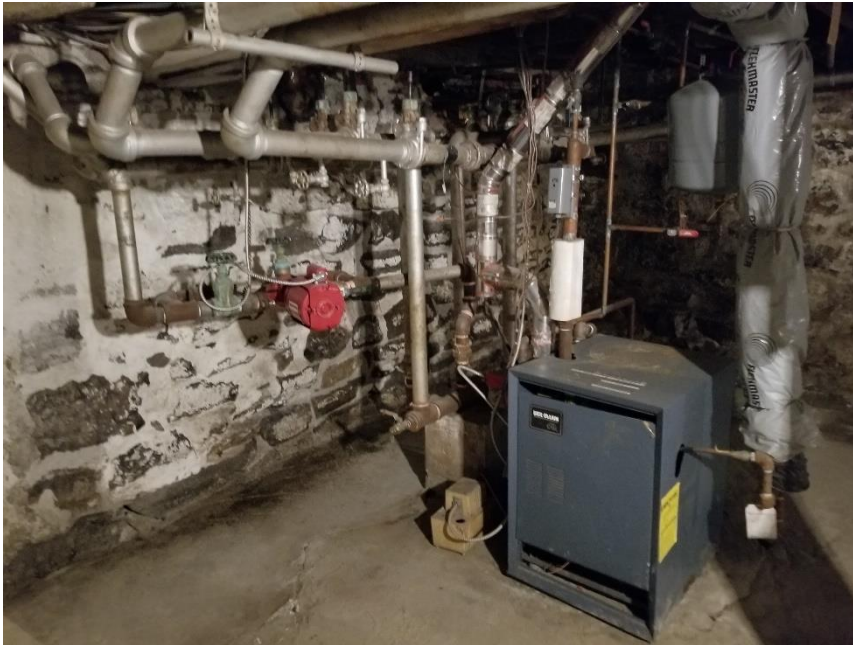
Photo 1: Typical electric boiler connected to radiant heating system. No pipe insulation observed.

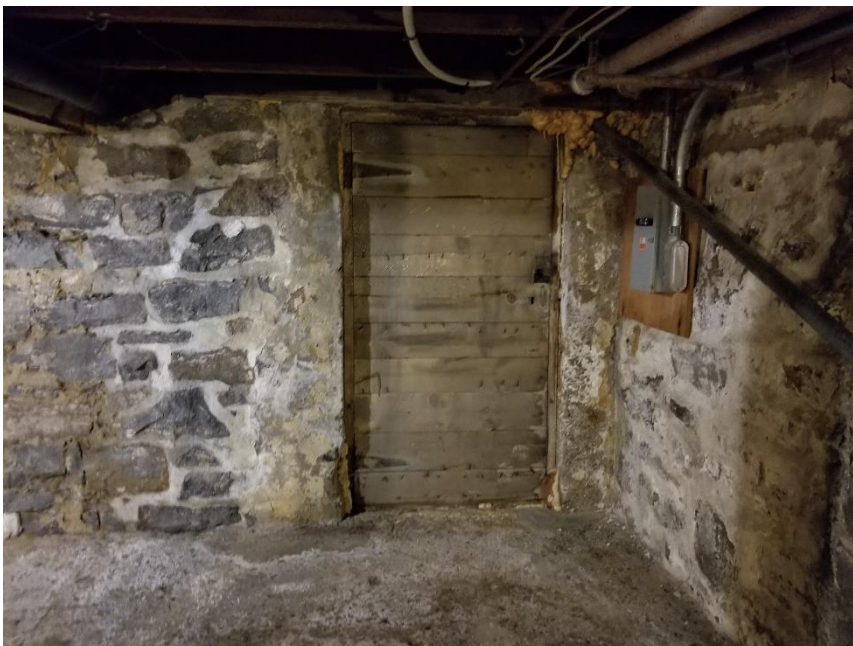
Photo 2: Representative view of the finishes observed throughout the basement level.

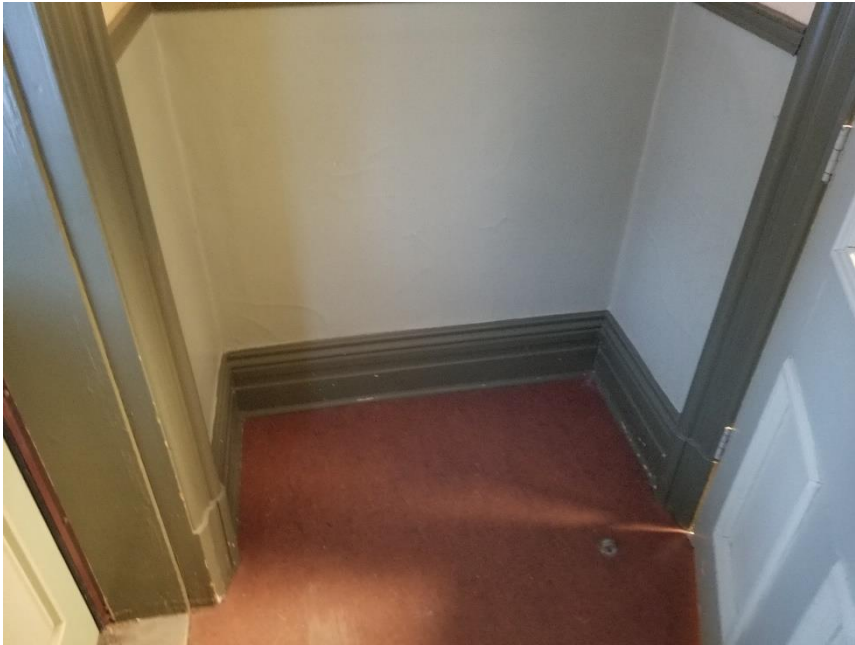
Photo 3: Representative view of the vinyl sheet flooring (VSF) identified in the subject building.

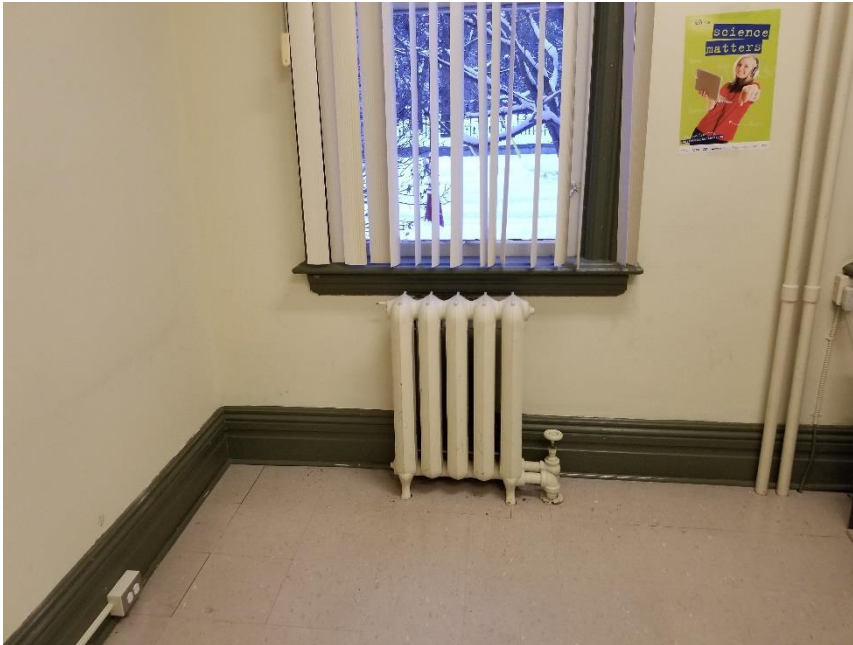
Photo 5: Representative view of the non-asbestos vinyl floor tiles 12"x12" Purple w/ White flakes observed in Room 104.

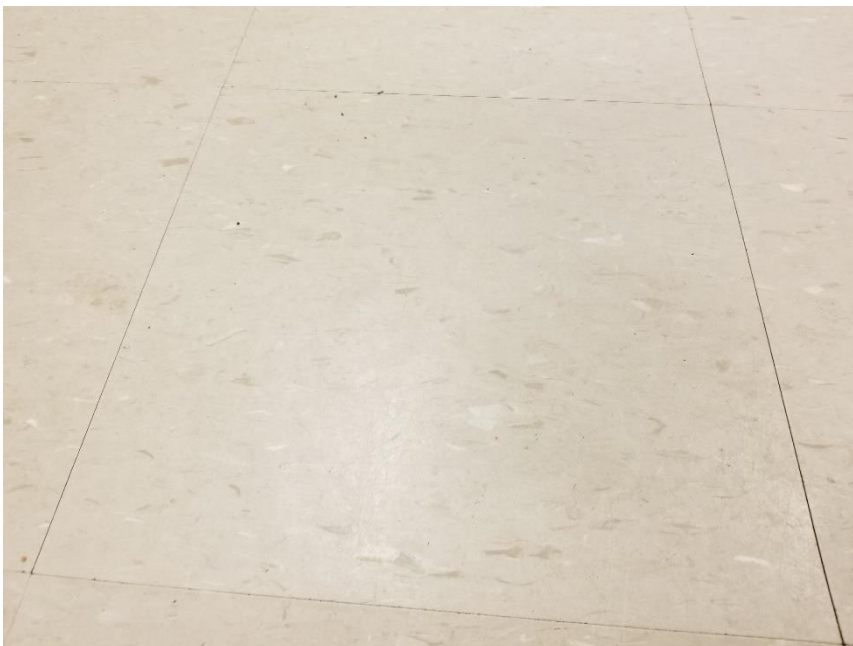
Photo 6: View of the non-asbestos vinyl floor tile finishes observed throughout the subject building.

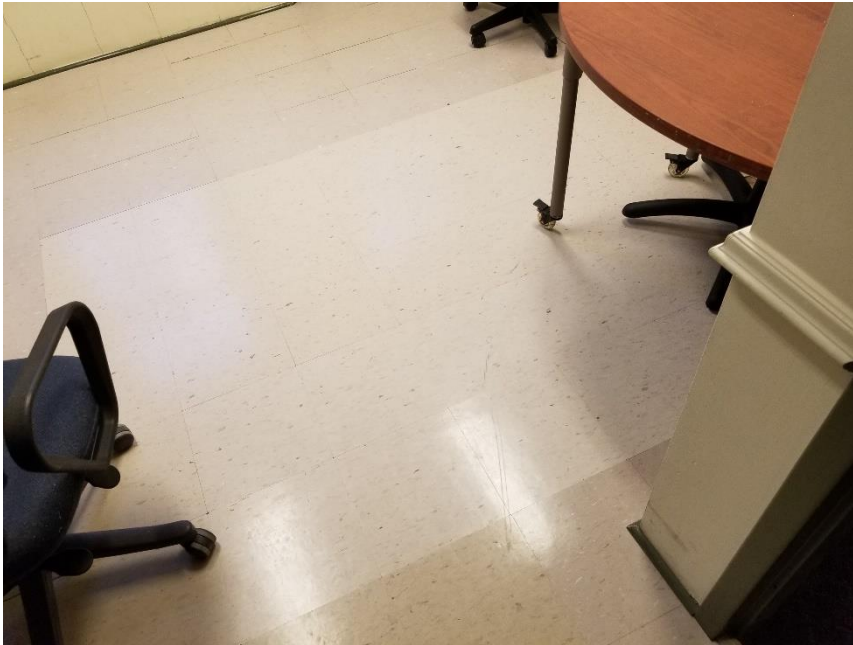
Photo 7: Room 101 which contains all three observed types of non-asbestos VFT.

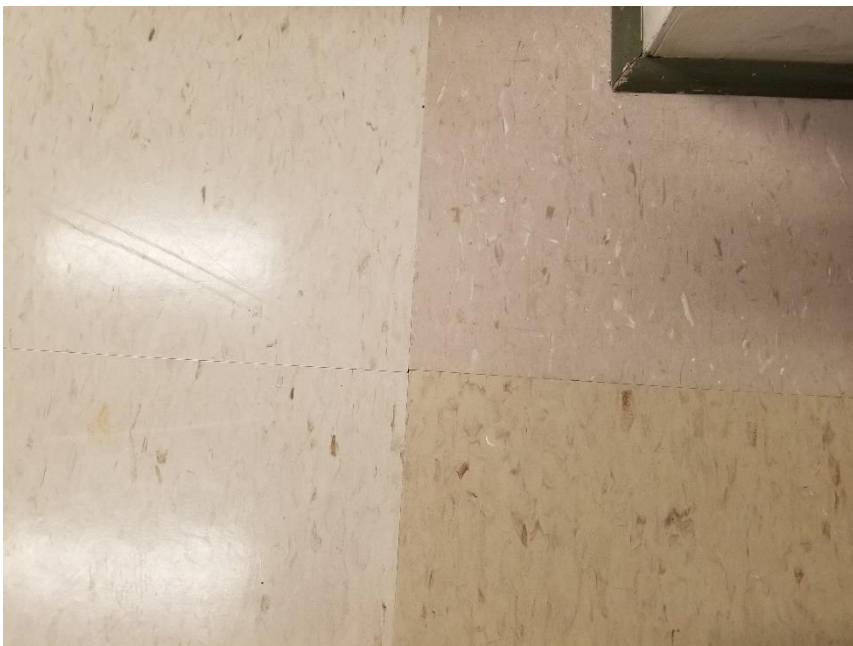
Photo 8: Representative view of the non-asbestos vinyl floor tiles observed throughout the subject building.

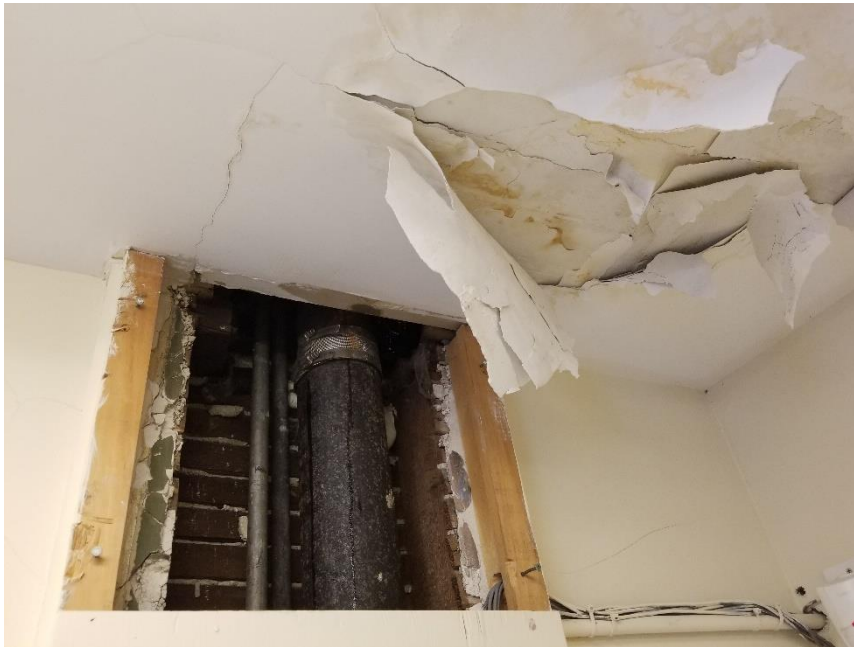
Photo 9: View of the poor condition asbestos-containing drywall joint compound peeling on ceiling from apparent water damage.

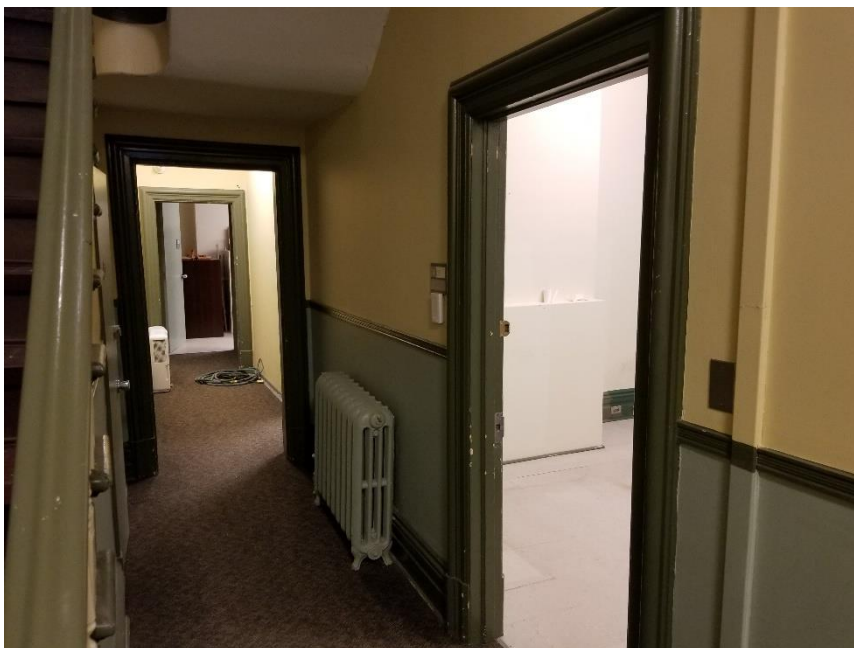
Photo 10: Representative view of the interior finishes observed throughout the subject building.

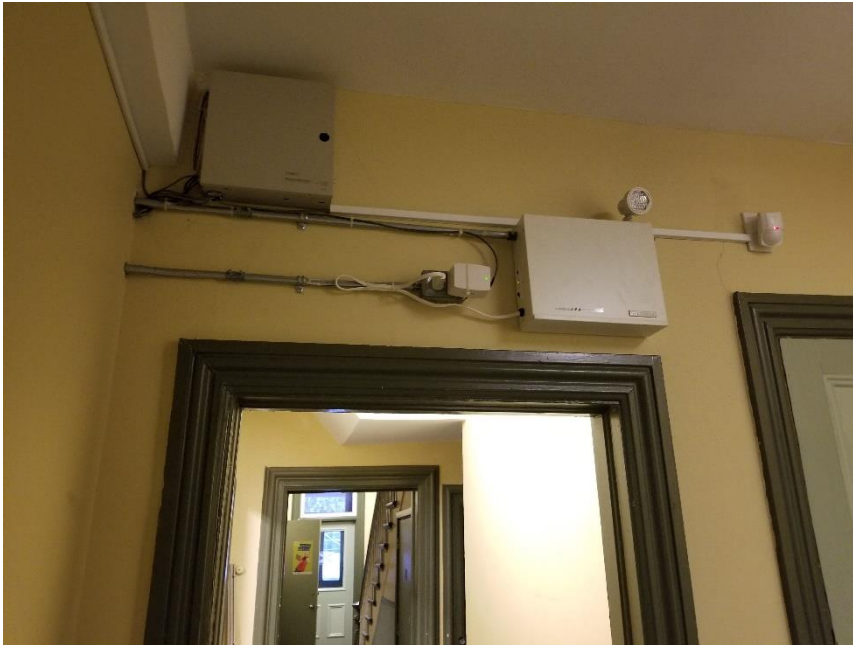
Photo 11: Emergency lighting present throughout the subject building. Lights are expected to contain lead-acid batteries
