HAZARDOUS MATERIALS SURVEY AND 2022 REASSESSMENT 157 SERAPHIN-MARION PRIVATE, OTTAWA, ON

Project No.:0Z2021101HZ / CCC-230252-00

University of Ottawa

October 31, 2022

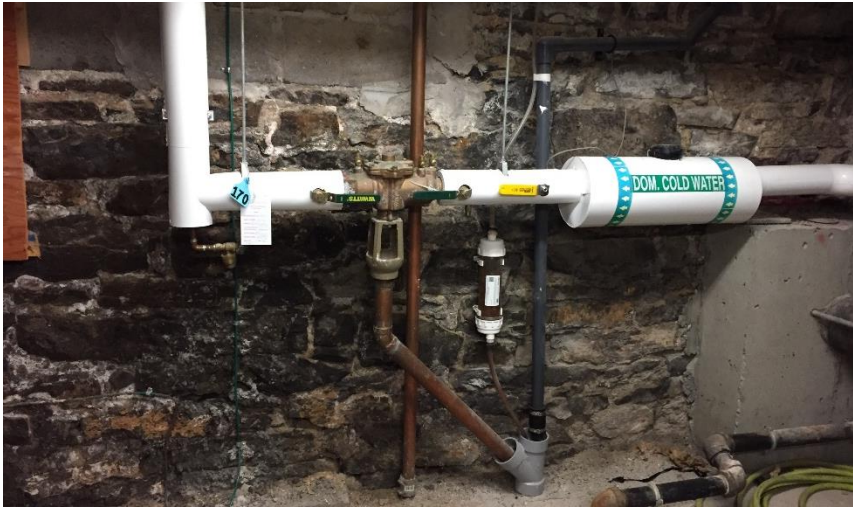
Mechanical pipe straight insulation was observed throughout the subject building. MPL made several incisions throughout to investigate its composition, and it was visually identified as fiberglass, and therefore not suspected of containing asbestos.

Photo 1: Representative view of the fiberglass insulation observed throughout the subject building.

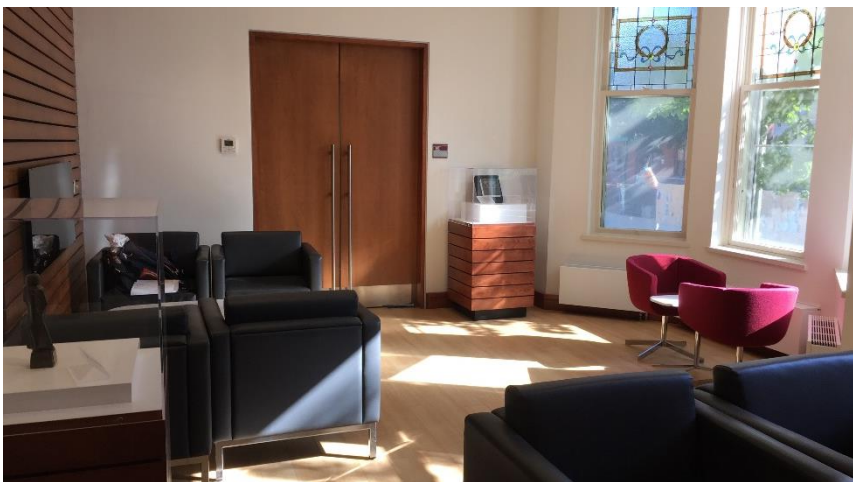
Photo 2: View of the interior finishes observed throughout the subject building.

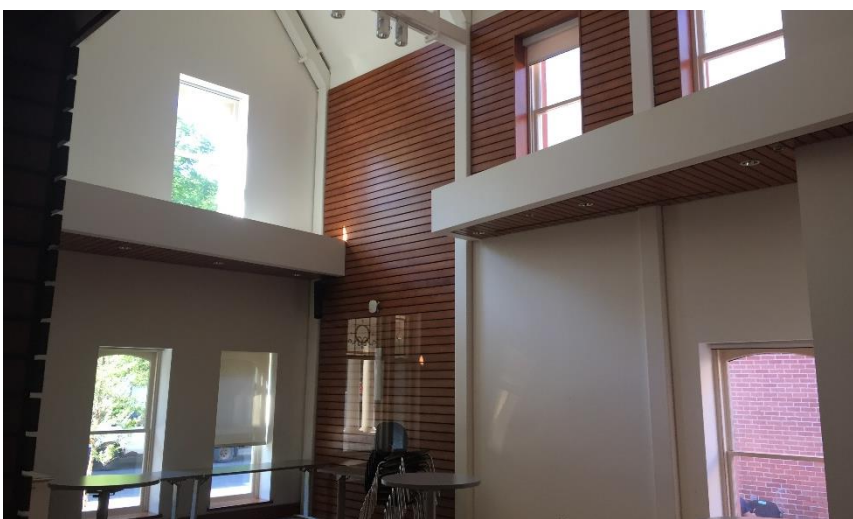
Photo 3: View of the interior finishes observed throughout the subject building.

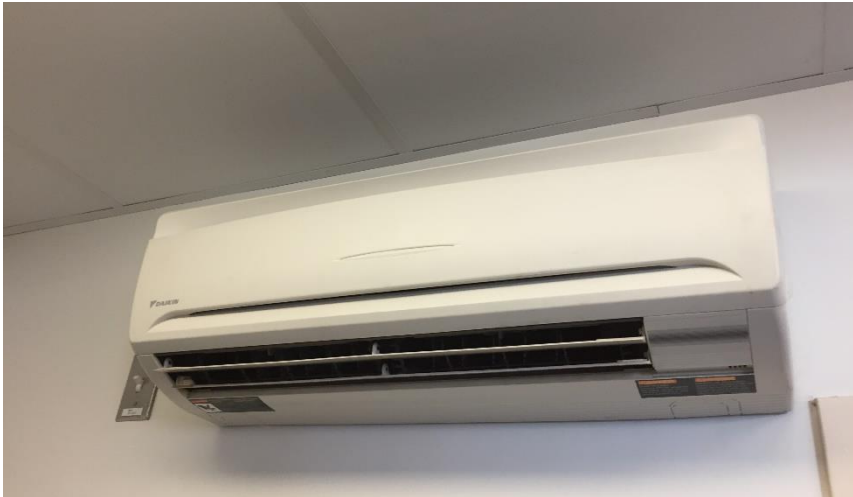
A visual assessment for equipment potentially containing ODSs and other halocarbons was conducted. Equipment containing ODSs or other halocarbons was observed in the subject building.

Photo 4: View of the equipment containing ODSs observed throughout the subject building.

Please refer to Appendix F – Hazardous Materials Checklist for equipment conditions, approximate quantities (where applicable), and recommended actions.

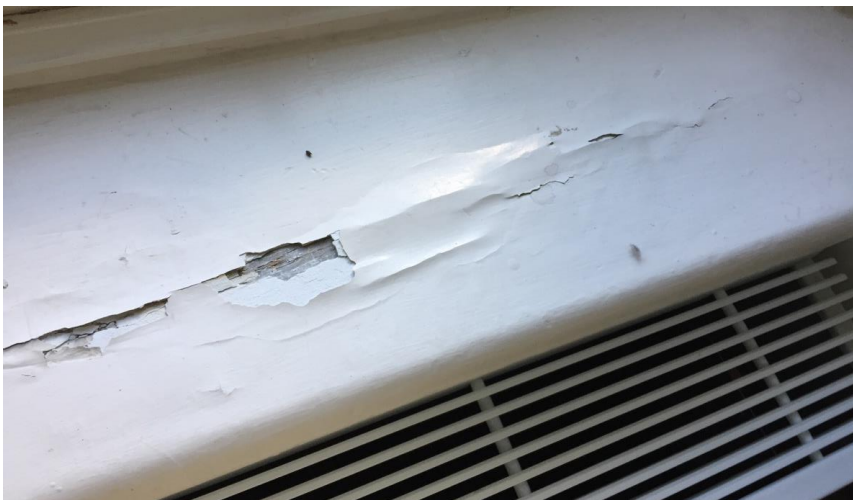
The paint finishes highlighted in pink in the above table are considered lead-containing paints or surface coatings with concentrations greater than 0.1% lead by weight. These paint finishes were observed to be in good condition with the exception of select areas that were observed in poor condition.

Photo 5: View of the poor condition lead paint (White) observed in Room 303.

Paints identified to contain lead that are in poor condition must be immediately repaired and/or stabilized following a minimum Type 1/2 lead abatement procedures as per OMOL "Lead on Construction Project" dated April 2011.
