HAZARDOUS MATERIALS SURVEY AND 2022 REASSESSMENT 1 STEWART STREET, OTTAWA, ON

Project No.: Z2021101HZ / CCC-230252-00

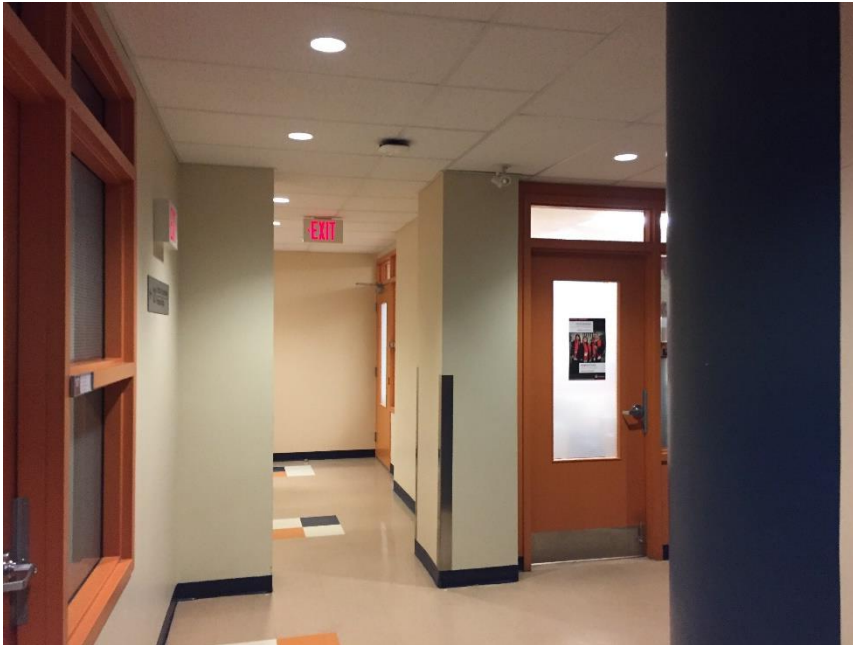
Photo 1: Typical view of finishes observed within the subject building.

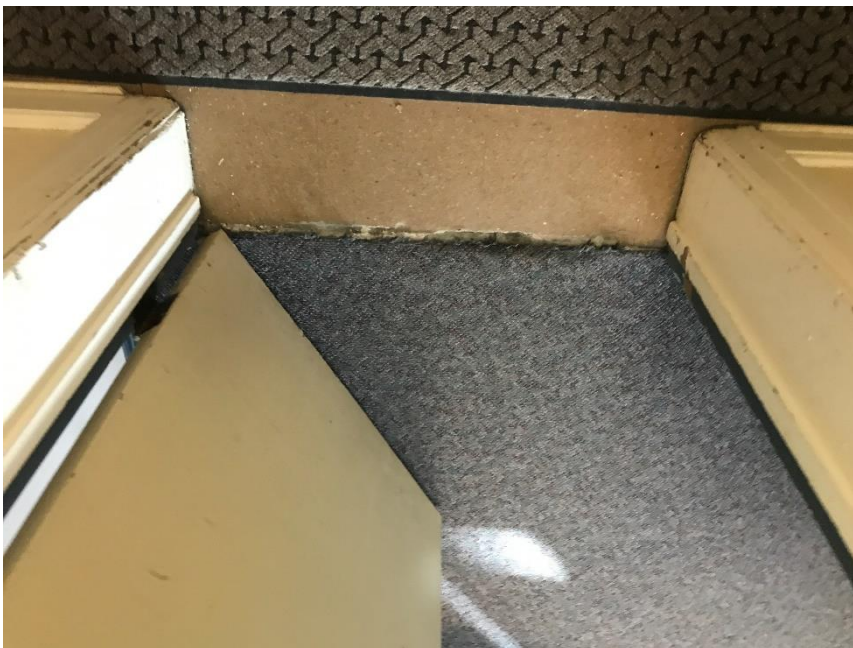
Photo 2: View of asbestos-containing vinyl sheet flooring (grey) underneath the carpet observed in Room 223.

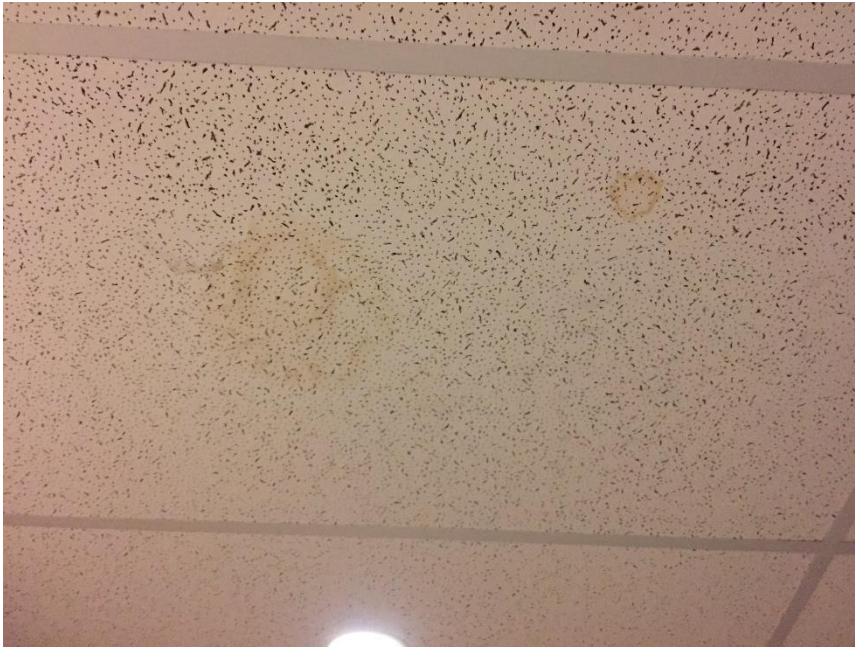
Photo 3: View of water damaged suspended ceiling tiles observed in Room 100.

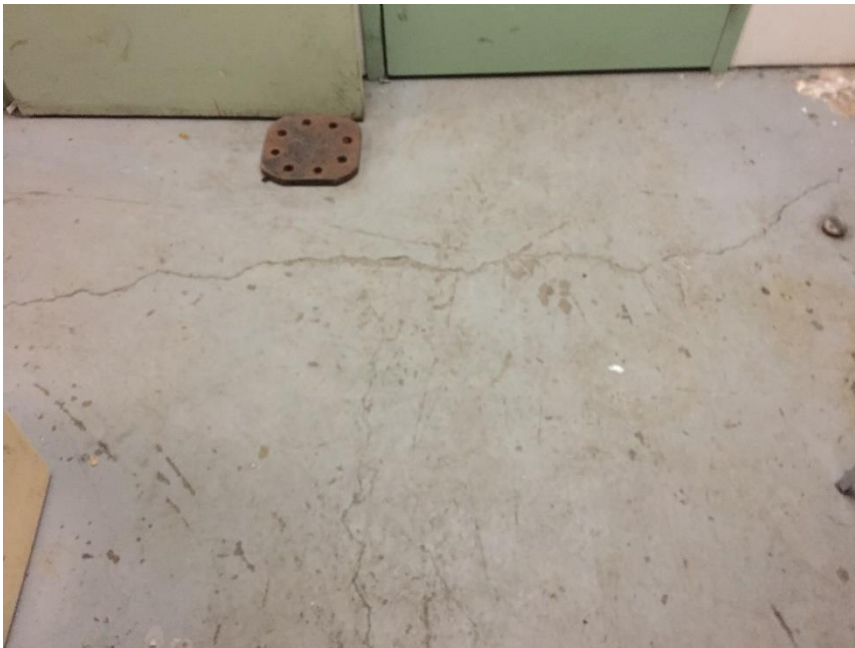
Photo 4: View of low level lead-containing grey paint within Room 06A observed to be in good condition.

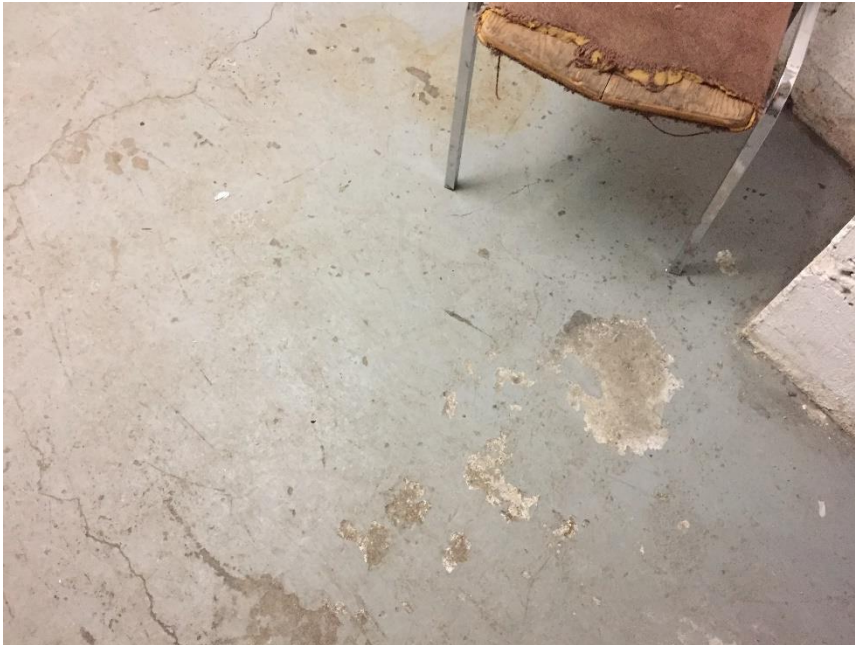
Photo 5: View of low level lead-containing grey paint within Room 06A observed to be in poor condition in selected area

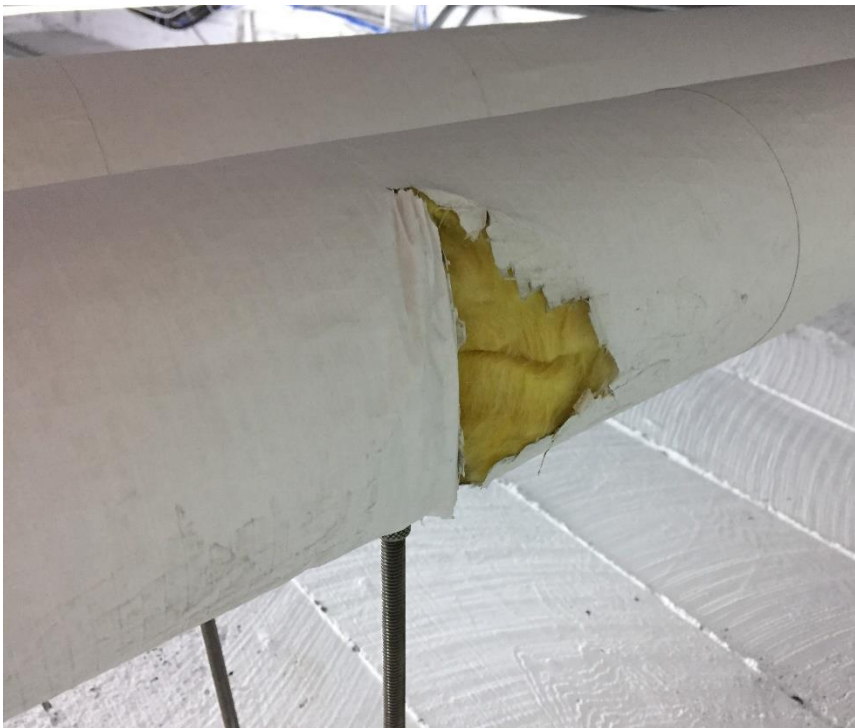
Photo 6: View of fiberglass pipe insulation within the Basement
