# HAZARDOUS MATERIALS SURVEY AND 2022 REASSESSMENT 200 WILBROD STREET, OTTAWA, ON

Project No.: Z1920014HZ / CCC-230252-00

University of Ottawa

McIntosh Perry Limited (MPL)

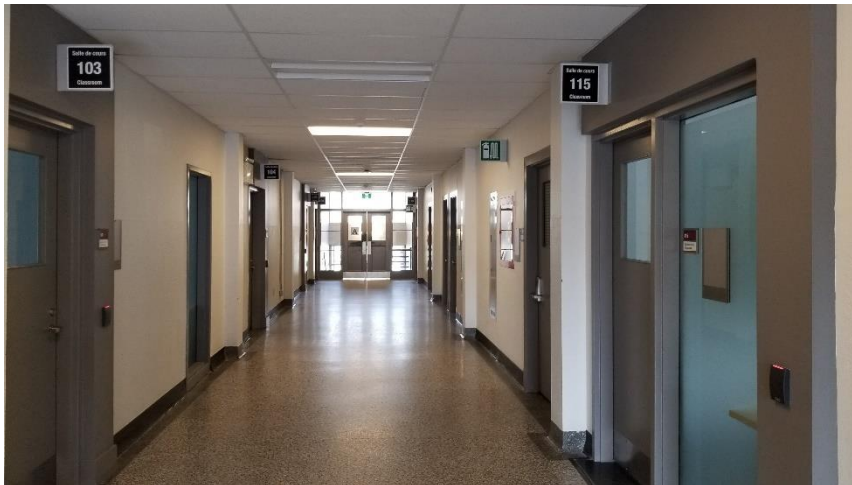
**Photo 2:** Representative view of the Level 1 main corridor area finishes. No asbestos containing materials were identified in this general area.

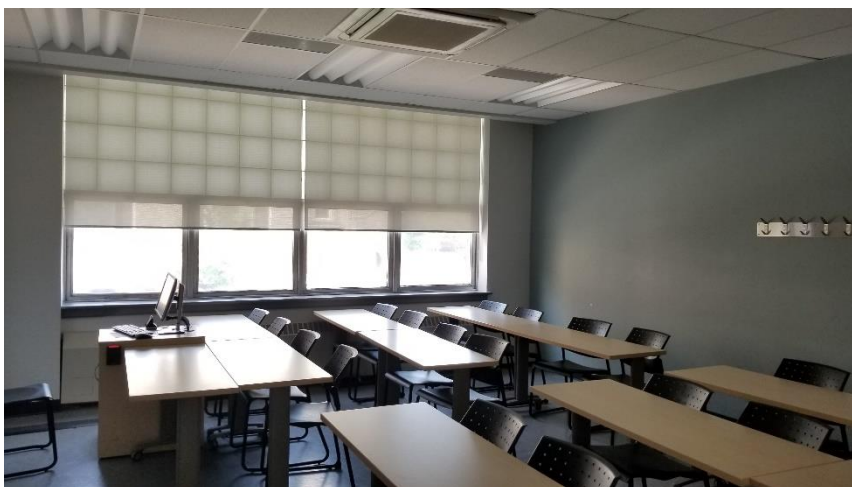
**Photo 3:** Representative view of Room 102 interior finishes, which were observed to be newly renovated. No asbestos materials are suspected to be present.

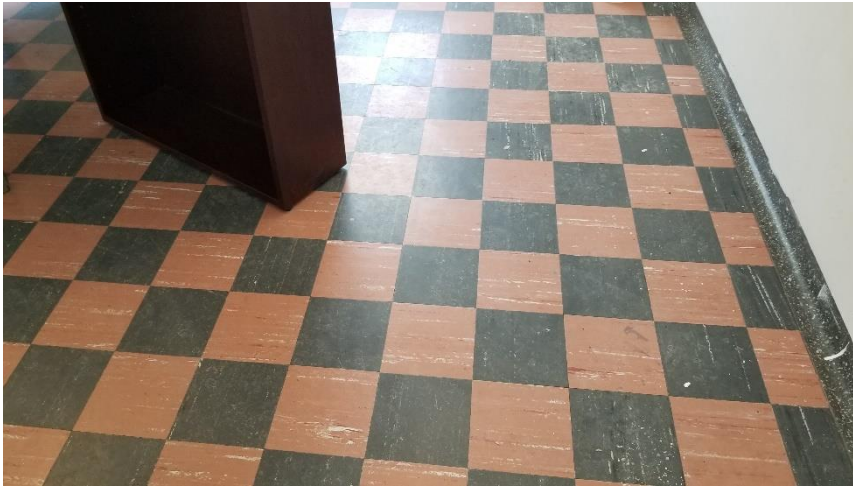
- Previously identified asbestos-containing vinyl floor tiles (9"x9" – Dark Grey w/ Streaks) were observed in Room 113A, 113B, 114A, and 114B. This material **contains 3% Chrysotile asbestos** and is considered to be non-friable. The associated mastic was also found to **contains 5% Chrysotile asbestos**. This material was observed to be in good condition.

**Photo 4:** View of the asbestos-containing VFT 9"x9" - Pink & Dark Grey observed in good condition in Room 114B.

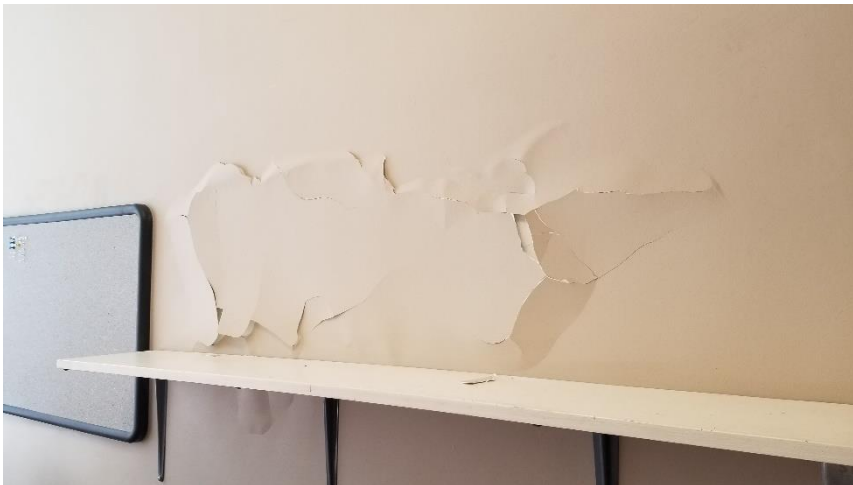
The paint finishes highlighted in blue in the above table were determined to contain low concentrations of lead which are less than or equal to 0.1%. These paint finishes were observed to be in good condition with the exception of select areas that were observed in poor condition. All remaining paints tested were below the laboratory limit of detection for lead. However, all other paints throughout the subject building that are not mentioned in this report must be considered to be lead-containing unless sampling and analysis proves otherwise.

**Photo 5:** View of the Beige low-level lead wall paint observed in poor condition in Room 111.

Paints identified to contain lead that are in poor condition must be immediately repaired and/or stabilized following a minimum Type 1/2 lead abatement procedures as per OMOL Guideline “Lead on Construction Project” dated April 2011.

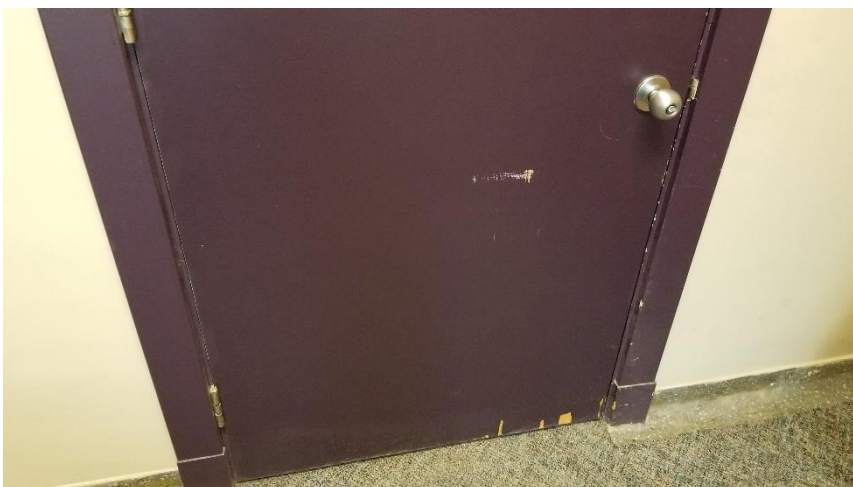
**Photo 6:** View of the Maroon low-level lead door paint observed in poor condition in Room 111.

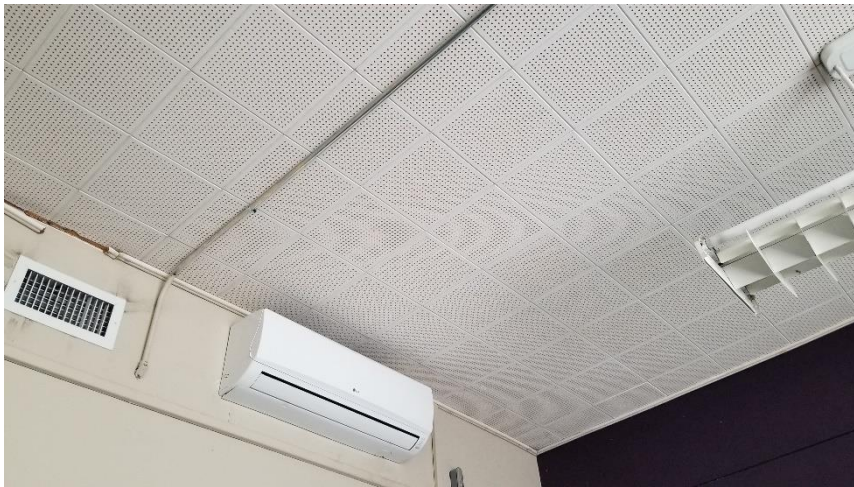
**Photo 7:** View of the non-asbestos acoustic stick-on ceiling tiles observed in Room 113.

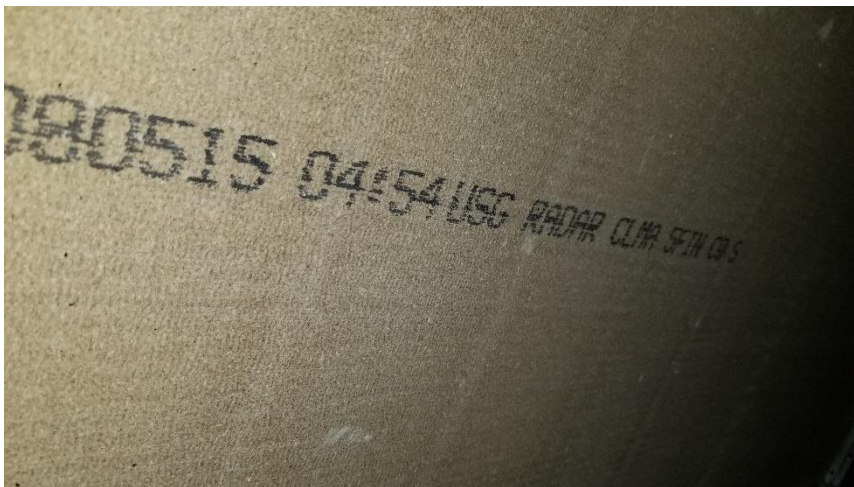
- Suspended ceiling tiles (2'x4' – Pinholes & Small Fissures) were observed in Room 100. The date stamp on the back of these tiles indicated that they were manufactured in 2015 and therefore, this material is not considered to contain asbestos.
- Suspended ceiling tiles (2'x4' – Pinholes & Small Fissures) were observed in Room 102. The date stamp on the back of these tiles indicated that they were manufactured in 2016 and therefore, this material is not considered to contain asbestos.

**Photo 8:** View of the ceiling tiles observed throughout the building with a 2015 date stamp.

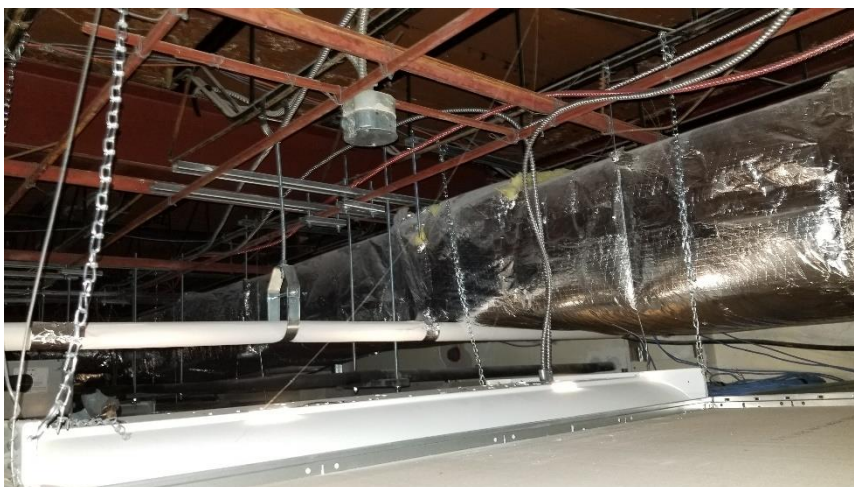
**Photo 9:** Representative view of the ceiling space throughout Level 1, with visible fiberglass mechanical insulation throughout.

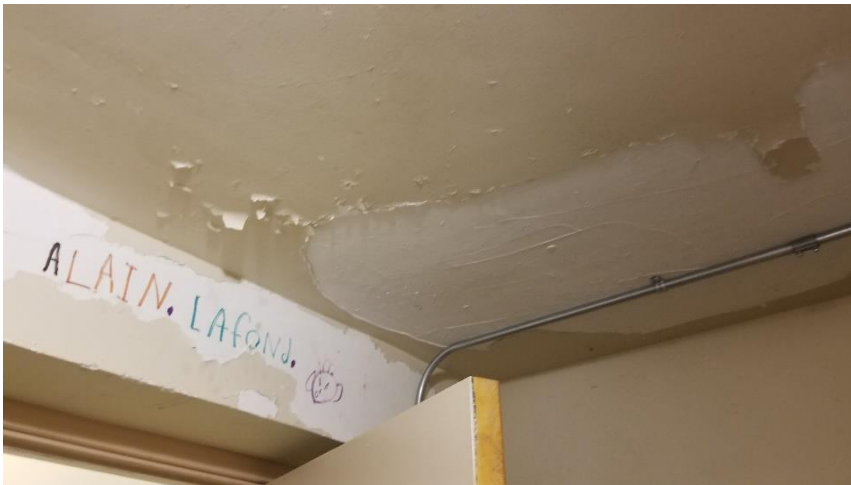
**Photo 11:** View of the poor condition low level lead paint (Beige) observed in Room 02A.

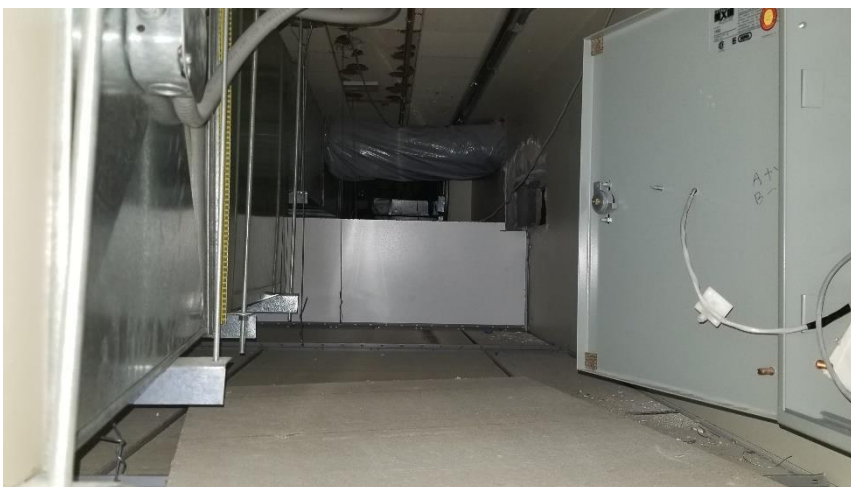
**Photo 12:** View of the ceiling space above the suspended ceiling tiles observed in the Level 0 corridor. Non-asbestos stick on ceiling tiles and mastic (Dark Brown) were visible.

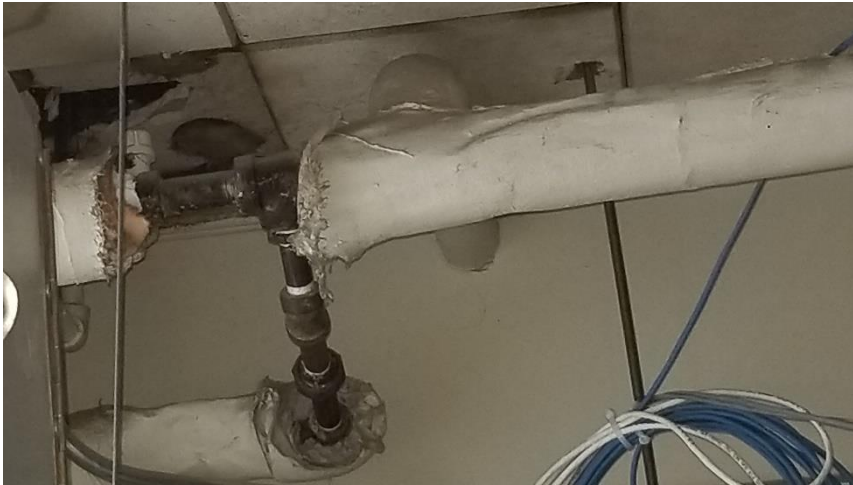
Previously identified parging cement elbows were observed in Room 02A, 03, 05, 07, 08 (A&C), 010 (A-C), 011, 013, 014 and 015B. This material **contains 65% Chrysotile asbestos** and is considered to be friable. This material was observed to be in good condition with the exception of select areas that were observed in poor condition.

**Photo 13:** Poor condition asbestos-containing paring cement elbows were observed in Room 010, above suspended ceiling tiles.

- Asbestos-containing materials identified to be in poor condition must be repaired/removed immediately, following Type 1/2/3 asbestos abatement work procedures as detailed in O. Reg. 278/05 and disposed of as asbestos waste under O. Reg. 347;

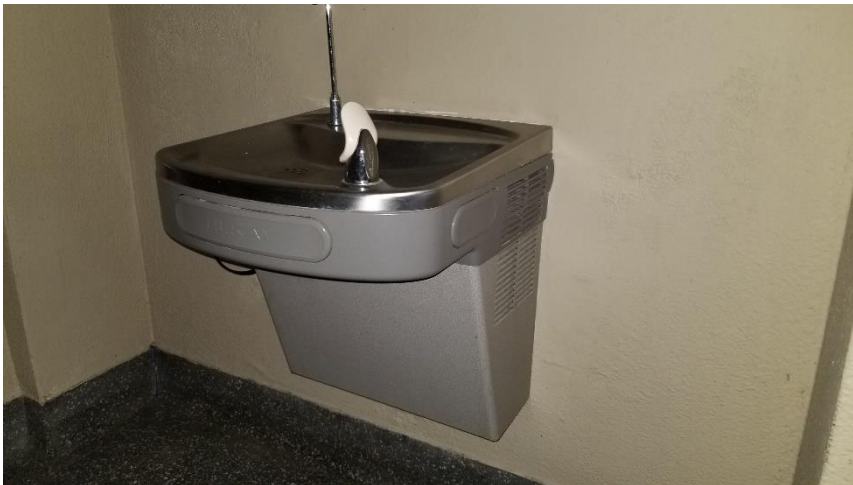
**Photo 14:** Representative view of the ElKay drinking water fountains observed throughout the subject building, containing a R134a refrigerant.

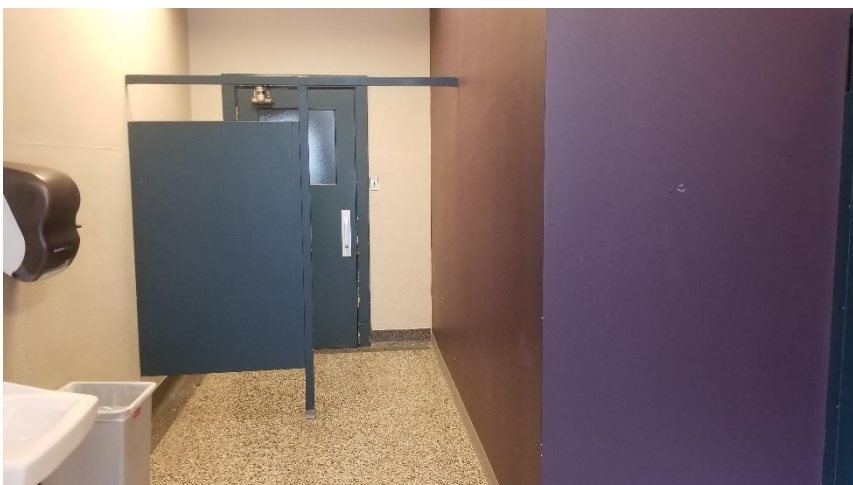
**Photo 15:** View of the Dark Purple paint observed in Room 013, which was determined to contain a level of lead that was below the limit of detection.

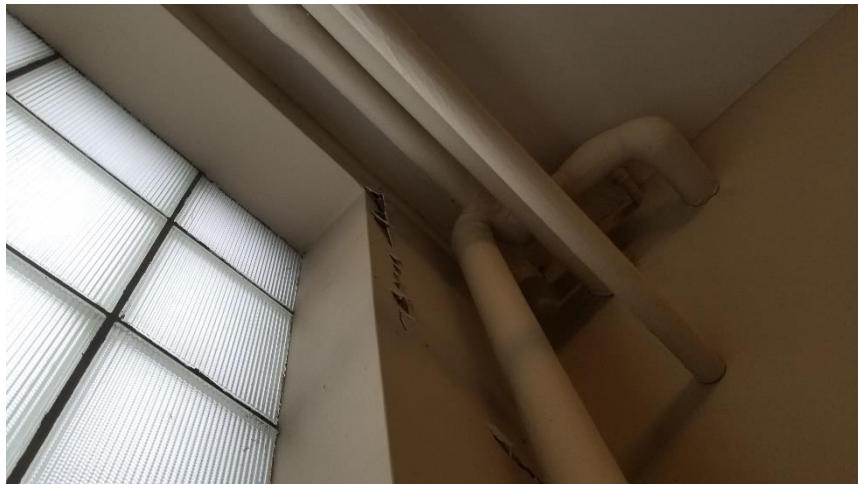
**Photo 16:** Representative view of the asbestos-containing parging cement elbows observed in good condition in the Women's Washroom Room 013.

- Materials identified to contain asbestos that are in good condition and do not pose a risk to workers or occupants can be managed in place. Prior to renovation/demolition activities that may disturb the ACMs, these materials must be removed following appropriate Type 1/2/3 asbestos abatement work procedures as detailed in O. Reg. 278/05 and disposed of as asbestos waste under O. Reg. 347;

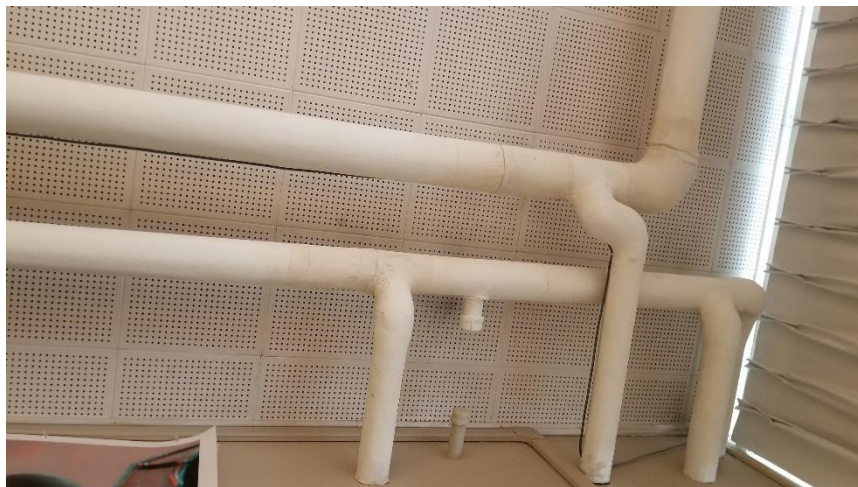
**Photo 17:** Representative view of the asbestos-containing parging cement elbows observed in good condition in Room 03.

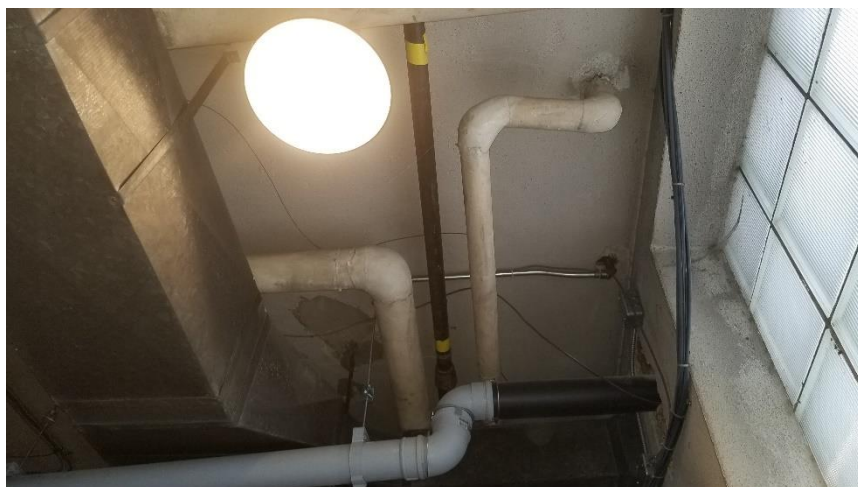
**Photo 18:** Representative view of the asbestos-containing parging cement elbows observed in good condition in the Furnace Room 011.

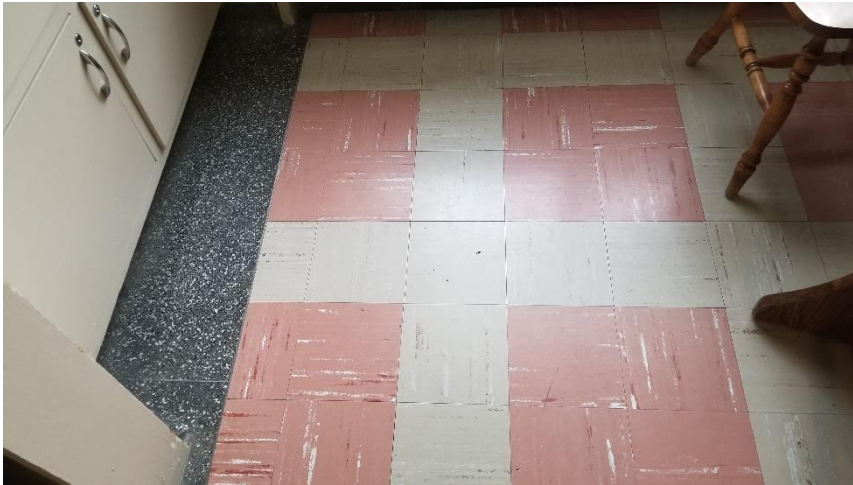
- Previously identified asbestos-containing vinyl floor tiles (9"x9" – Light Grey w/ Streaks) were observed in Room 015A, and 015. This material **contains 3% Chrysotile asbestos** and is considered to be non-friable. The associated mastic was also found to **contain 5% Chrysotile asbestos**. This material was observed to be in good condition.

**Photo 19:** View of the asbestos-containing VFT 9"x9" - Pink & Beige observed in good condition in Room 015A.

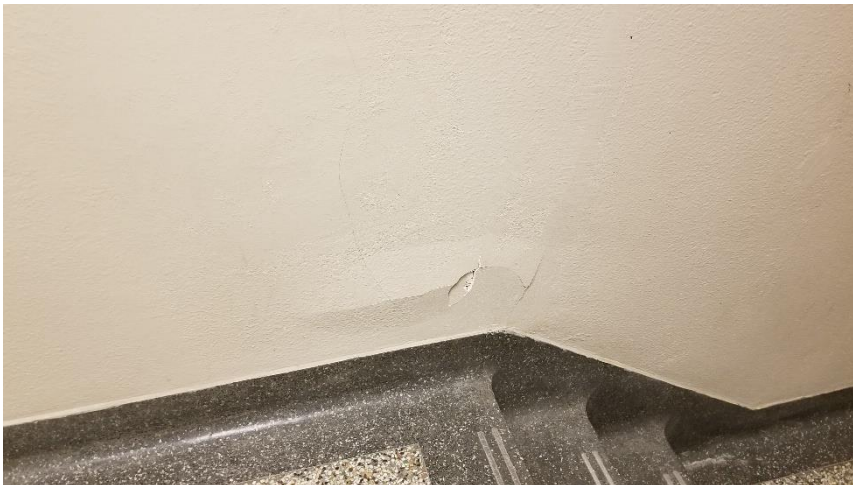
Wall plaster was observed throughout the subject building and sampled from Rooms 02, 03, 06, 08C, 010B, 011, 015B, 100, 101, and 113A. The laboratory analytical results of the wall plaster samples collected indicated that this material does not contain asbestos.

**Photo 20:** View of the non-asbestos wall plaster observed throughout the subject building.

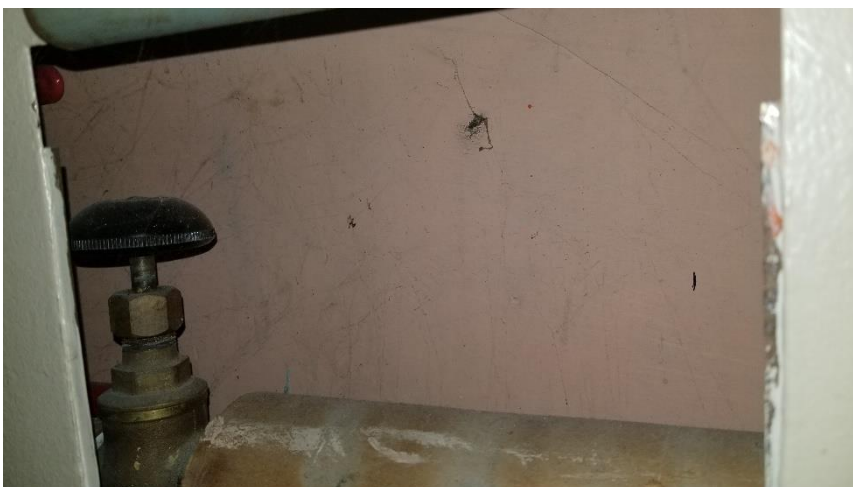
**Photo 21:** View of the Light Pink paint observed in Room 012, which was determined to contain low levels of lead, and enclosed behind radiator units.

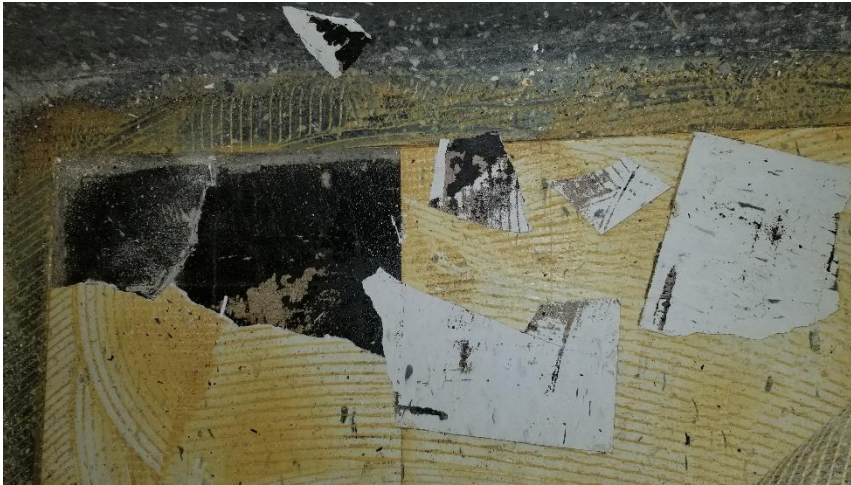
- Vinyl floor tiles (12"x12"-White with Black Flakes) were observed and sampled in Room 03 and 07. The laboratory analytical results of the vinyl floor tile samples collected indicate that this material does not contain asbestos. The associated mastic (Black) was found to **contains 5% Chrysotile asbestos**. This material was observed to be in good condition.

**Photo 22:** View of asbestos-containing vinyl floor tile mastic (Black) observed to be in good condition on the underside of the carpet in Room 07.

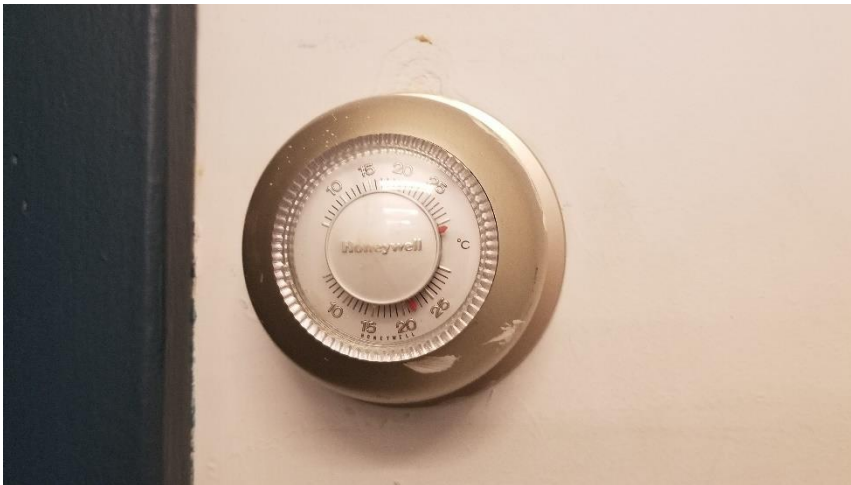
MPL observed thermostat switches suspected of containing liquid mercury throughout the subject building.

**Photo 23:** View of Honeywell thermostat containing one ampoule of liquid mercury observed to be in good condition on Room 07.

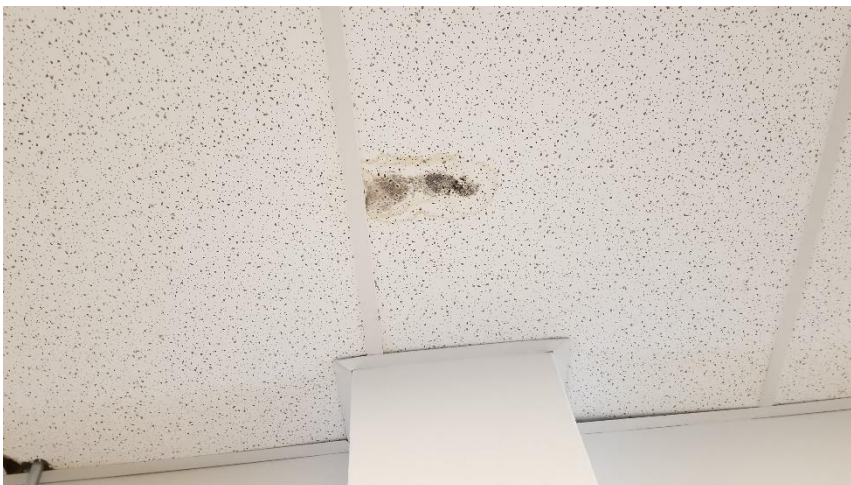
**Photo 24:** View of the mould impacted ceiling tile observed in Room 100.
