HAZARDOUS MATERIALS SURVEY AND 2022 REASSESSMENT HENDERSON RESIDENCE, OTTAWA, ON

Project No.: Z2021102HZ / CCC-230252-00

University of Ottawa

September 9, 2022

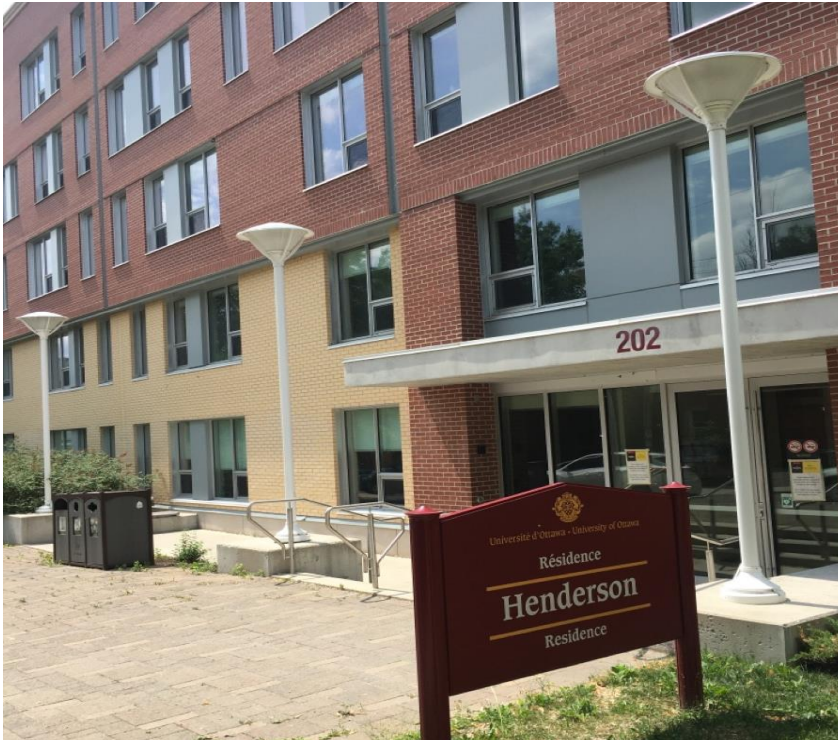
Photo 1: View of building located at 202 Henderson Avenue in Ottawa.

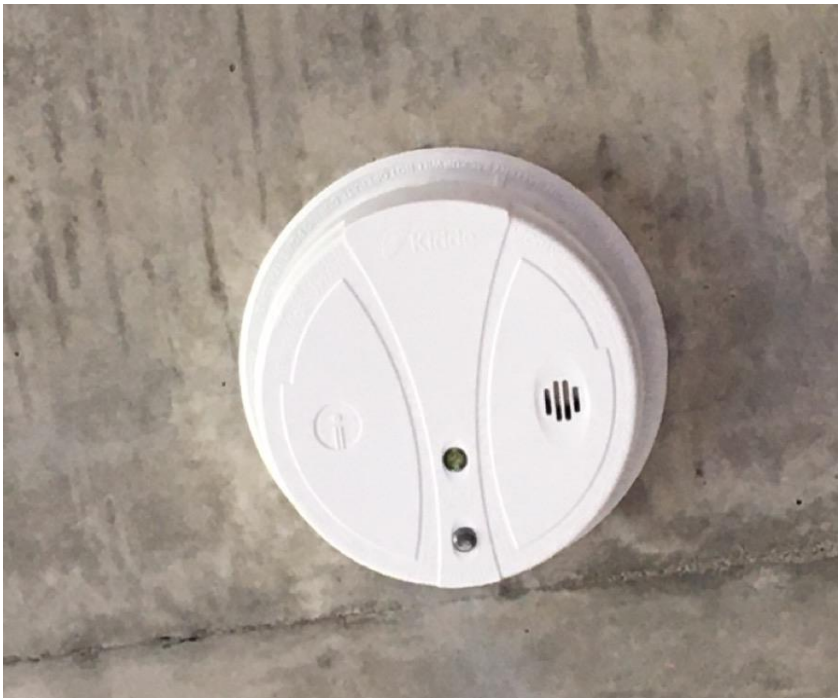
A visual assessment of the subject building was conducted to determine if any electrical components containing radioactive materials were present. MPL observed smoke detectors containing radioactive materials throughout the subject building.

Photo 2: Typical view of smoke detectors containing radioactive materials observed throughout the subject building.

Please refer to Appendix E – Hazardous Materials Checklist for equipment conditions, quantities (where applicable), and recommended actions.

The radioactive sources in smoke alarms are sealed and contained within a metal case inside the smoke detector and must not be damaged or tampered with. These materials do not pose a hazard as long as they remain contained and properly disposed at the time of removal or replacement.

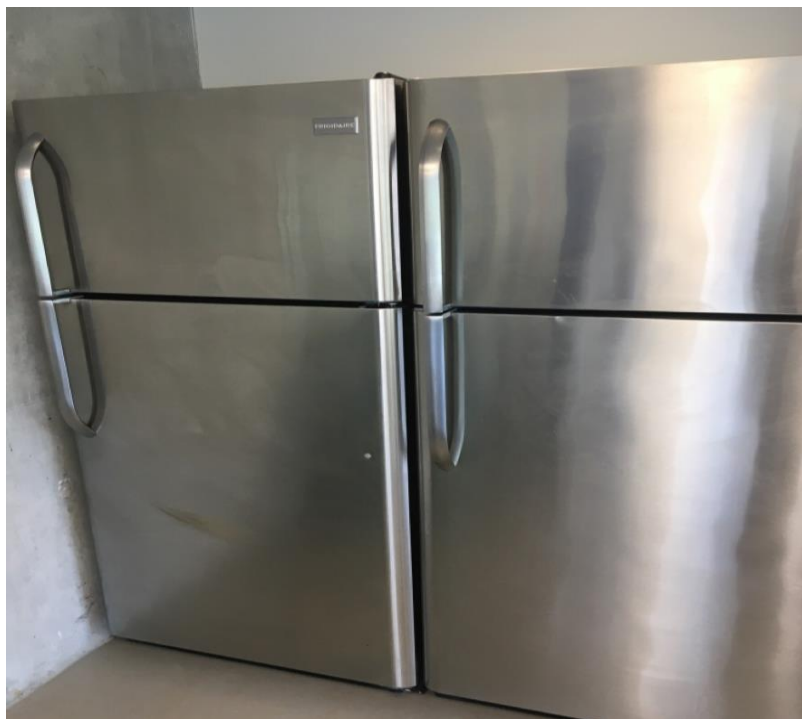
A visual assessment for equipment potentially containing ODSs and other halocarbons was conducted. MPL observed equipment such as refrigerators, water fountains, water coolers, freezers, etc. which contain or are suspected of containing ODSs or other halocarbons.

Photo 3: Typical view of ODS containing re Fridgerators observed throughout the subject building.

Please refer to Appendix E – Hazardous Materials Checklist for equipment conditions, quantities (where applicable), and recommended actions.
