# HAZARDOUS MATERIALS SURVEY AND 2022 REASSESSMENT 20 MARIE CURIE (CAREG), OTTAWA, ON

Project No.:0Z2021101HZ / CCC-230252-00

University of Ottawa

McIntosh Perry Limited (MPL)

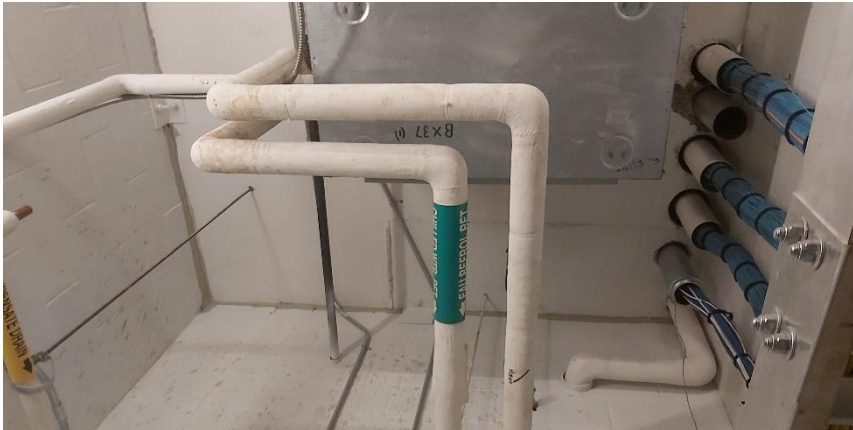
Mechanical pipe straight insulation was observed throughout the subject building. MPL made several incisions throughout to investigate its composition, and it was visually identified as fiberglass, and therefore not suspected of containing asbestos.

**Photo 1:** Representative view of the non-asbestos containing mechanical insulation observed throughout the subject building.

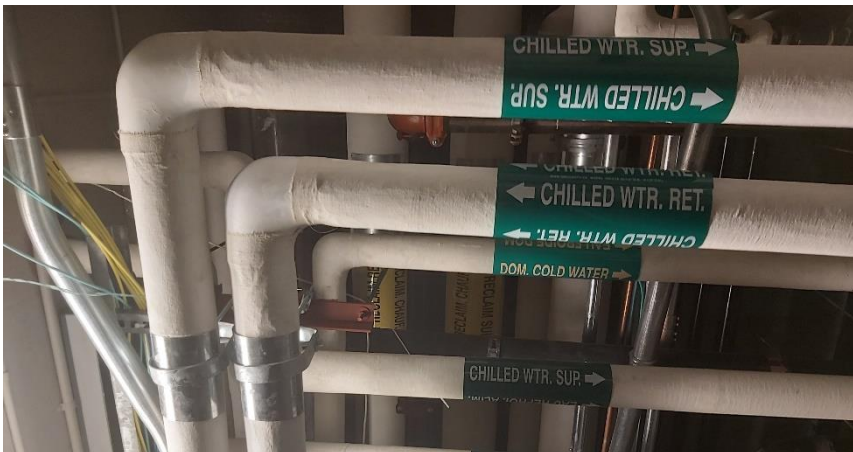
Mechanical pipe elbows/fittings insulation was observed throughout the subject building. MPL made several incisions throughout to investigate its composition, and it was visually identified as fiberglass, and therefore not suspected of containing asbestos.

**Photo 2:** Representative view of the non-asbestos containing mechanical insulation observed throughout the subject building.

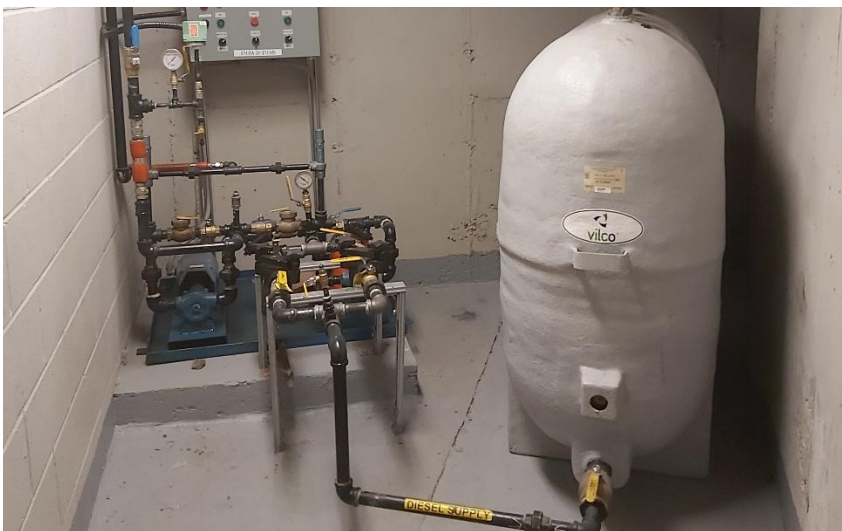
**Photo 3:** View of the diesel tank identified in Room 01.

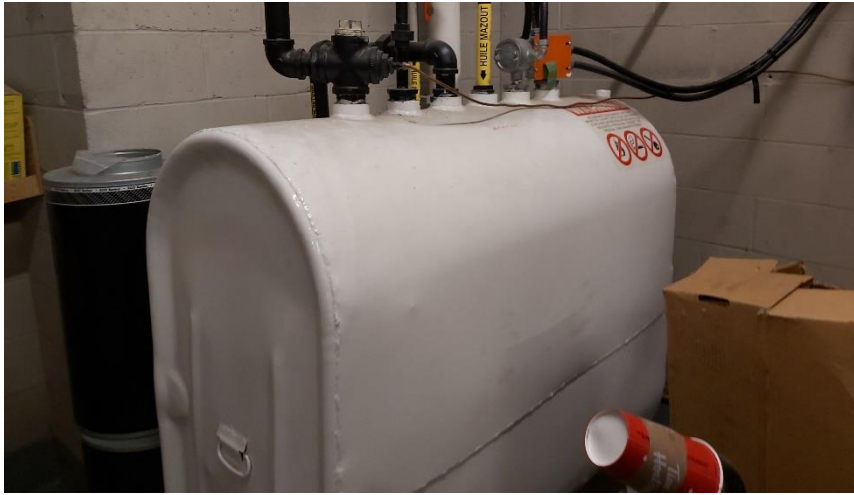
**Photo 4:** View of the diesel tank identified in Room 508.

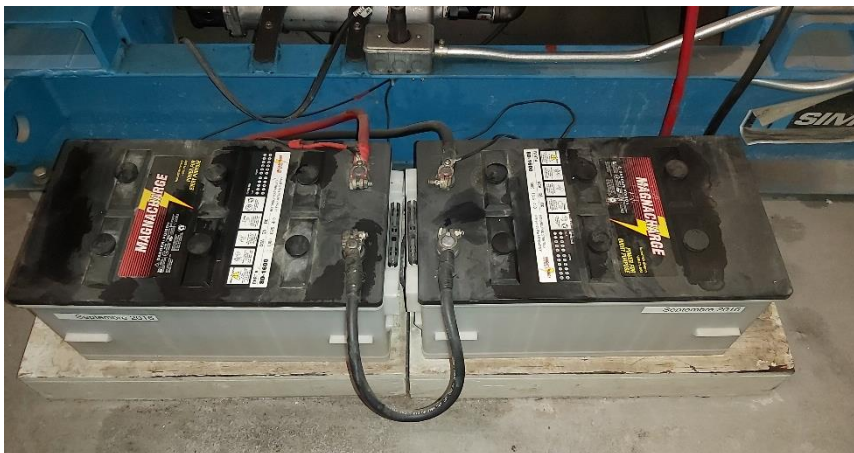
MPL observed lead-containing acid battery packs in Room 508.

**Photo 5:** View of the lead-containing battery packs observed in Room 508.

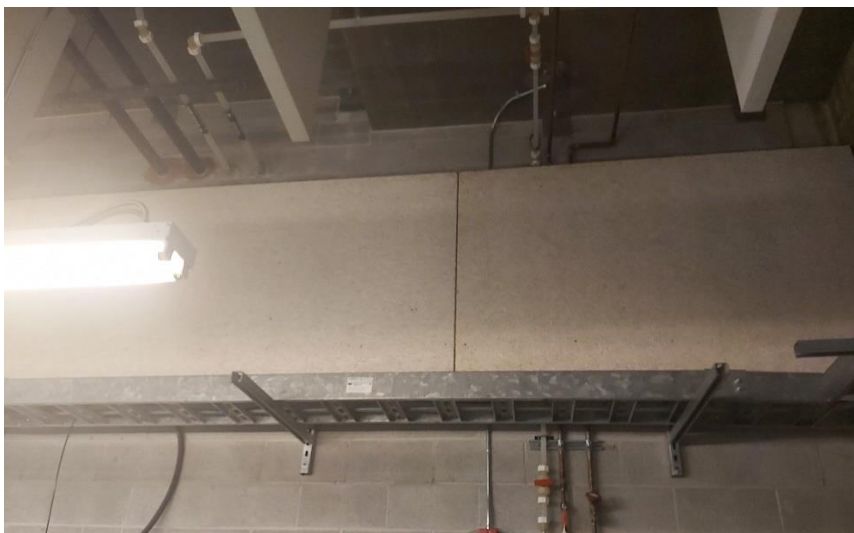
Previously identified asbestos-containing transite wall panels were observed in Room 010. This material **contains 25% Chrysotile** and is considered to be non-friable. This material was observed to be in good condition.

**Photo 6:** View of the asbestos-containing transite panels observed in Room 010.

- All repairs or removal of asbestos-containing materials must be conducted according to Ontario Regulation 278/05, Regulation respecting Asbestos on Construction Projects and in Buildings and Repair Operations - made under the Occupational Health and Safety Act. Asbestos containing waste must also be handled and disposed of according to Ontario Regulation 347/90 as amended – made under the Environmental Protection Act. Any suspect building materials encountered that were not assessed as part of this survey, should be assumed to contain asbestos until proven otherwise by analytical testing;

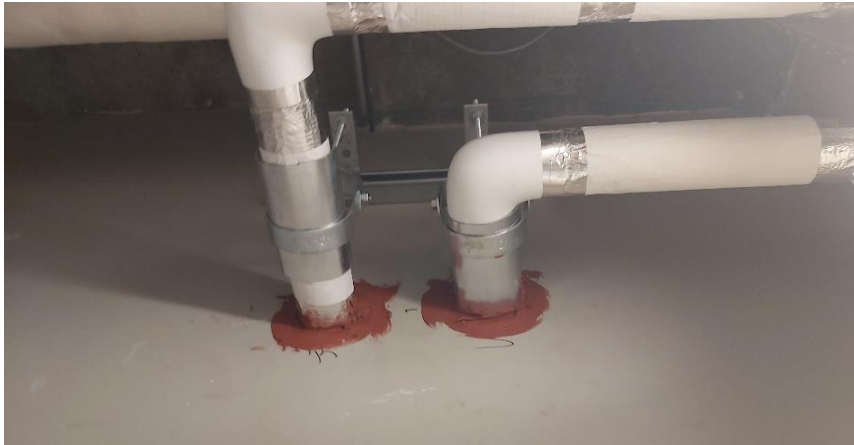
Firestop caulking (Red) was observed and sampled in Room 205. The laboratory analytical results of the samples collected indicate that this material does not contain asbestos.

**Photo 7:** View of the non-asbestos containing firestop caulking (Red) observed throughout the subject building.

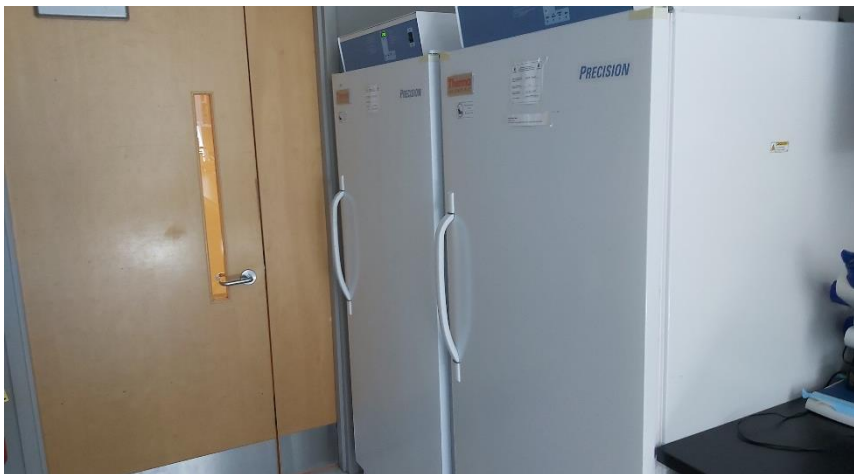
A visual assessment for equipment potentially containing ODSs and other halocarbons was conducted. Equipment containing ODSs or other halocarbons was observed in the subject building.

**Photo 8:** Representative view of the equipment containing ODS's observed throughout the subject building.

Please refer to Appendix F – Hazardous Materials Checklist for equipment conditions, approximate quantities (where applicable), and recommended actions.

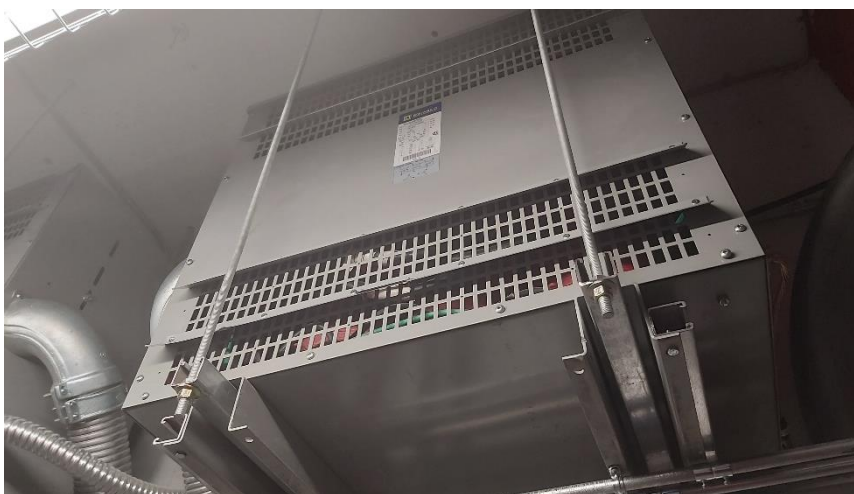
MPL did not observe any PCBs containing electrical transformers within the subject building. Transformers that could be assessed were observed to be dry-type and manufactured by Hammond Manufacturing.

**Photo 9:** Representative view of the non-PCB dry-type transformers observed throughout the subject building.

Since no PCB-containing equipment was observed or suspected to be present during the site survey, no further action is required.

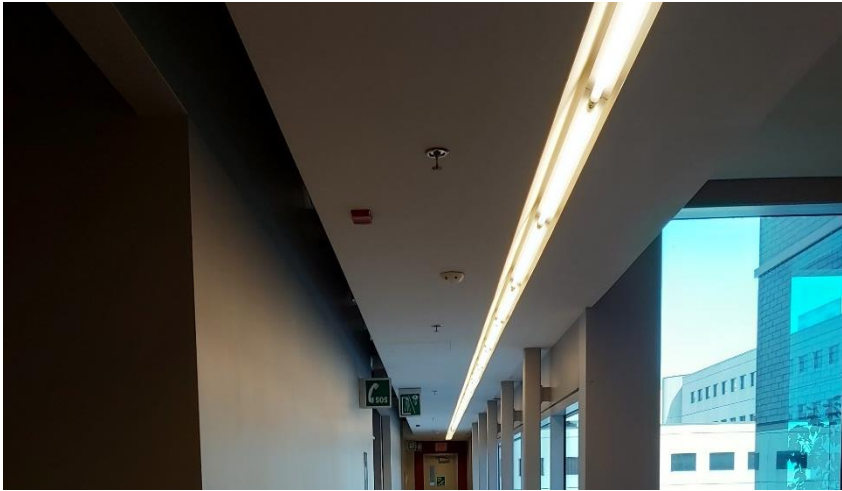
**Photo 10:** Representative view of the fluorescent light fixtures containing mercury vapour observed throughout the subject building.

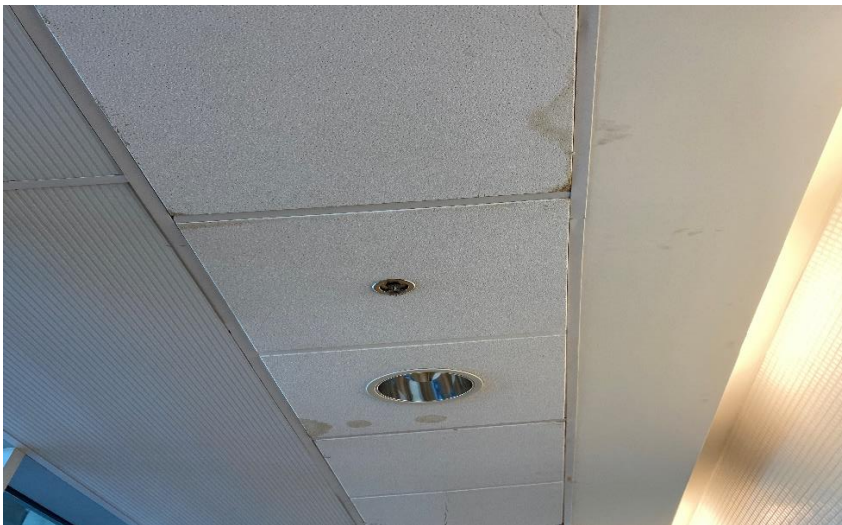
A visual survey of the subject building was conducted to determine if any water damaged was present. MPL identified select areas throughout the subject building, where materials were affected by water damage.

**Photo 11:** View of water damaged acoustic ceiling tiles (Non-ACM).

Please refer to Appendix F – Hazardous Materials Checklist for equipment conditions, quantities (where applicable), and recommended actions.

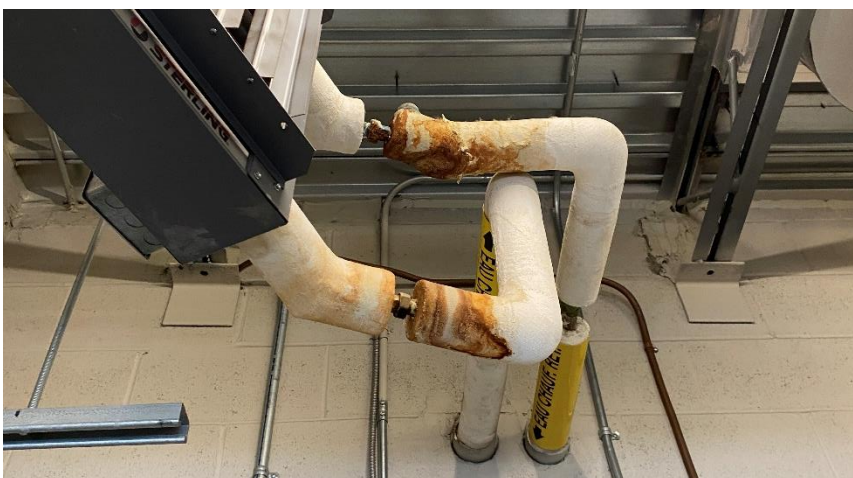
**Photo 12:** View of water damaged mechanical pipe insulation – fiberglass (Non-ACM).
