Ceiling Space Investigation for Asbestos-Containing Material rev.1

Vanier Hall
136 Jean-Jacques-Lussier Private, Ottawa, ON

BCE Project: 23-1041
Report Issued: November 30, 2023
Revision Issued: December 8, 2023

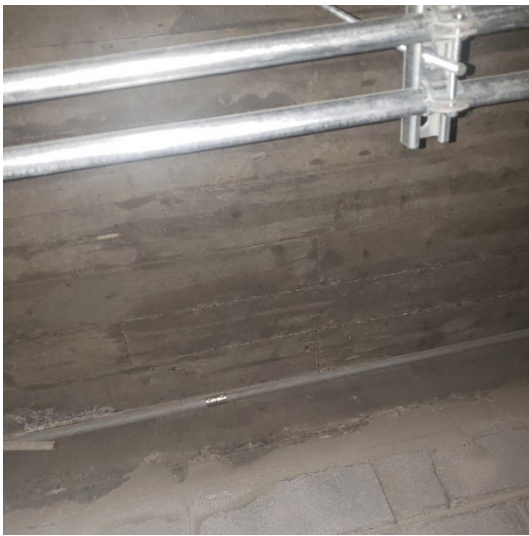
Photo 1. Example of bare concrete ceiling observed on the 6th floor.

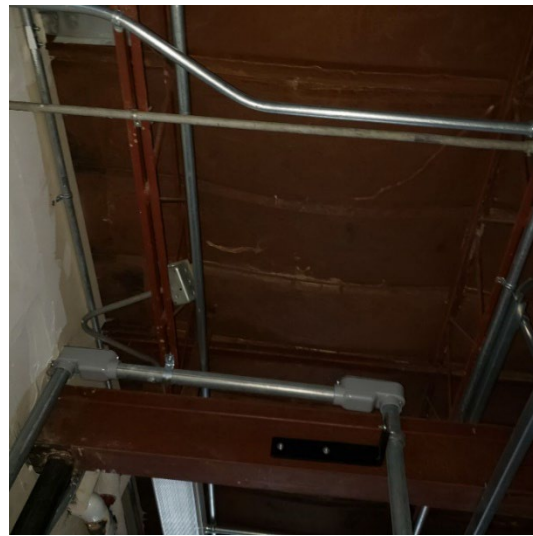
Photo 2. Example of corrugated metal ceiling observed on the 7th floor.

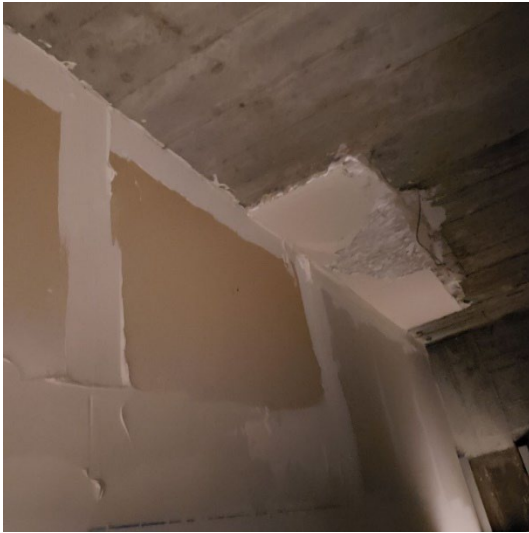
Smooth open plaster was observed in fair and good condition within the stairwells throughout the building. Smooth plaster was also observed above acoustic ceiling tiles in good, fair, poor and debris condition throughout the building. The following photos are examples of smooth plaster above acoustic ceiling tiles observed in poor and debris condition during the ceiling investigation.

Photo 2. Smooth plaster above acoustic ceiling tiles observed in poor condition within room 5075A.

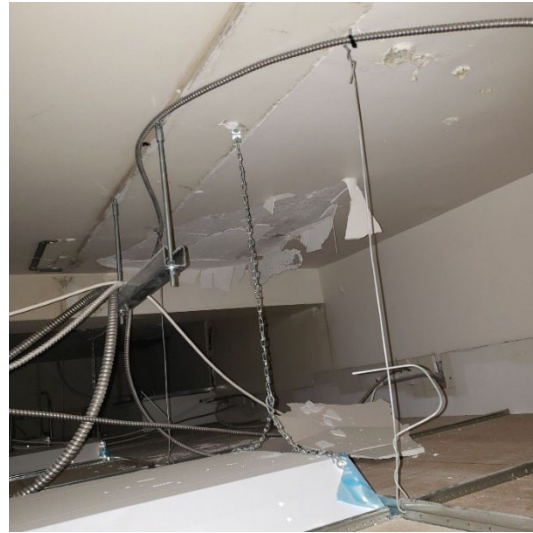
Photo 3. Smooth plaster debris observed above acoustic ceiling tiles within room 3040.

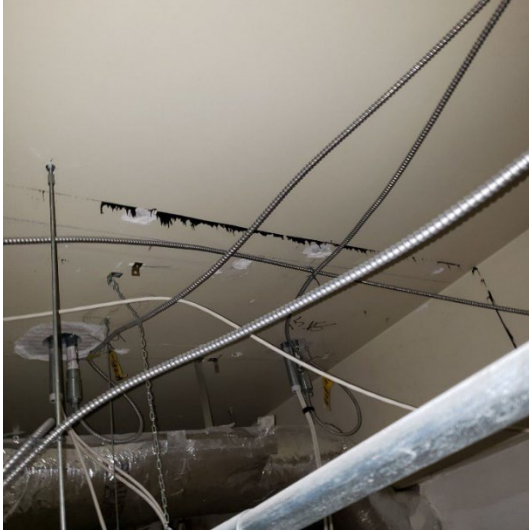
Photo 4. Example of ACM tar observed in good condition on the 1st floor.

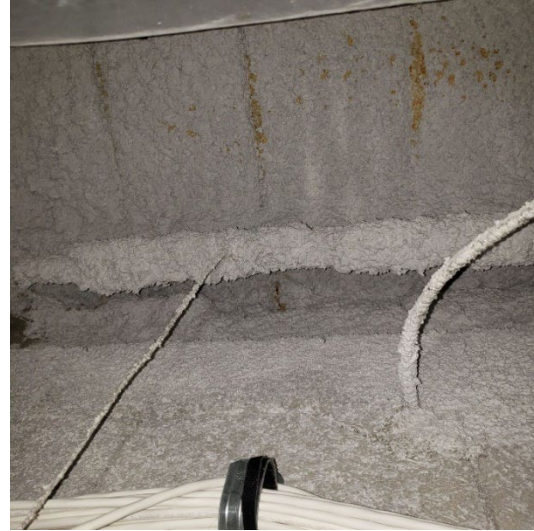
Photo 5. Example of non-ACM grey sprayed fireproofing observed on the 5th floor.

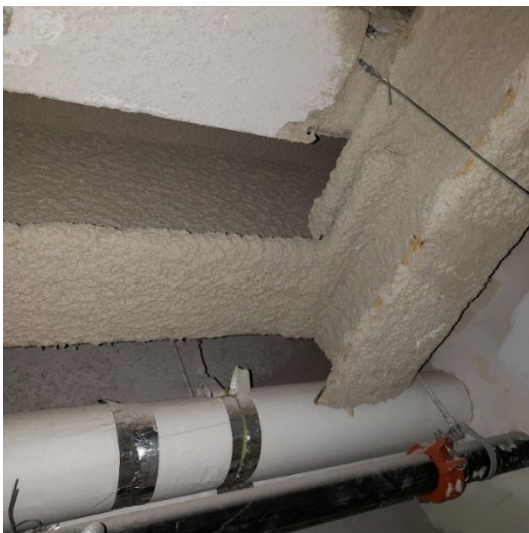
Photo 6. Example of non-ACM beige sprayed fireproofing observed on the 1st floor.

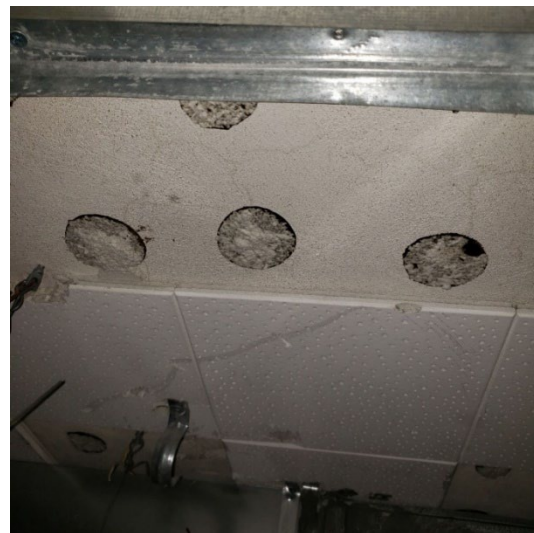
Photo 7. Example of ACM brown puck mastic observed on the 3rd floor.

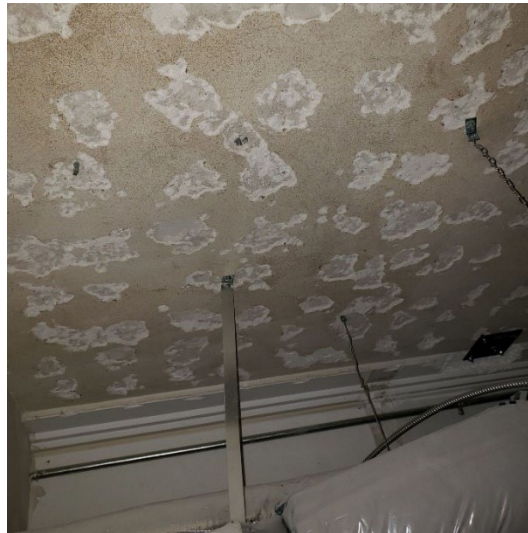
- Skim coat (ASo4), observed and sampled by BCE. It was determined not to contain a regulated concentration of asbestos.

Photo 8. Example of non-ACM skim coat observed on the 4th floor.
