# Ceiling Space Investigation for Asbestos-Containing Materials

Fauteux Hall Building, University of Ottawa Campus, Ottawa, Ontario

BCE Project: 23-366

Report Issued: August 22, 2023

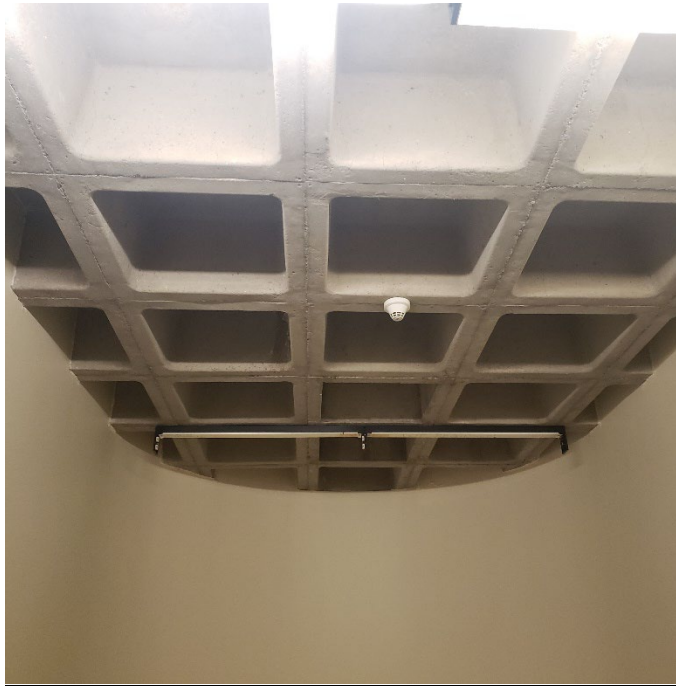
Photo 1. Example of bare concrete ceiling.

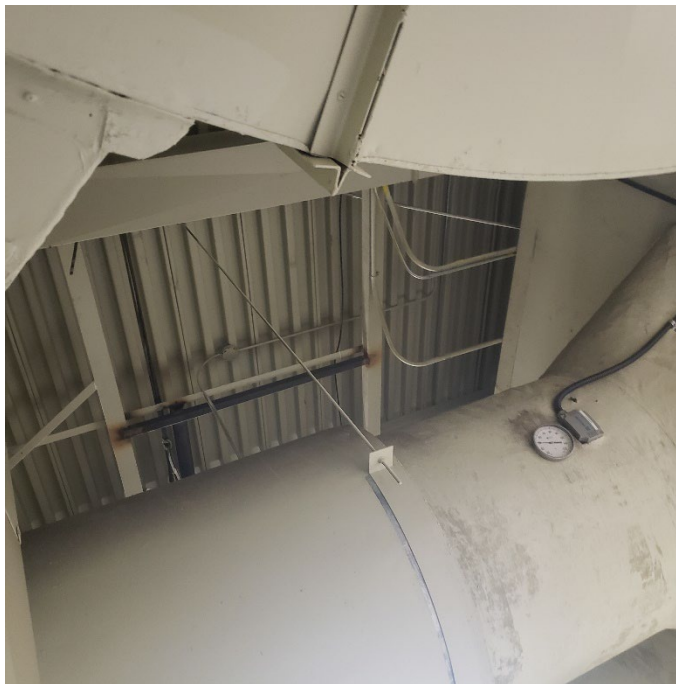
Photo 2. Example of corrugated metal ceiling.

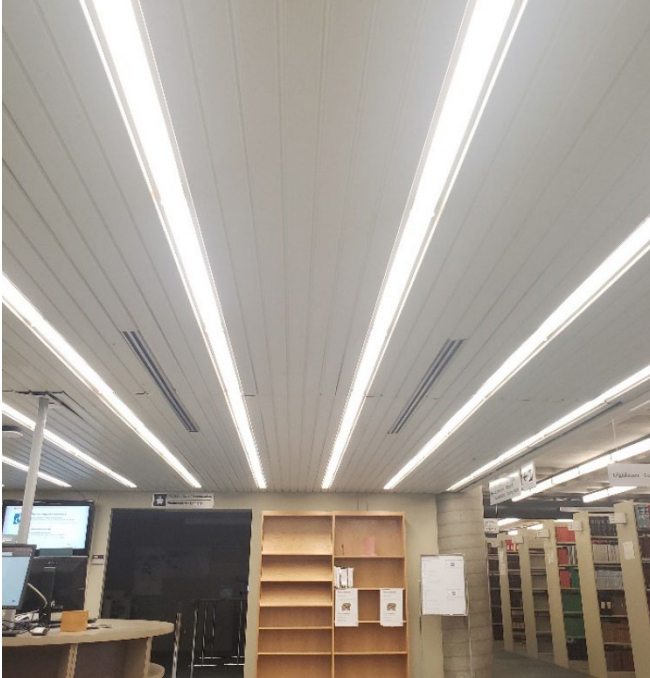
Metal clad ceiling observed within room 419.
2

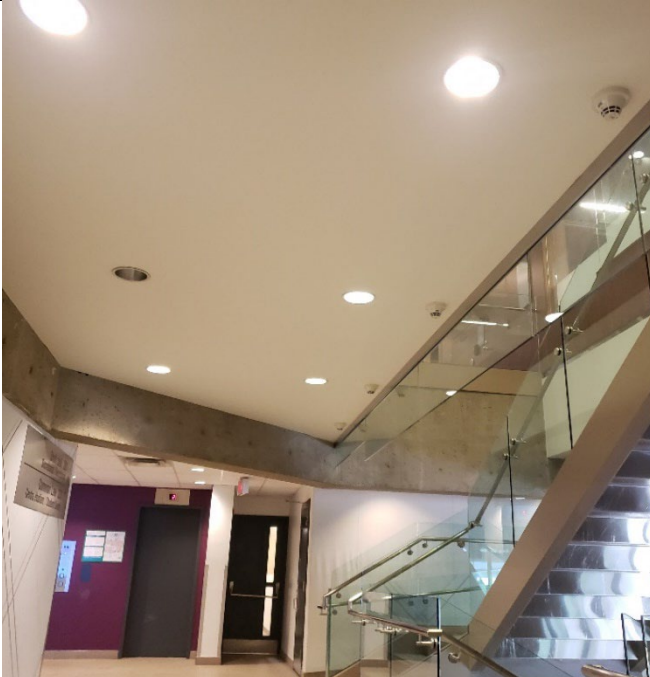
Solid drywall drop ceiling observed in room 200A.
