# Ceiling Space Investigation for Asbestos-Containing Materials

Morisset Library, University of Ottawa Campus, Ottawa, Ontario

BCE Project: 23-367

Report Issued: August 22, 2023

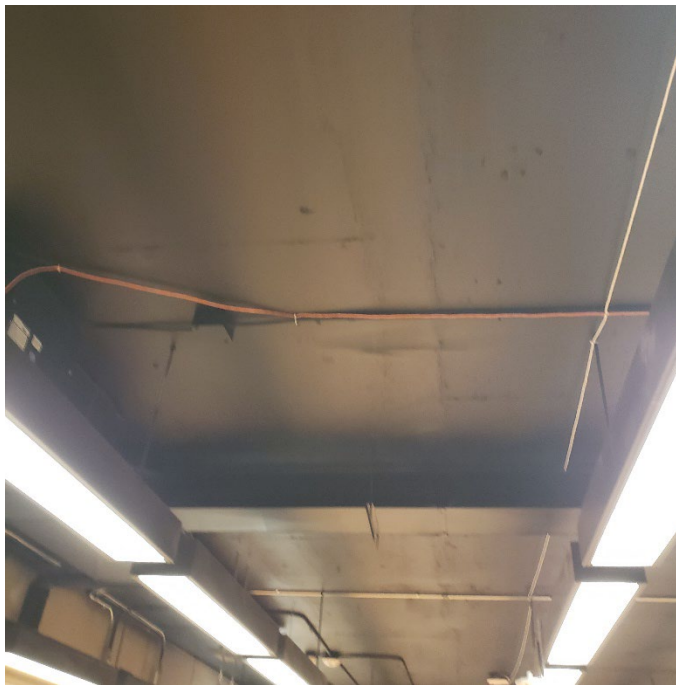
Photo 1. Example of bare concrete ceiling.

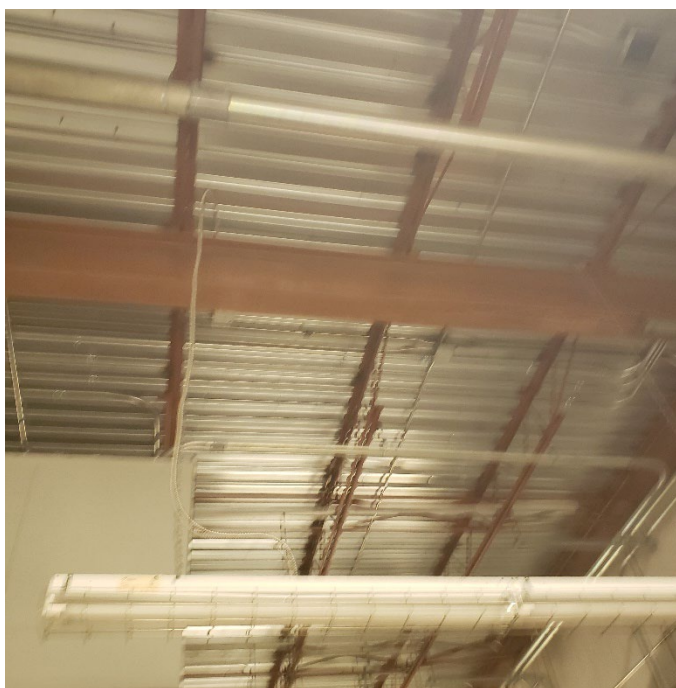
Photo 2. Example of corrugated metal ceiling.

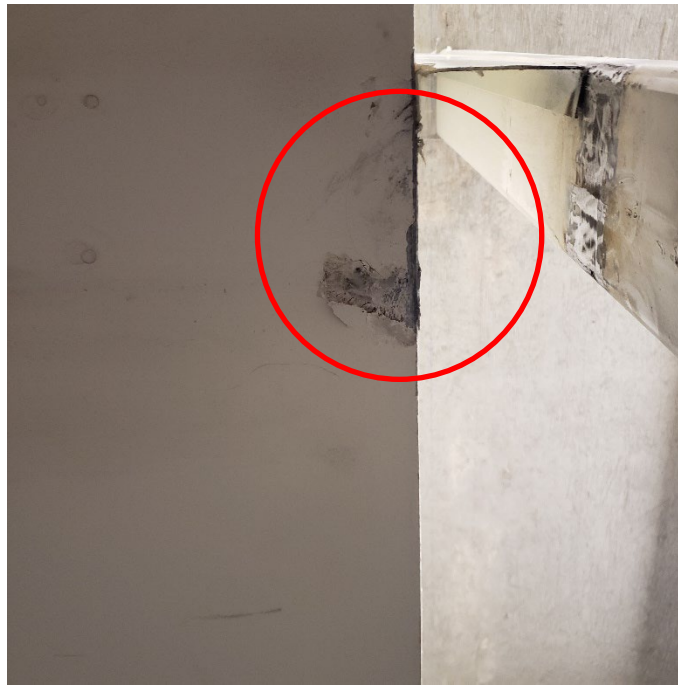
Smooth plaster bulkheads were observed in good condition within the majority of the stairwells throughout the building. BCE observed approximately 0.25 m<sup>2</sup> of smooth plaster in poor condition within stairwell 3C (see photo below). The following photo is an example of smooth plaster observed during the ceiling investigation.

Photo 3. Smooth plaster observed in poor condition within stairwell 3C.

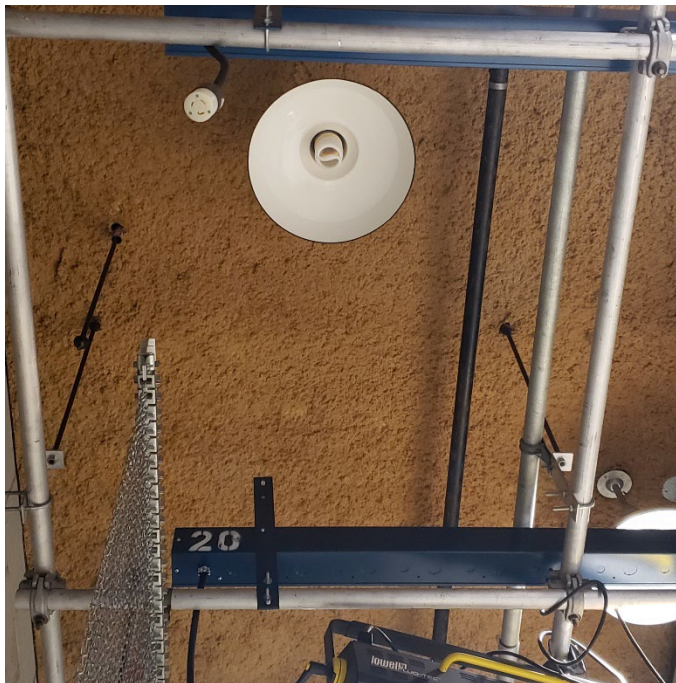
The following photos are examples of additional ceiling finishes that were noted in good condition, however, were inaccessible and unable to be sampled due to height restrictions.

Photo 4. Example of yellow textured ceiling finish observed within rooms 0028 and 0029.

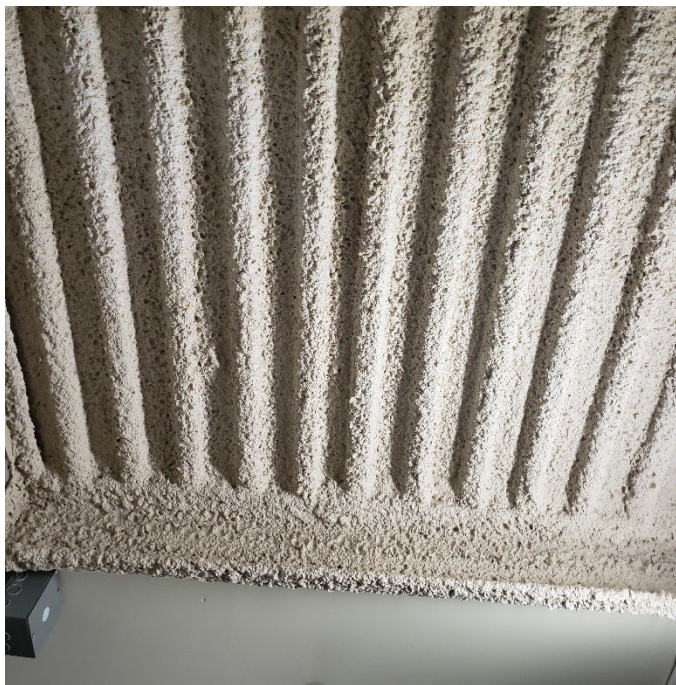
Photo 5. Example of sprayed fireproofing within room 0042B.

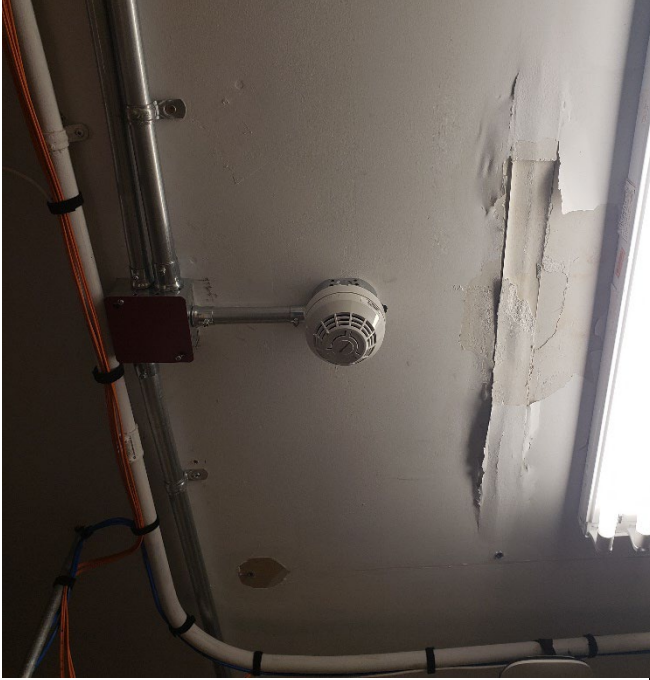
View of solid drywall ceiling observed in poor condition within room 0046.
2

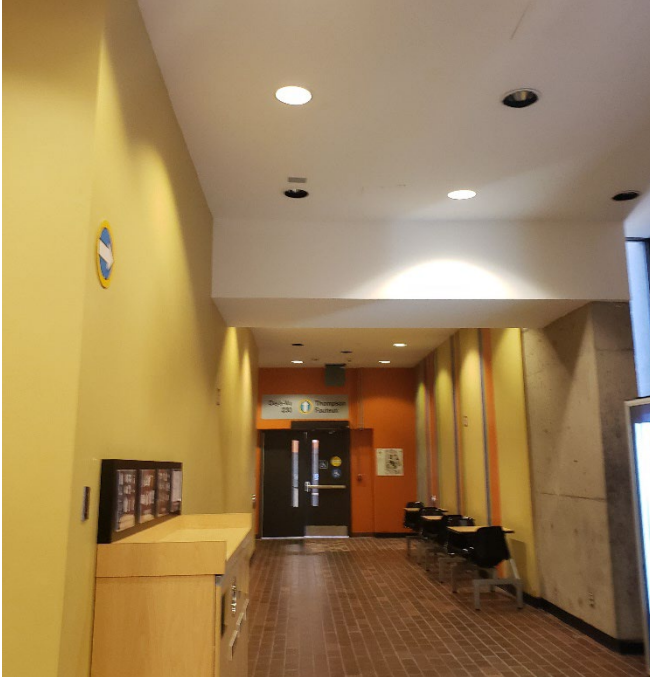
View of solid drywall suspended ceilings within corridor 202C.

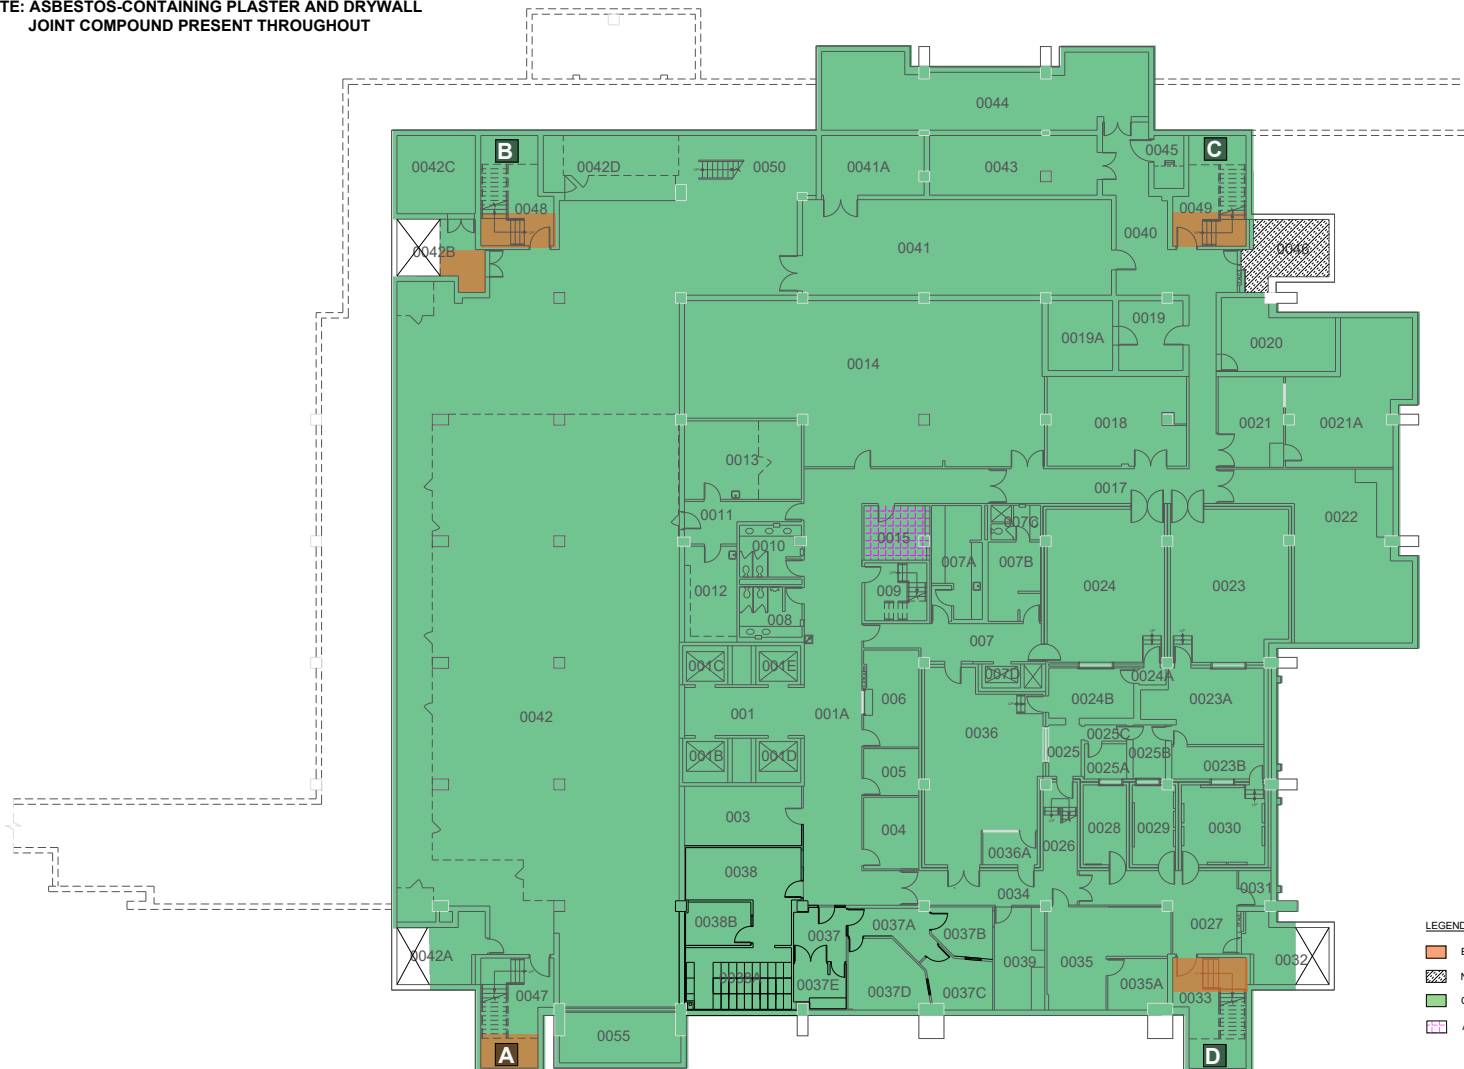
1 LEVEL 00 FLOOR PLAN, MORISSET HALL  
NTS

**NOTE: ASBESTOS-CONTAINING PLASTER AND DRYWALL  
JOINT COMPOUND PRESENT THROUGHOUT**

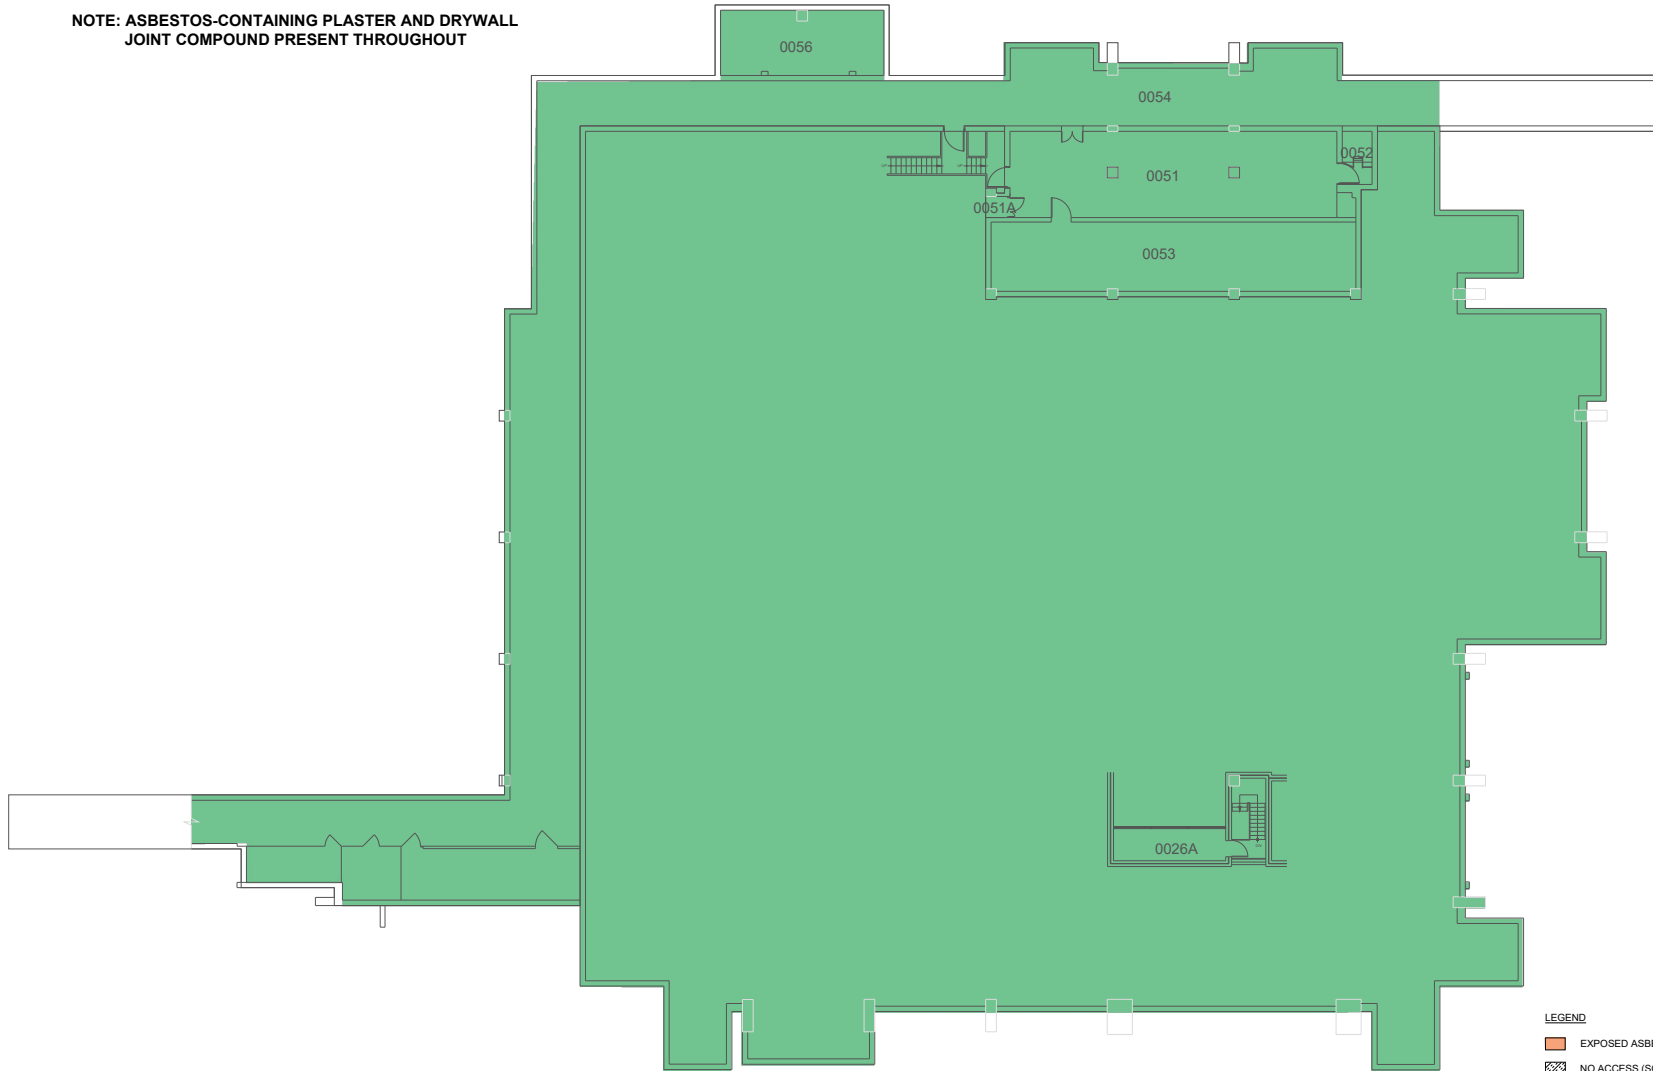
1 LEVEL 00.5 FLOOR PLAN, MORISSET HALL  
NTS

NOTE: ASBESTOS-CONTAINING PLASTER AND DRYWALL  
JOINT COMPOUND PRESENT THROUGHOUT

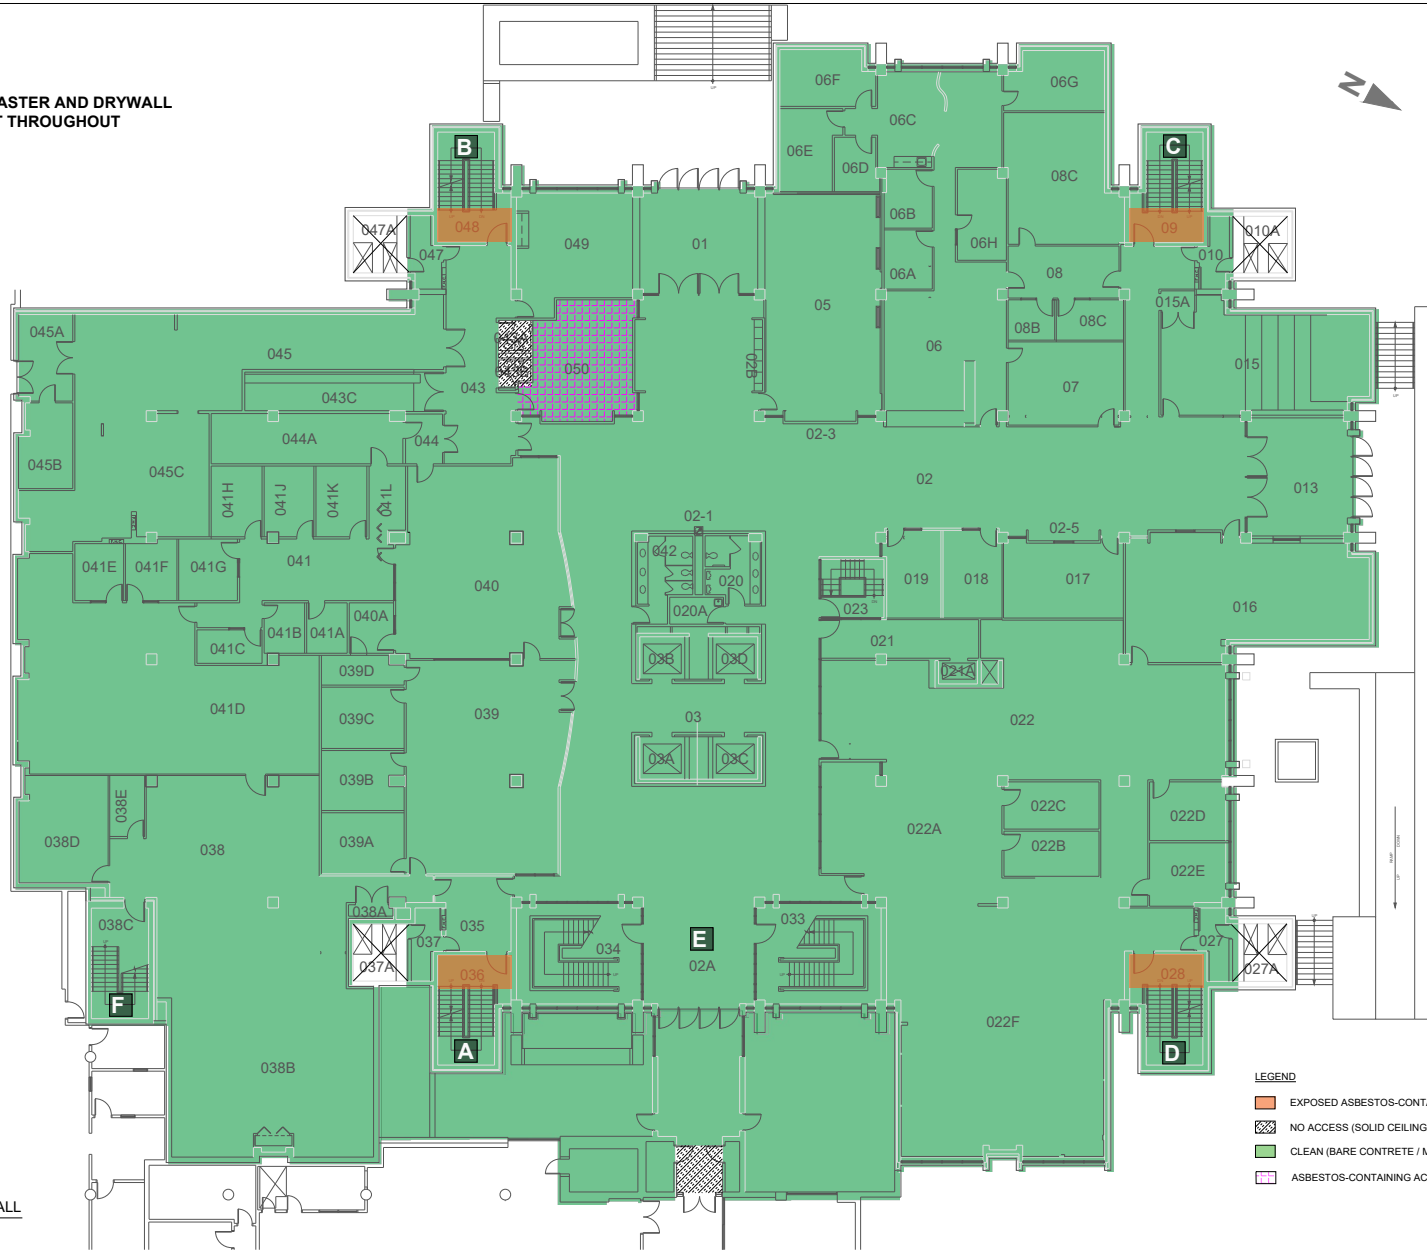
1 LEVEL 0 FLOOR PLAN, MORISSET HALL  
NTS

NOTE: ASBESTOS-CONTAINING PLASTER AND DRYWALL JOINT COMPOUND PRESENT THROUGHOUT

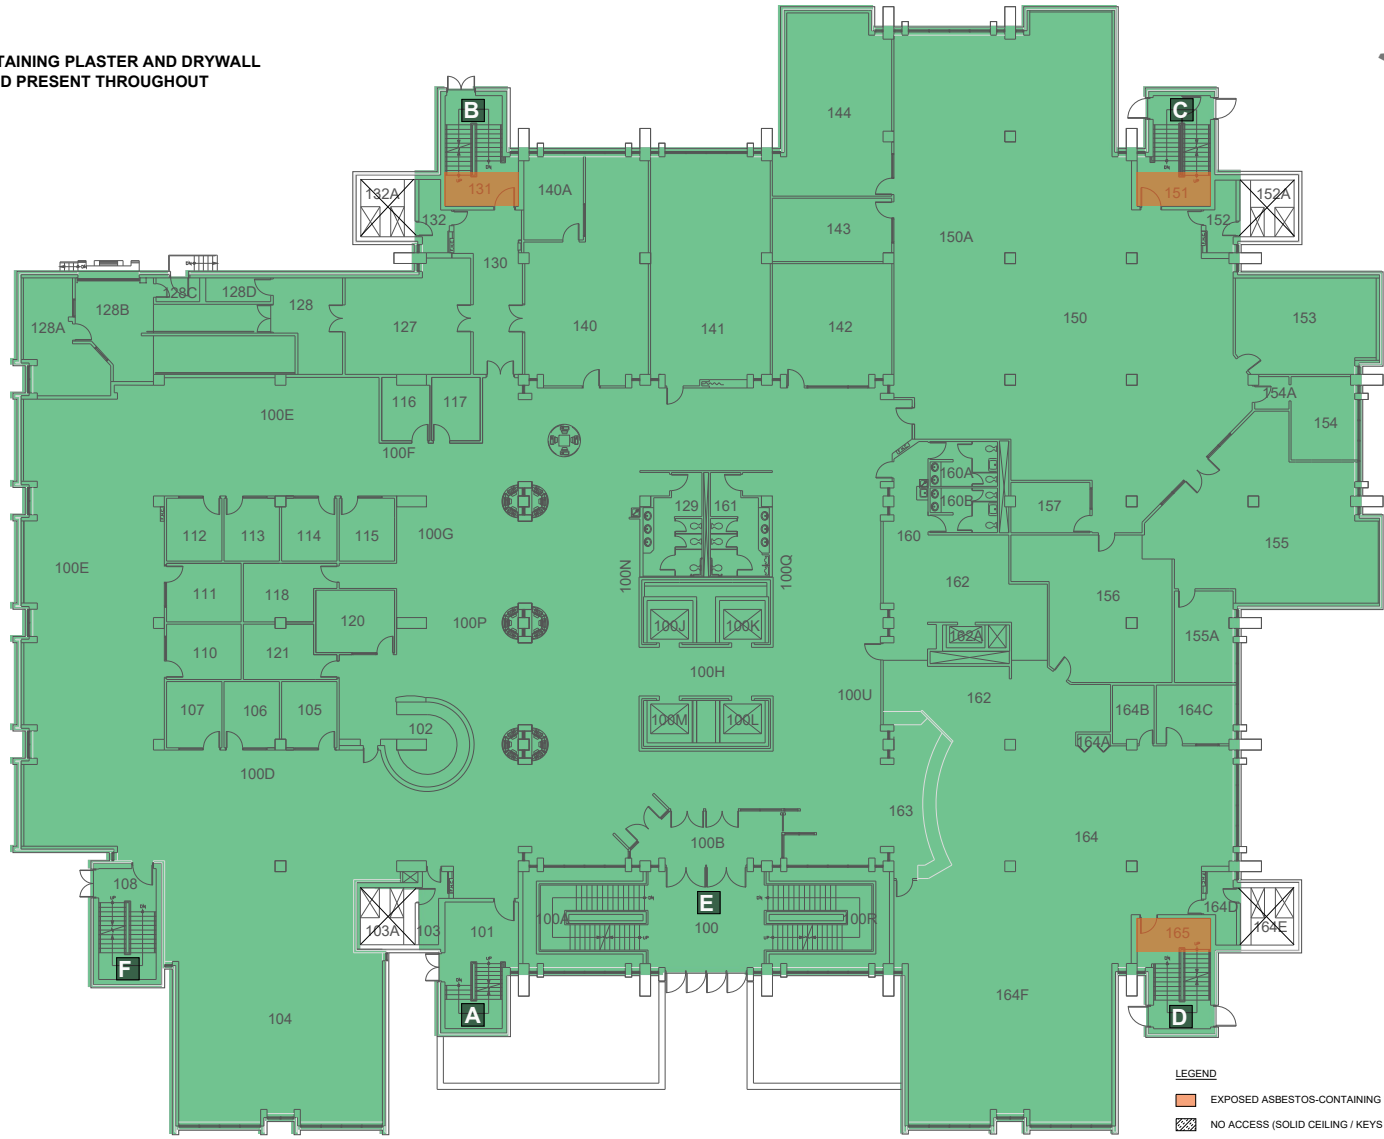
1 LEVEL 1 FLOOR PLAN, MORISSET HALL  
NTS

**NOTE: ASBESTOS-CONTAINING PLASTER AND DRYWALL JOINT COMPOUND PRESENT THROUGHOUT**

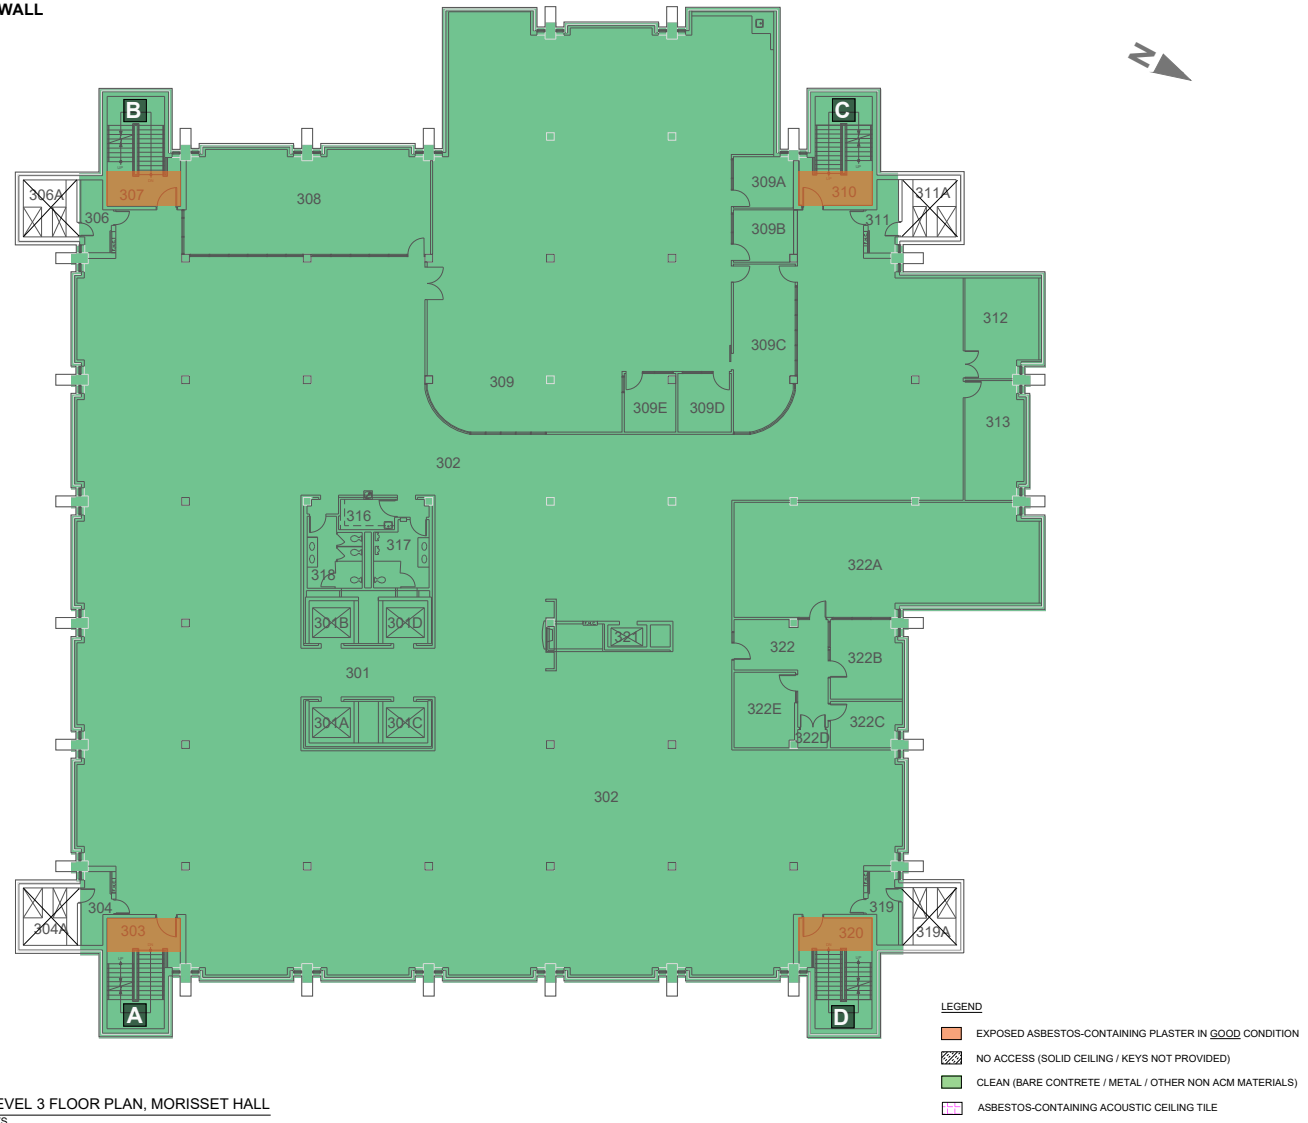
1 LEVEL 3 FLOOR PLAN, MORISSET HALL  
NTS

**NOTE: ASBESTOS-CONTAINING PLASTER AND DRYWALL  
JOINT COMPOUND PRESENT THROUGHOUT**

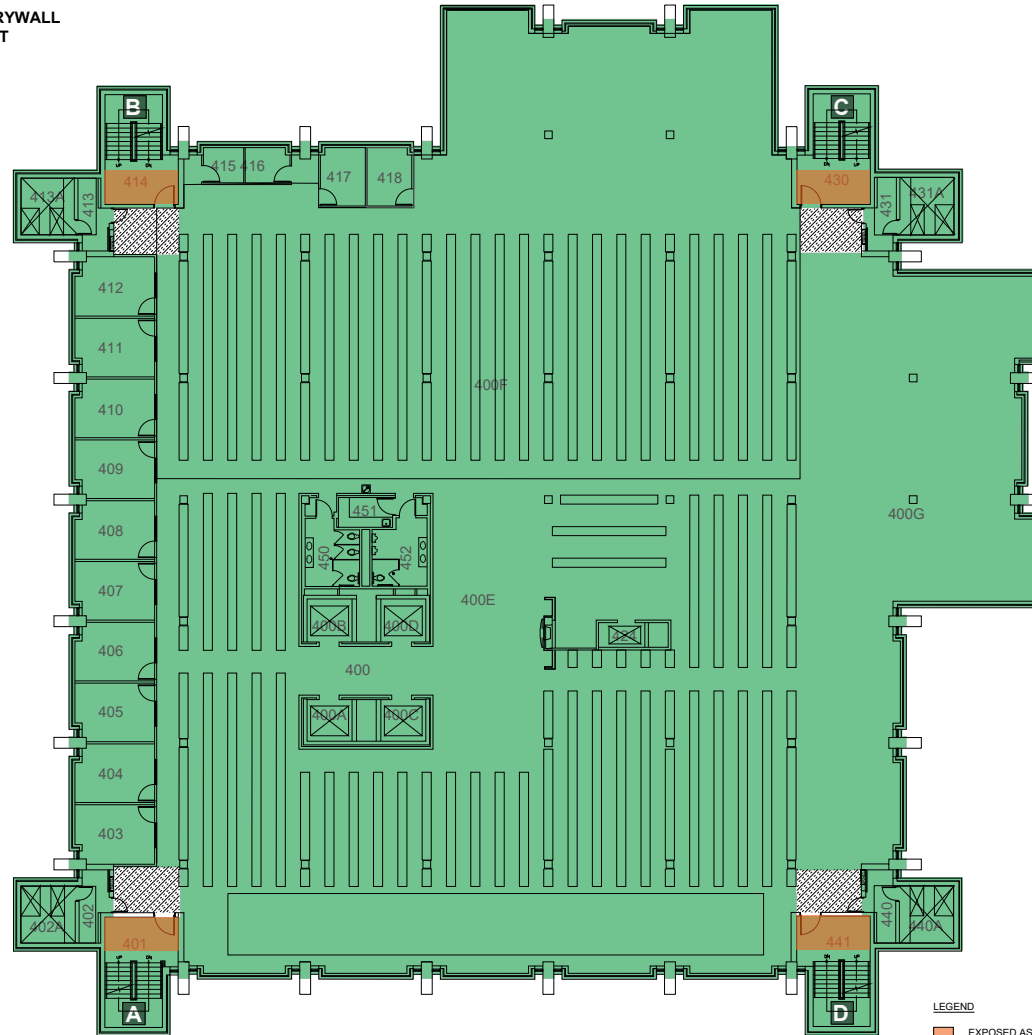
1 LEVEL 4 FLOOR PLAN, MORISSET HALL  
NTS

NOTE: ASBESTOS-CONTAINING PLASTER AND DRYWALL  
JOINT COMPOUND PRESENT THROUGHOUT

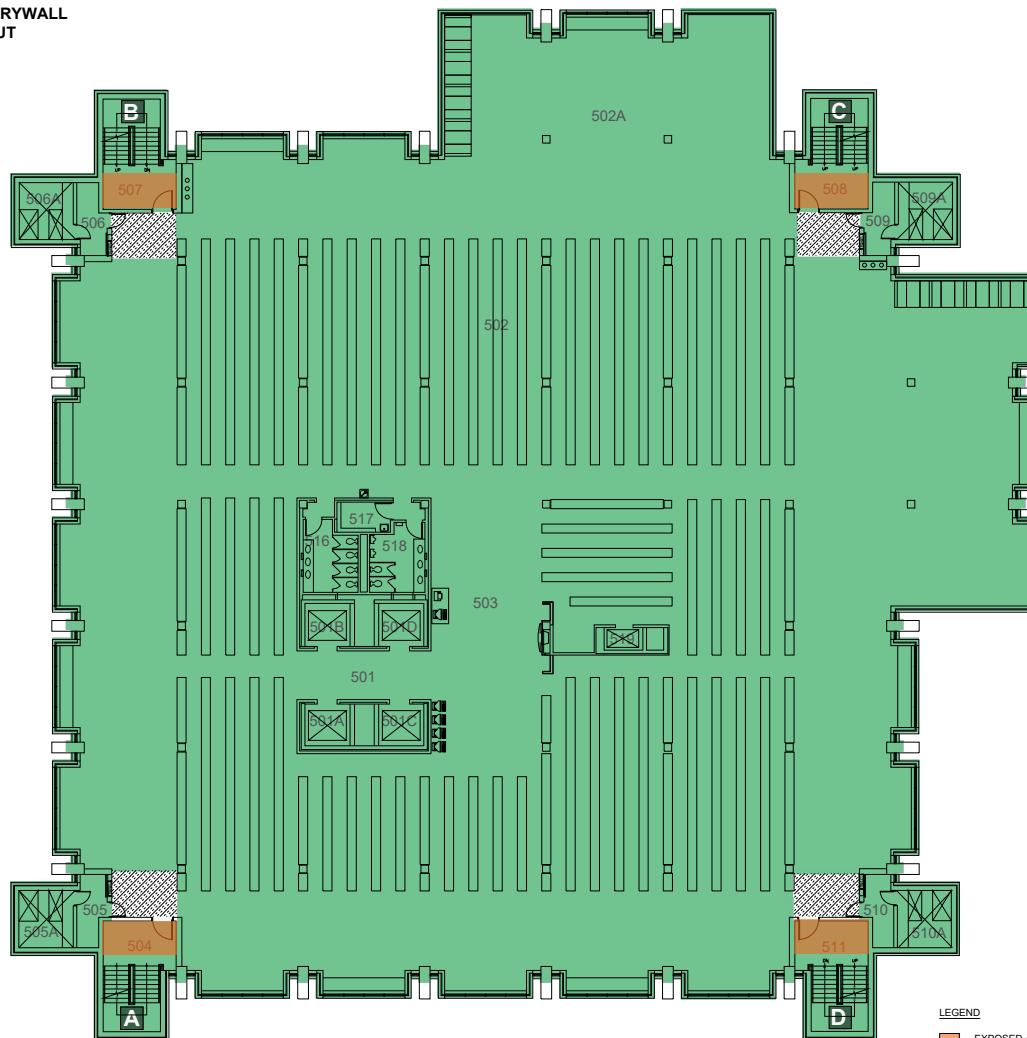
1 LEVEL 5 FLOOR PLAN, MORISSET HALL  
NTS

NOTE: ASBESTOS-CONTAINING PLASTER AND DRYWALL  
JOINT COMPOUND PRESENT THROUGHOUT

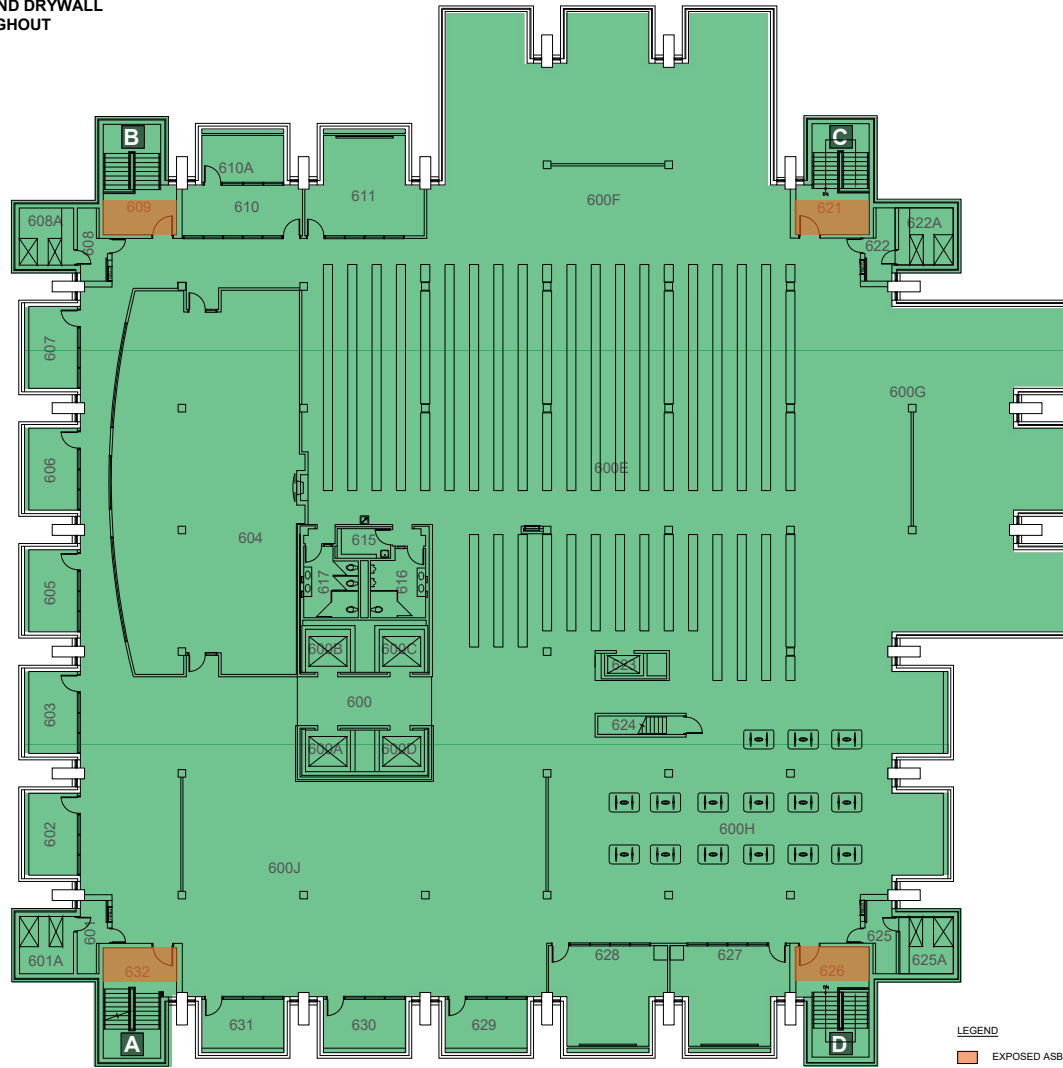
1 LEVEL 6 FLOOR PLAN, MORISSET HALL  
NTS

NOTE: ASBESTOS-CONTAINING PLASTER AND DRYWALL  
JOINT COMPOUND PRESENT THROUGHOUT

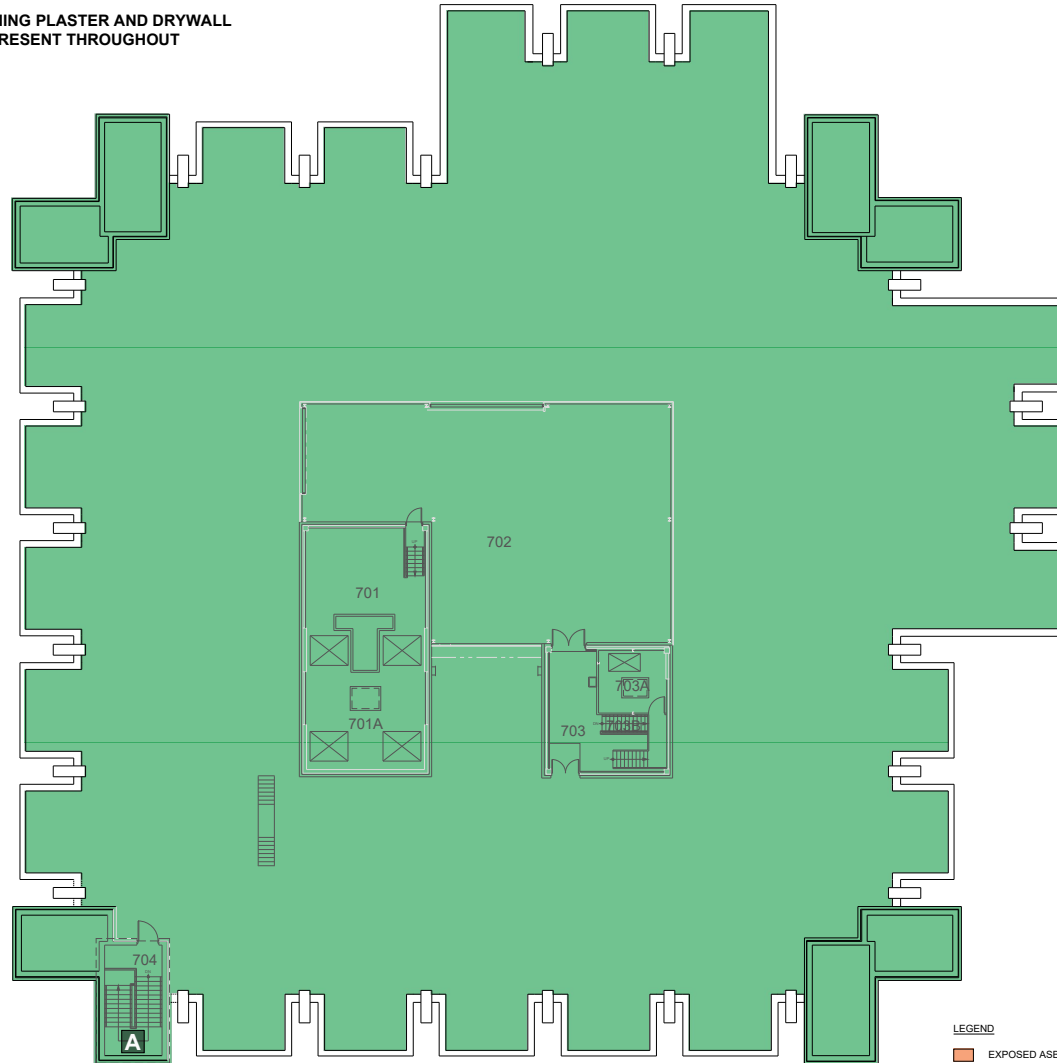
1 LEVEL 7 FLOOR PLAN, MORISSET HALL  
NTS

NOTE: ASBESTOS-CONTAINING PLASTER AND DRYWALL  
JOINT COMPOUND PRESENT THROUGHOUT
