HAZARDOUS MATERIALS SURVEY AND 2022 REASSESSMENT 30-32 STEWART STREET, OTTAWA, ON

Project No.: OZ2021101HZ / CCC-230252-00

University of Ottawa

McIntosh Perry Limited (MPL)

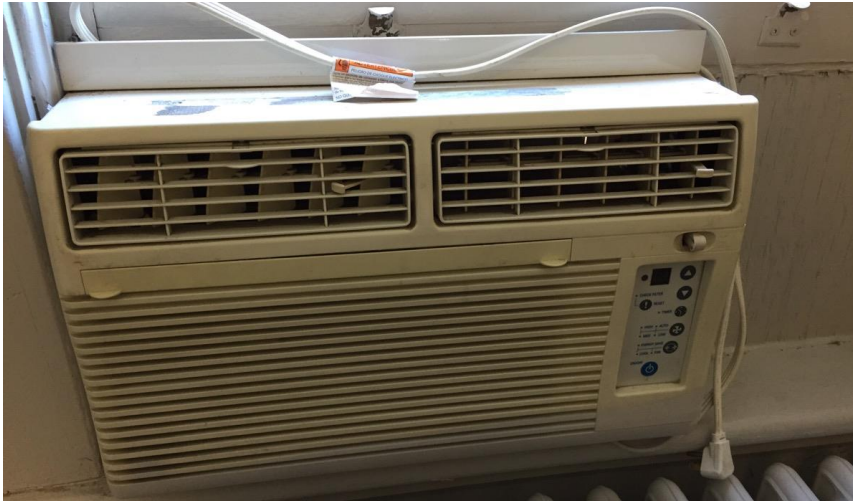
A visual assessment for equipment potentially containing ODSs and other halocarbons was conducted. Equipment containing ODSs or other halocarbons was observed in the subject building.

Photo 4: View of the ODS-containing equipment observed throughout the subject building.

Please refer to Appendix F – Hazardous Materials Checklist for equipment conditions, approximate quantities (where applicable), and recommended actions.

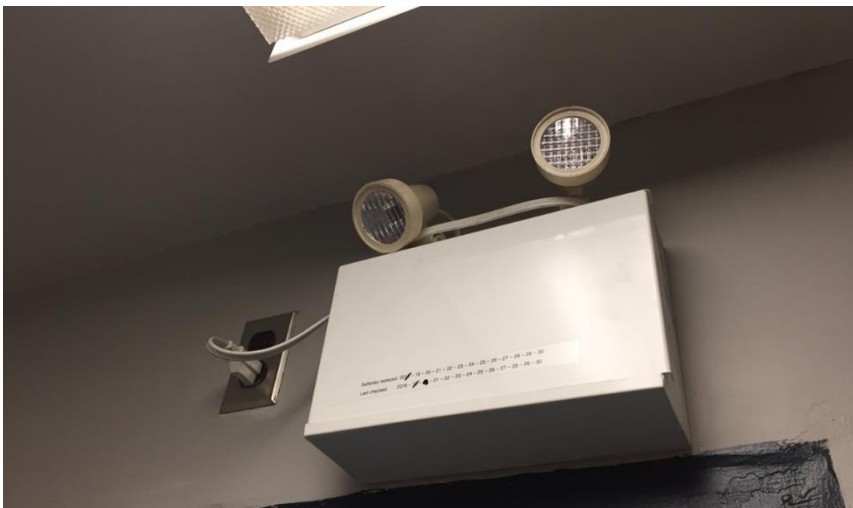
MPL identified lead-containing acid battery packs throughout the subject building. These battery packs were observed on walls and above exits throughout the surveyed building.

Photo 5: View of the lead-containing battery pack observed in Room 300.

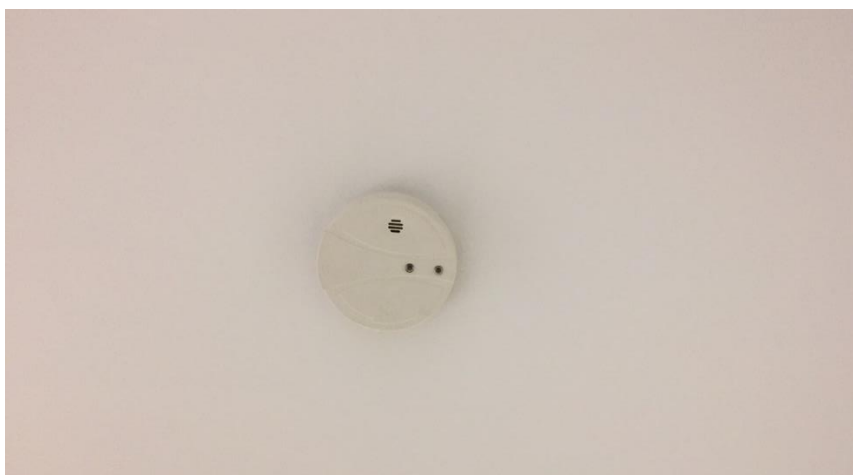
A visual assessment of the subject building was conducted to determine if any electrical components containing radioactive materials were present. MPL observed Kidde brand smoke detectors which contains small quantities of radioactive material.

Photo 6: View of the smoke detectors containing radioactive materials observed in Room 001.

The radioactive sources in smoke alarms are sealed and contained within a metal case inside the smoke detector and must not be damaged or tampered with. These materials do not pose a hazard as long as they remain contained and properly disposed at the time of removal or replacement.

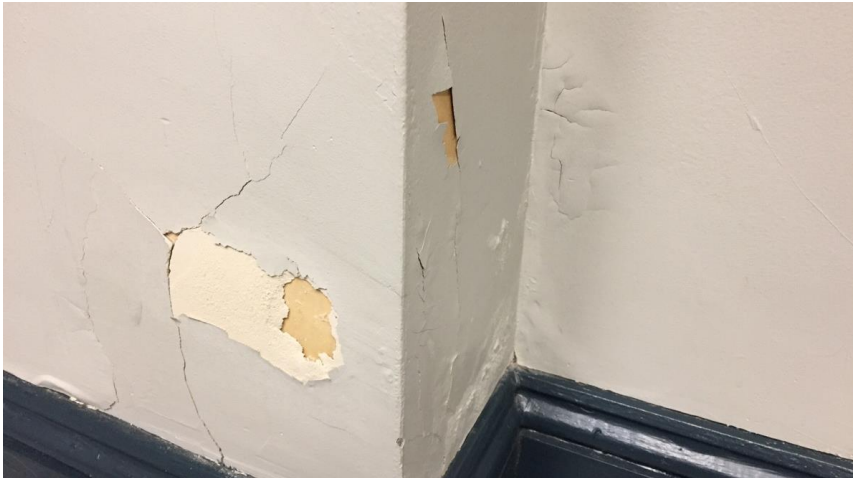
Previously identified asbestos-containing drywall joint compound was observed throughout the subject building. This material contains 2% Chrysotile asbestos. This material is non-friable and was observed in good condition, with the exception of select areas which were observed to be in fair and poor condition during the 2022 Reassessment. Since drywall joint compound is a homogeneous material, all areas must be treated as asbestos-containing unless additional bulk sampling and analysis proves otherwise.

Photo 7: View of the poor condition asbestos-containing drywall joint compound was observed in Room 100D.

- Asbestos-containing materials identified to be in poor condition must be repaired/removed immediately, following Type 1/2/3 asbestos abatement work procedures as detailed in O. Reg. 278/05 and disposed of as asbestos waste under O. Reg. 347;
- Asbestos-containing materials that have been identified to be in fair condition should be either repaired (where possible) and/or closely monitored for signs of further deterioration. Depending on type of material and location, these materials should be scheduled for removal if there is potential risk of exposure to worker and/or occupants;
- Materials identified to contain asbestos that are in good condition and do not pose a risk to workers or occupants can be managed in place. Prior to renovation/demolition activities that may disturb the

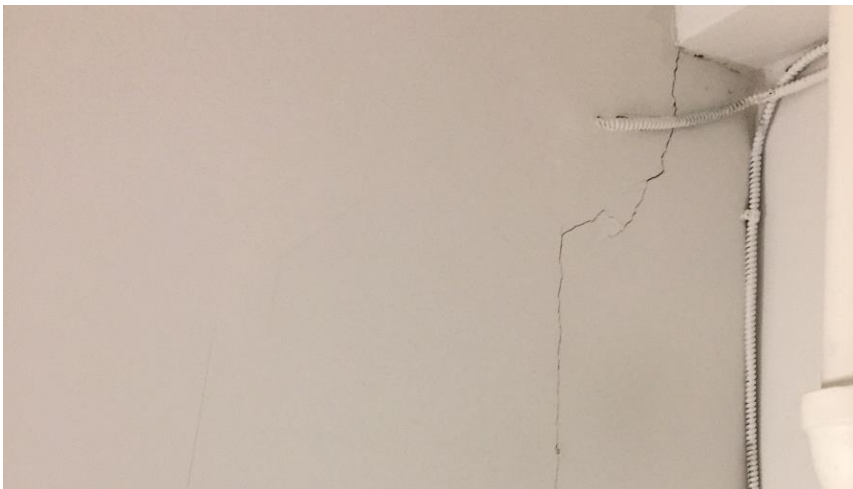
Plaster was observed and sampled in Rooms 002, 008, 205, 210, and 310. The laboratory analytical results indicate that this material contains 1% Chrysotile asbestos. This material is friable and was observed in good condition, with the exception of select areas which were observed to be in fair and poor condition during the 2022 Reassessment. Since plaster is a homogeneous material, all areas must be treated as asbestos-containing unless additional bulk sampling and analysis proves otherwise.

Photo 8: View of the asbestos-containing plaster observed in fair condition in Room 004.

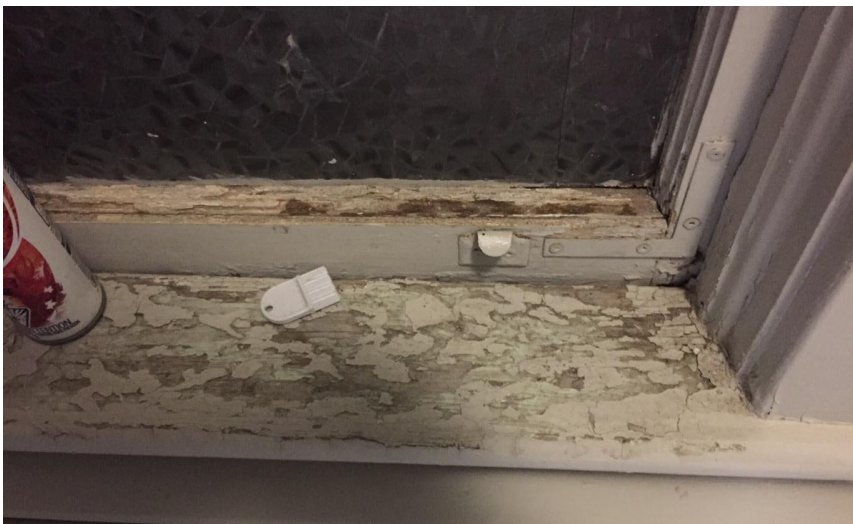
The paint finishes highlighted in pink in the above table are considered lead-containing paints or surface coatings with concentrations greater than 0.1% lead by weight. These paint finishes were observed to be in good condition, with the exception of select areas which were observed in poor condition.

Photo 9: View of the poor condition lead-containing windowsill paint (Grey) observed in Room 303.

Paints identified to contain lead that are in poor condition must be immediately repaired and/or stabilized following a minimum Type 1/2 lead abatement procedures as per OMOL "Lead on Construction Project" dated April 2011.

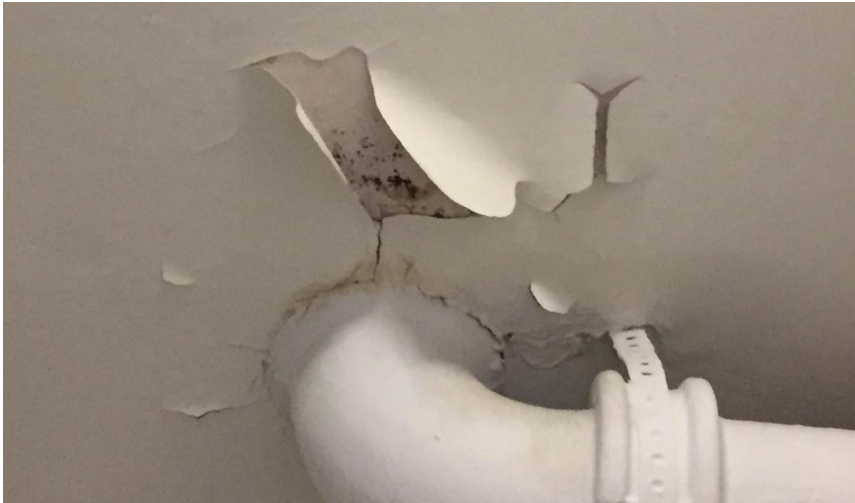
Photo 10: View of the poor condition lead-containing ceiling paint (White) observed in Room 207.

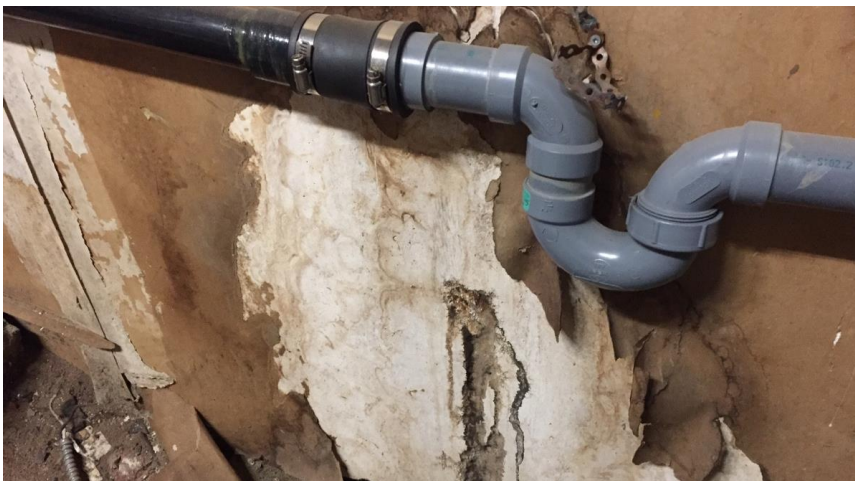
Photo 11: View of the poor condition drywall with asbestos-containing joint compound observed in Room 002A.

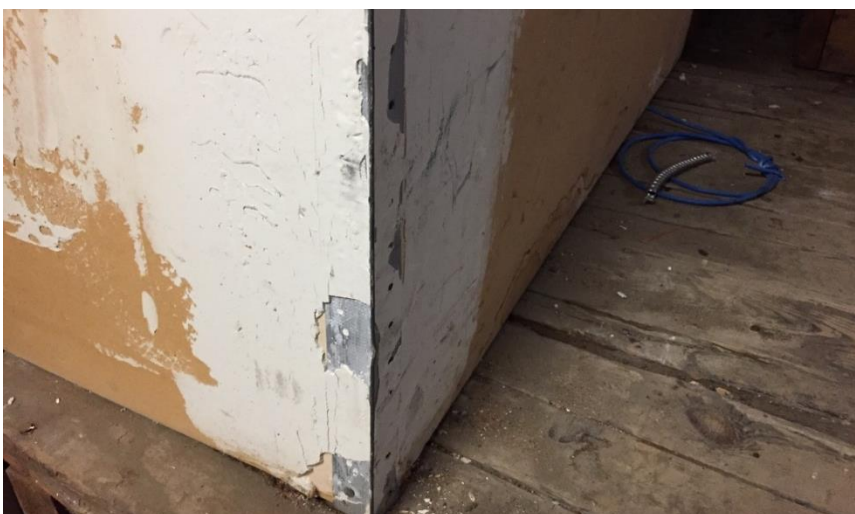
Photo 12: View of the poor condition drywall with asbestos-containing joint compound observed in Room 002.

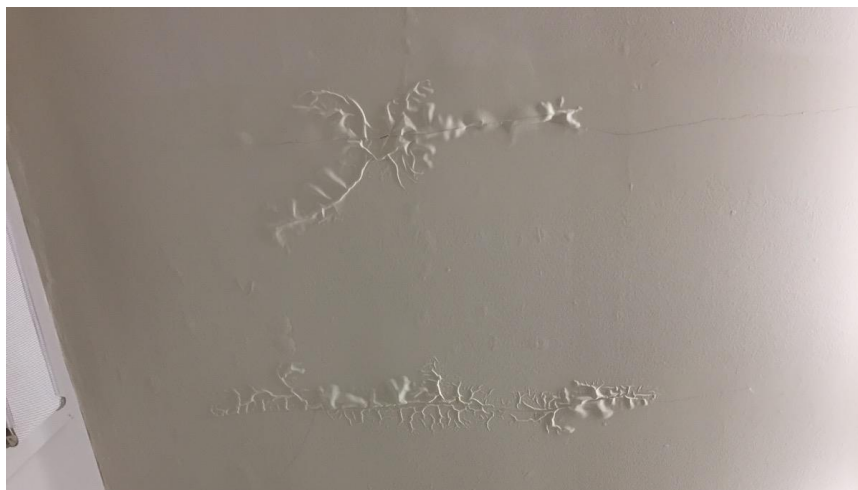
Photo 13: View of the poor condition lead-containing ceiling paint (White) observed in Room 207.

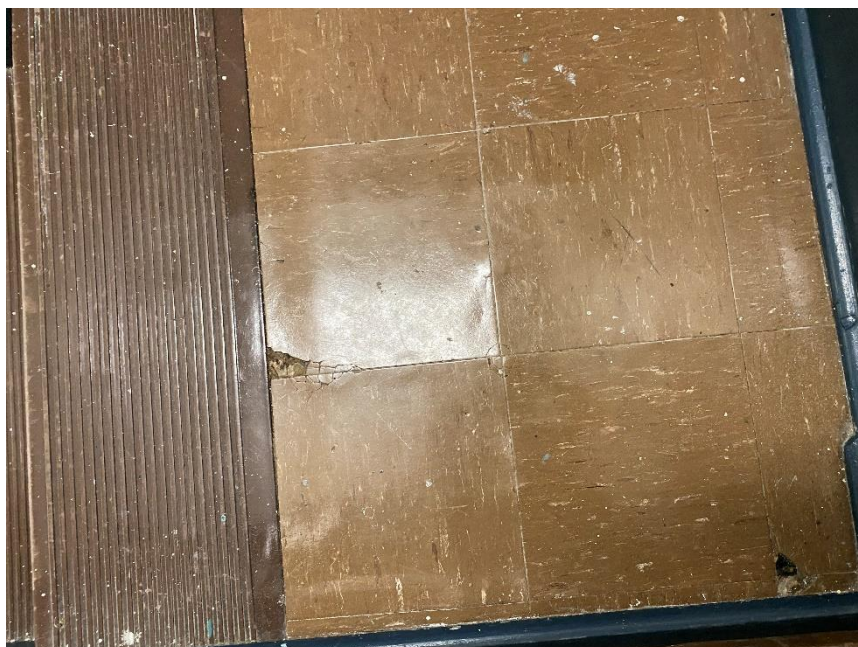
Photo 14: View of the fair condition asbestos-containing vinyl floor tiles observed in Room 112.

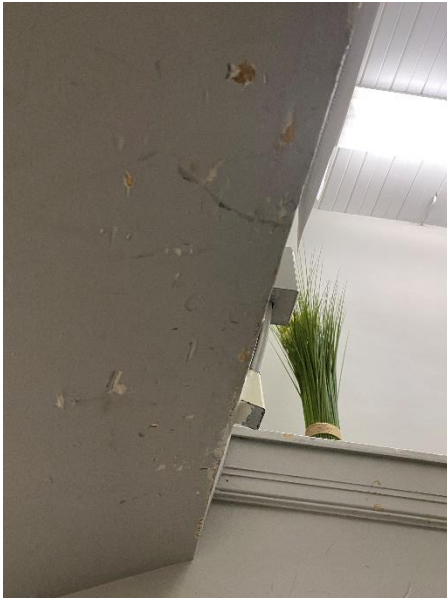
Photo 15: View of the fair condition asbestos-containing drywall bulkhead observed in Room 009.

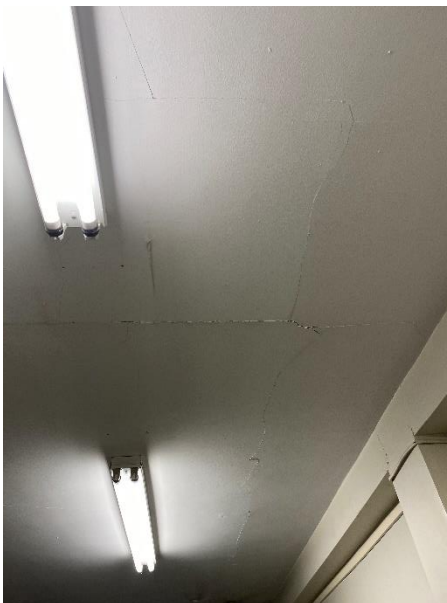
Photo 16: View of the poor condition asbestos-containing plaster ceiling observed in Room 008.

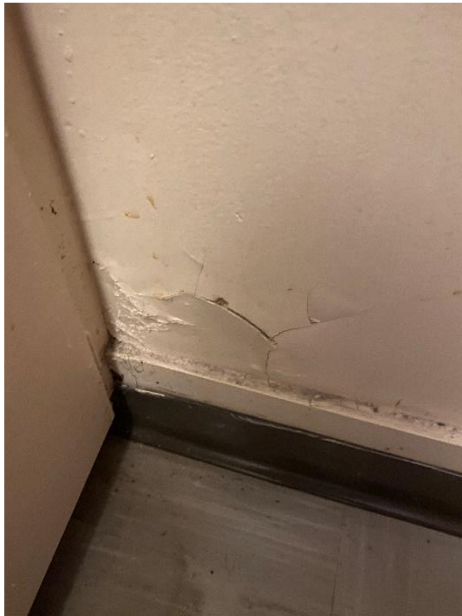
Photo 17: View of the poor condition asbestos-containing drywall joint compound wall observed in Room 007.

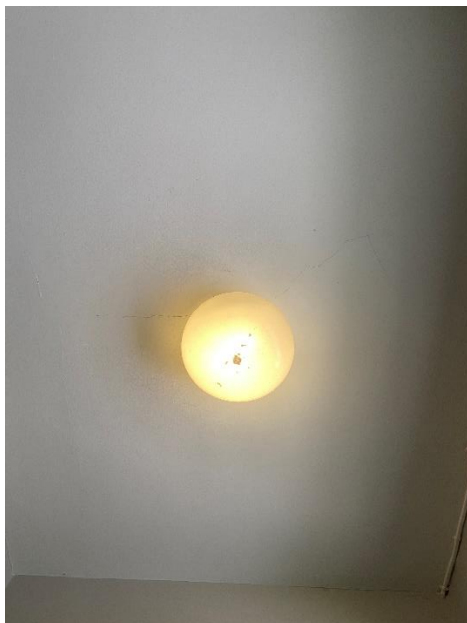
Photo 18: View of the fair condition asbestos-containing plaster ceiling observed in Room 100C.

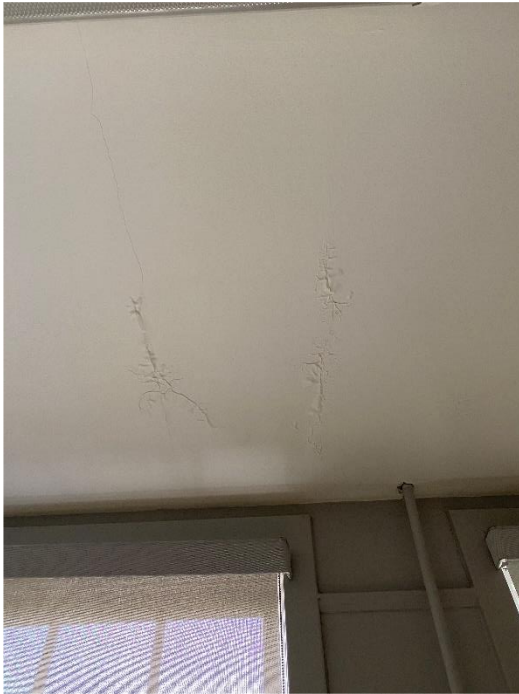
Photo 19: View of the fair condition asbestos-containing drywall ceiling observed in Room 205.
