HAZARDOUS MATERIALS SURVEY AND 2022 REASSESSMENT 34-36 STEWART STREET, OTTAWA, ON

Project No.: OZ2021101HZ / CCC-230252-00

University of Ottawa

McIntosh Perry Limited (MPL)

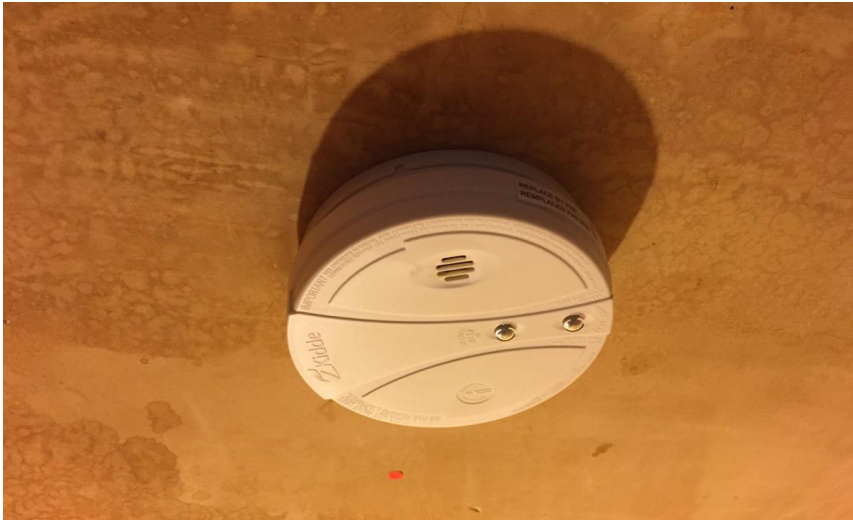
A visual assessment of the subject building was conducted to determine if any electrical components containing radioactive materials were present. MPL observed Kidde brand smoke detectors which contains small quantities of radioactive material.

Photo 4: View of the Kidde brand smoke detector containing radioactive materials observed in Room 105A.

The radioactive sources in smoke alarms are sealed and contained within a metal case inside the smoke detector and must not be damaged or tampered with. These materials do not pose a hazard provided they remain contained and properly disposed at the time of removal or replacement.

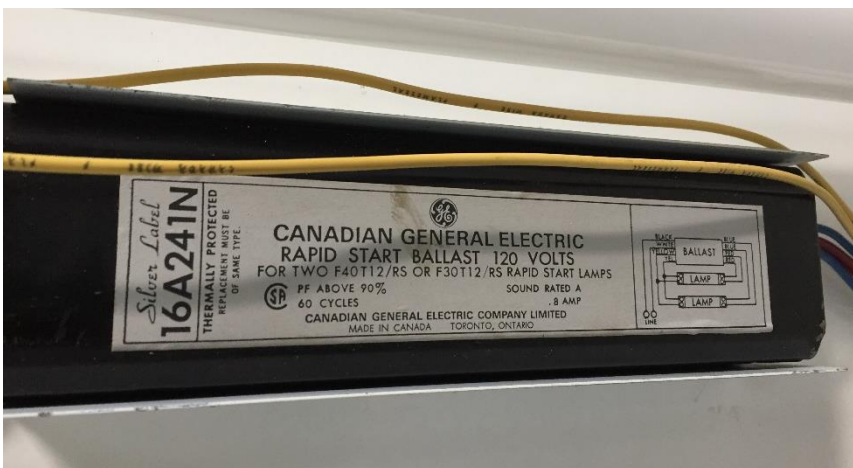
The subject building is illuminated by LED and fluorescent lights. MPL assessed representative ballasts in the building, and these ballasts were observed to be manufactured by Canadian General Electric. These ballasts are suspected to contain PCBs.

Photo 6: Representative view of the suspected PCB-containing light ballasts observed in the subject building.

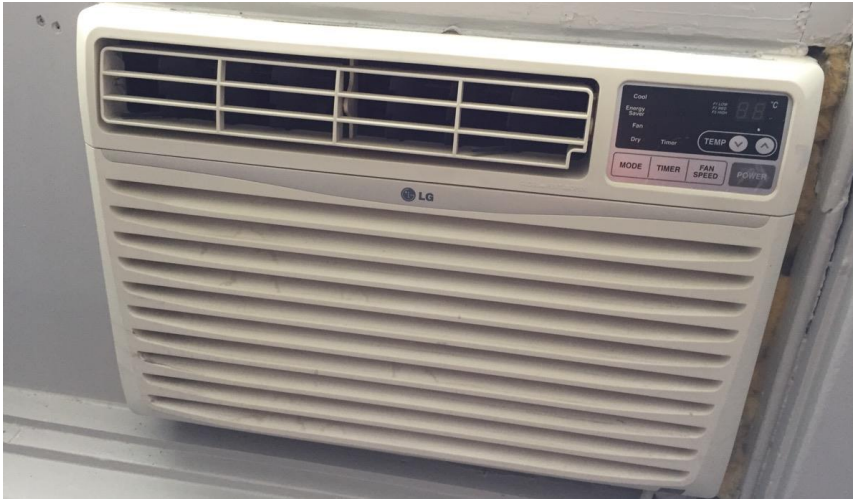
A visual assessment for equipment potentially containing ODSs and other halocarbons was conducted. Equipment containing ODSs or other halocarbons was observed throughout the subject building.

Photo 7: View of equipment with unknown reffridgerant observed throughout the subject building.

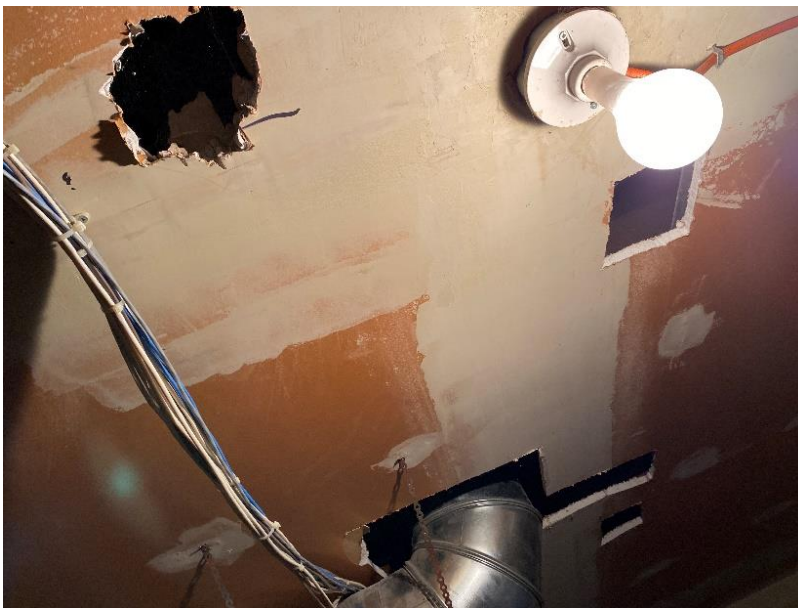
Previously identified asbestos-containing drywall joint compound was observed throughout the subject building. This material contains 2% Chrysotile asbestos. Since drywall joint compound is a homogeneous material, all areas must be treated as asbestos-containing unless additional bulk sampling and analysis proves otherwise. This material was observed in good condition, with the exception of select areas observed to be in fair and poor condition during the 2022 Reassessment.

Photo 8: View of asbestos-containing drywall joint compound (ceiling) observed to be in poor condition in Room B1

Unencapsulated asbestos-containing drywall joint compound was observed to be in fair condition during the 2022 Reassessment.

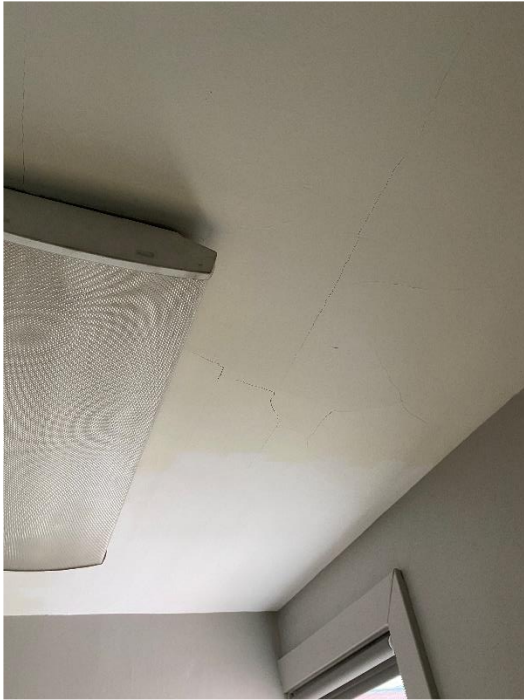
Photo 9: View of asbestos-containing drywall joint compound (ceiling) observed to be in fair condition in Room 203 during the 2022 Reassessment.

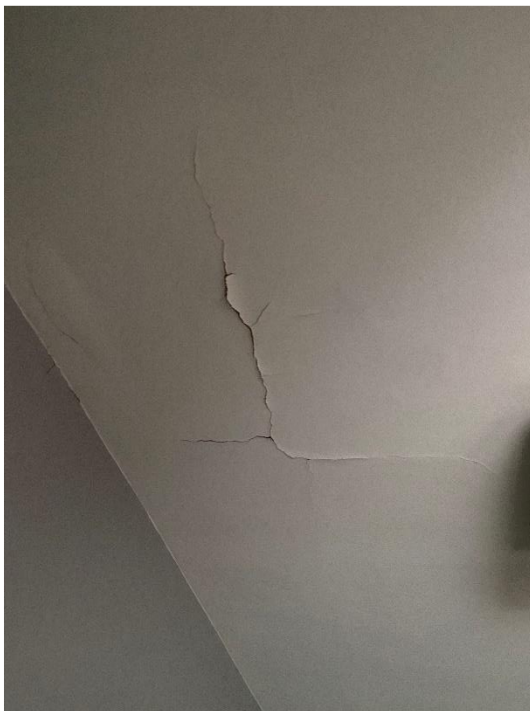
Photo 10: View of asbestos-containing drywall joint compound (ceiling) observed to be in fair condition in Room 301 during the 2022 Reassessment.
