HAZARDOUS MATERIALS SURVEY AND 2022 REASSESSMENT 45 MANN AVENUE, OTTAWA, ON

Project No.: CCC-214243-00 / CCC-230252-00

University of Ottawa

November 24, 2022

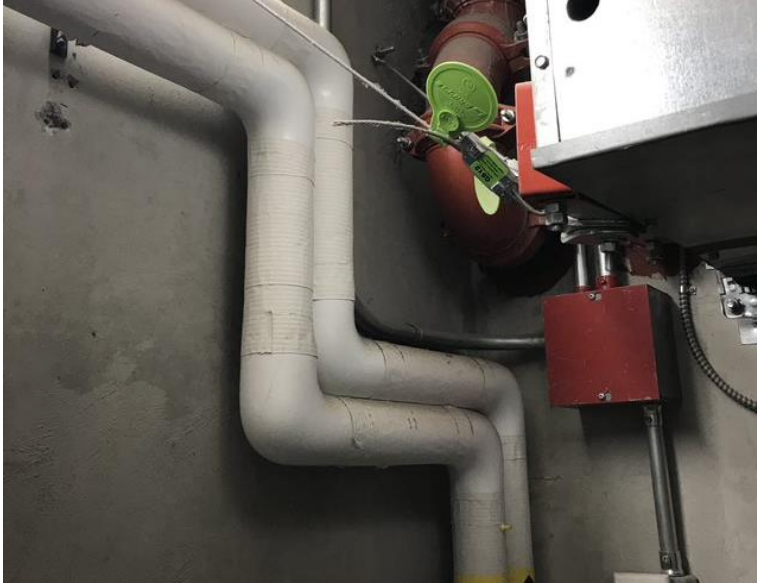
Mechanical pipe straight insulation was observed in the parking garage. MPL made several incisions throughout to investigate its composition, and it was visually identified as fiberglass, and therefore not suspected of containing asbestos.

Mechanical pipe elbows/fittings insulation was observed in the parking garage. MPL made several incisions throughout to investigate its composition, and it was visually identified as fiberglass, and therefore not suspected of containing asbestos.

Photo 1: View of fibreglass pipe insulation observed in the parking garage of the subject building.

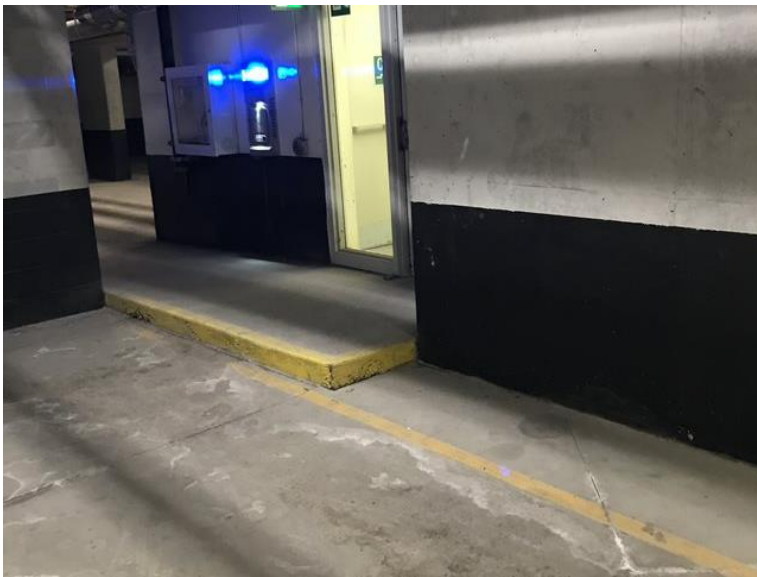
The paint finishes highlighted in blue in the above table were determined to contain low concentrations of lead which are less than or equal to 0.1%. These paint finishes were observed to be in good condition.

Photo 2: View of the low level lead paints (black and yellow) observed in the parking garage of the subject building.

Paints identified to contain lead that are in good condition and do not pose a risk to workers or occupants can be managed in place.
