HAZARDOUS MATERIALS SURVEY AND 2022 REASSESSMENT 538-540 KING EDWARD AVENUE, OTTAWA, ON

Project No.: Z2021101HZ / CCC-230252-00

University of Ottawa

McIntosh Perry Limited (MPL)

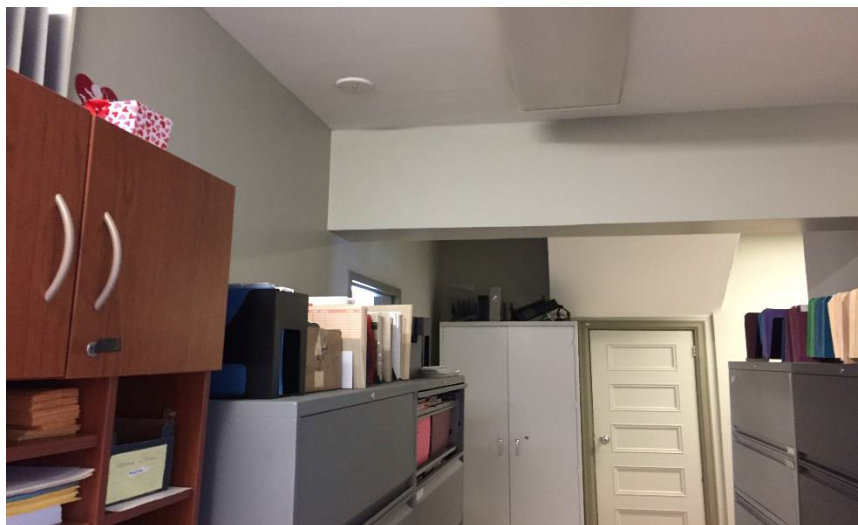
Photo 1: Representative view of finishes observed within the subject building.

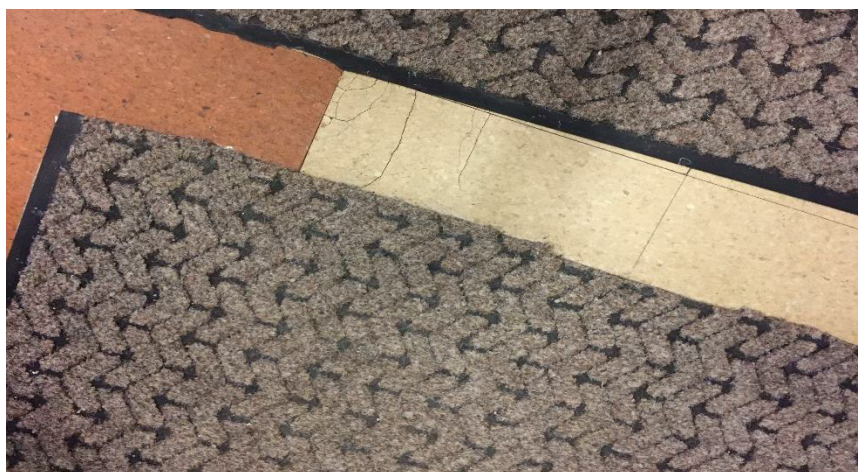
- Vinyl floor tiles (12"x12"- Grey with Grey and White) were observed and sampled in Room 012. The laboratory analytical results of the samples collected from Room 012 indicate that this material does not contain asbestos. The associated mastic (yellow) was also determined not to contain asbestos.

Photo 2: View of non-asbestos-containing vinyl floor tiles observed throughout the subject building.

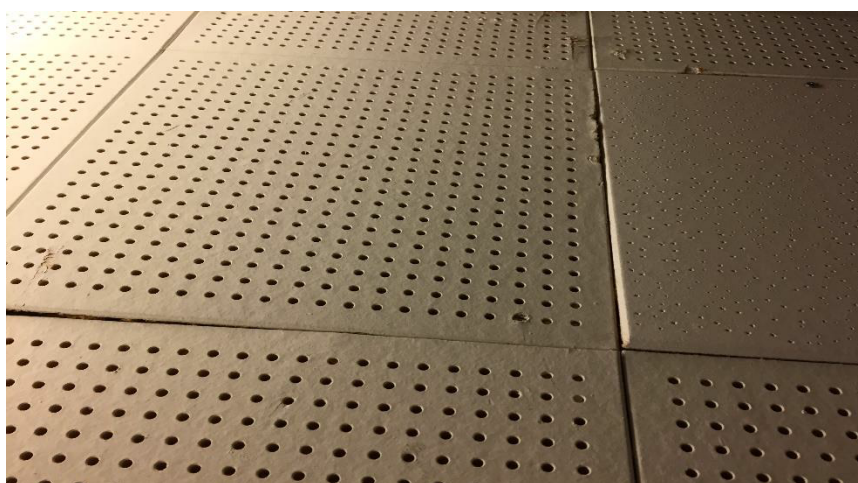
- Stick-on ceiling tiles (1'x1' – Scattered Pinholes) were observed and sampled in Rooms 001 and 003. The laboratory analytical results of the collected from Rooms 001 and 003 indicate that this material does not contain asbestos.
- Stick-on ceiling tiles (1'x1' – Linear with Pinholes) were observed and sampled in Room 001. The laboratory analytical results of the samples collected from Room 001 indicate that this material does not contain asbestos.

Photo 3: View of non-asbestos-containing ceiling tiles observed throughout the basement of the subject building.

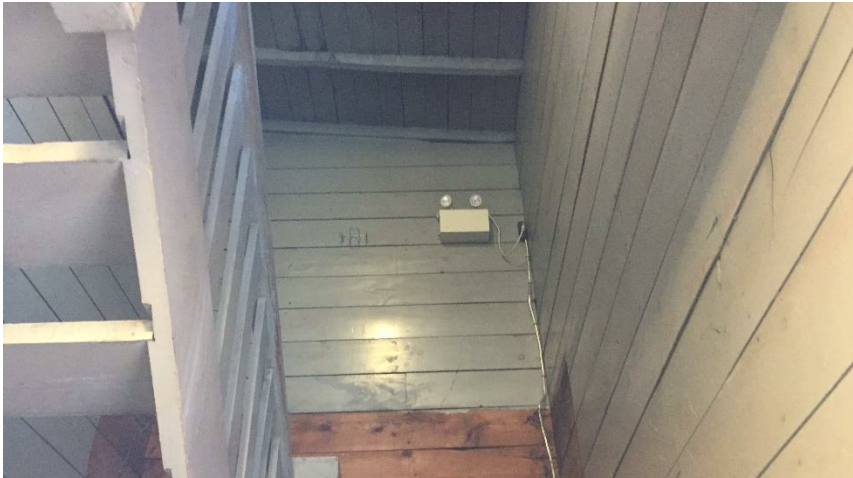
MPL observed battery packs throughout the subject building.

Photo 4: View of lead-containing battery pack observed in emergency lights..

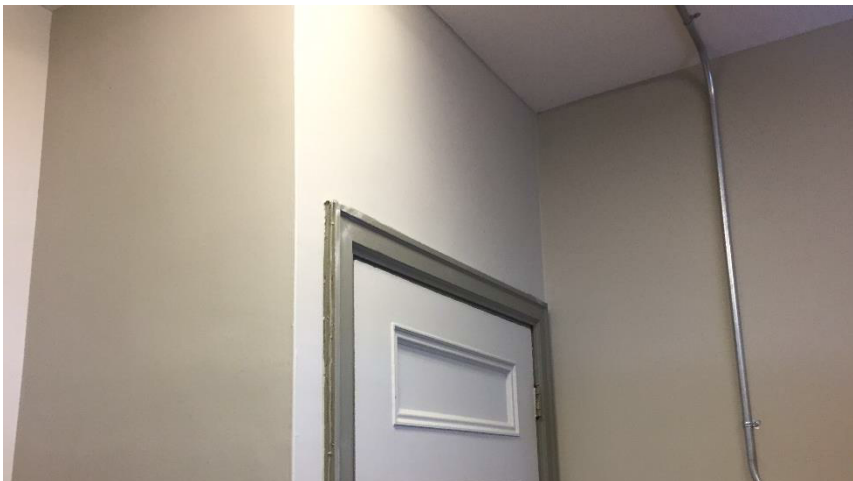
Drywall joint compound was observed and sampled throughout the subject building. The laboratory analytical results of drywall joint compound samples collected from various locations indicate that this material contains

between 4% Chrysotile asbestos. Since drywall joint compound is a homogeneous material, all areas must be treated as asbestos-containing unless additional testing confirms otherwise. This material was observed to be in good condition.

The paint finishes highlighted in blue in the above table were determined to contain low concentrations of lead which are less than or equal to 0.1%. These paint finishes were observed to be in good condition.

Photo 5: View of low-level lead containing paint and view of asbestos-containing drywall joint compound observed throughout the subject building.

Paints identified to contain lead that are in good condition and do not pose a risk to workers or occupants can be managed in place.

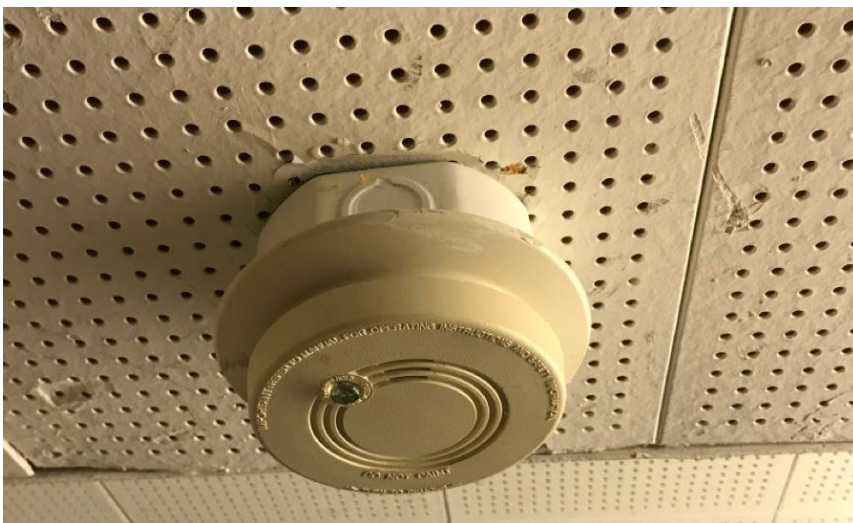
A visual assessment of the subject building was conducted to determine if any electrical components containing radioactive materials were present. MPL observed smoke detectors, which contains small quantities of radioactive material.

Photo 6: Typical view of radioactive-containing smoke detectors observed throughout the subject building.

The radioactive sources in smoke alarms are sealed and contained within a metal case inside the smoke detector and must not be damaged or tampered with. These materials do not pose a hazard as long as they remain contained and properly disposed at the time of removal or replacement.
