HAZARDOUS MATERIALS SURVEY AND 2022 REASSESSMENT 545 KING EDWARD AVENUE, OTTAWA, ON

Project No.:0Z2021101HZ / CCC-230252-00

University of Ottawa

McIntosh Perry Limited (MPL)

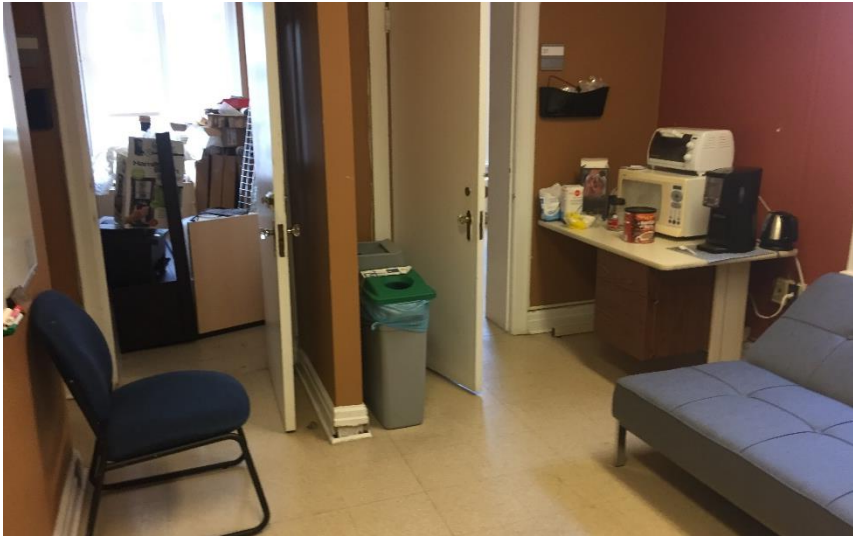
Photo 1: Representative view of the interior finishes observed throughout the subject building.

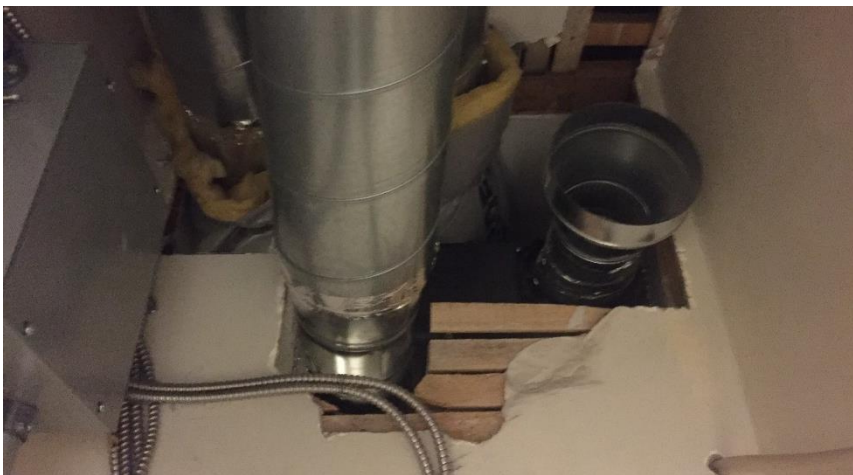
Wall and ceiling plaster was observed and sampled throughout the subject building. The laboratory analytical results of the samples collected from Rooms B8, B10, 13, 21C, 21A, and 27A indicate that this material does not contain asbestos.

Photo 2: View of the non-asbestos containing wall and ceiling plaster observed throughout the subject building.

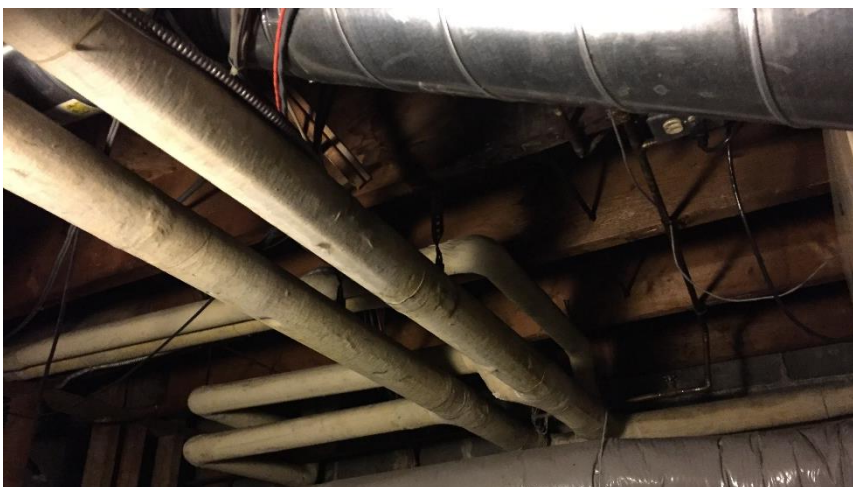
Previously identified asbestos-containing pipe straight insulation was observed in Room B8, B10, and B13. This material contains 50% Chrysotile asbestos. This material is considered friable and was observed in good condition, with the exception of select areas which were observed in fair condition during 2022 Reassessment.

Previously identified asbestos-containing pipe elbows/fittings insulation was observed in Room B8 and B10. This material contains 65% Chrysotile asbestos. This material is considered friable and was observed in good condition during the 2022 Reassessment.

Photo 3: Representative view of the asbestos-containing parging cement elbows and pipe straight insulation observed in Room B10.

- Materials identified to contain asbestos that are in good condition and do not pose a risk to workers or occupants can be managed in place. Prior to renovation/demolition activities that may disturb the ACMs, these materials must be removed following appropriate Type 1/2/3 asbestos abatement work procedures as detailed in O. Reg. 278/05 and disposed of as asbestos waste under O. Reg. 347;

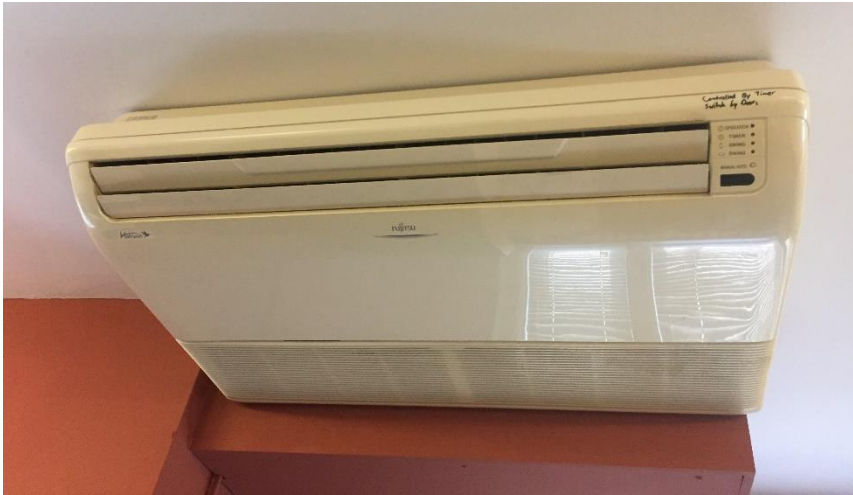
A visual assessment for equipment potentially containing ODSs and other halocarbons was conducted. Equipment containing ODSs or other halocarbons was observed in the subject building.

Photo 4: Representative view of equipment observed to contain ODSs throughout the subject building.

Please refer to Appendix F – Hazardous Materials Checklist for equipment conditions, approximate quantities (where applicable), and recommended actions.

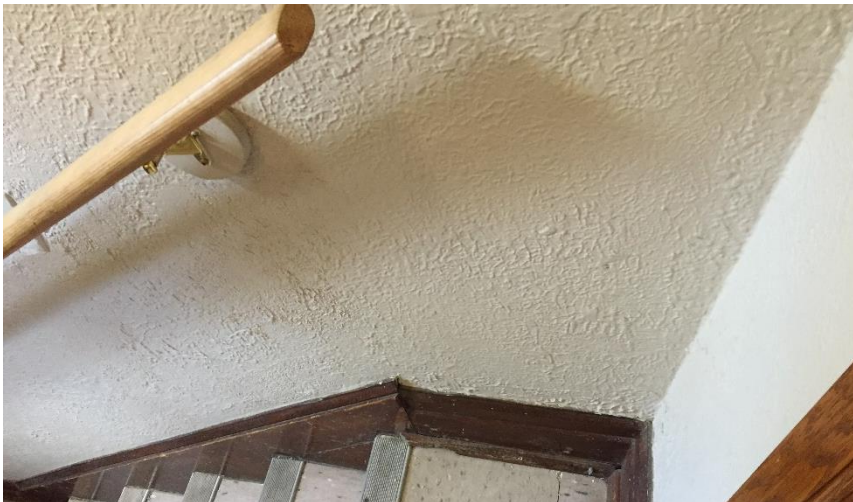
Wall texture coat (White) was observed and sampled in Room B6. The laboratory analytical results indicate that this material does not contain asbestos.

Photo 5: View of the non-asbestos containing wall texture coat observed in Room 10.

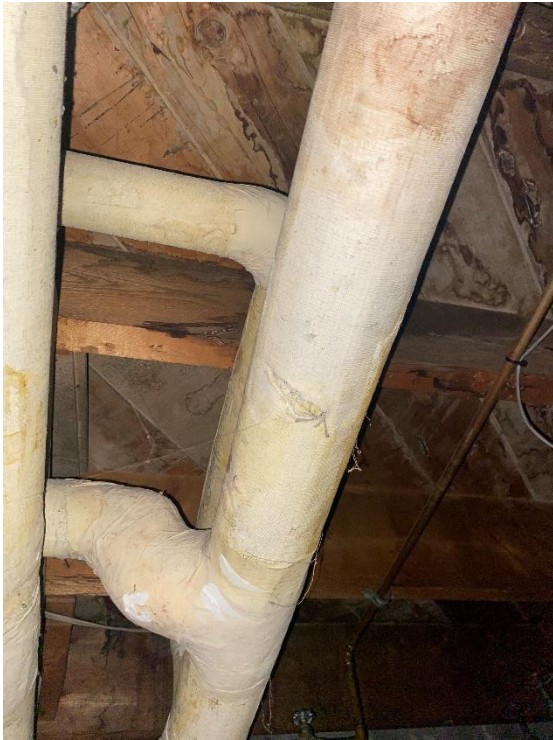
Photo 6: View of the asbestos-containing pipe straight insulation observed to be in fair in Room B10 during the 2022 Reassessment.
