# HAZARDOUS MATERIALS SURVEY AND 2022 REASSESSMENT 554 & 556 KING EDWARD AVENUE, OTTAWA, ON

Project No.: Z2021101HZ / CCC-230252-00

University of Ottawa

December 16, 2022

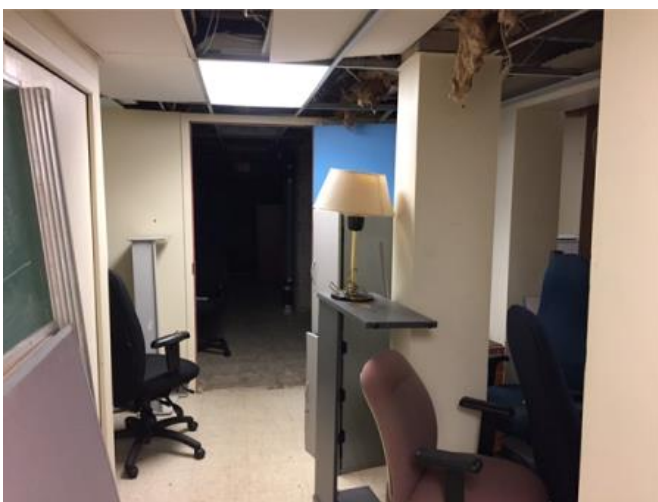
- Suspended ceiling tiles (Pinholes with no fissure) were observed in Room B4 of Building 554. The laboratory analytical results of ceiling tile samples collected from B4 indicate that this material **contains 3% Amosite**. This material was observed in good condition.

**Photo 3:** View of ACM 2x4 ceiling tiles (pinholes with no fissures), in Room B4 of Building 554.

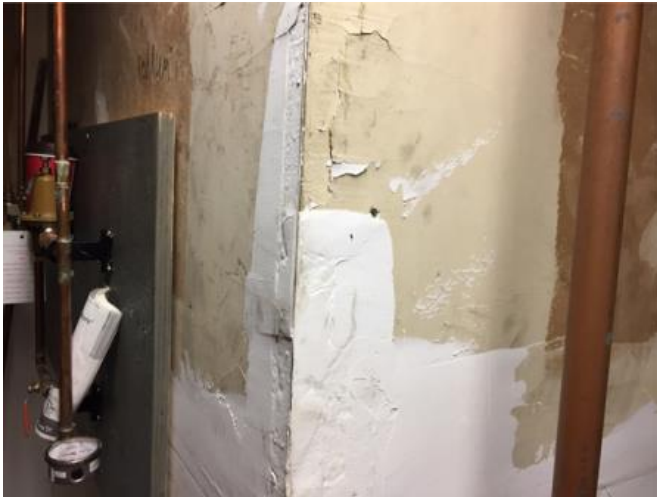
The laboratory analytical results of drywall joint compound samples collected from B1, B3 and B9 of Building 554 and of Room 302 in Building 556 indicate that this material **contains 3% Chrysotile asbestos**. Since drywall joint compound is a homogeneous material, all areas must be treated as asbestos-containing unless additional bulk sampling and analysis proves otherwise. This material was observed in good condition.

**Photo 4:** View of ACM drywall joint compound, observed to be in fair to poor condition in Room B3 of Building 554.

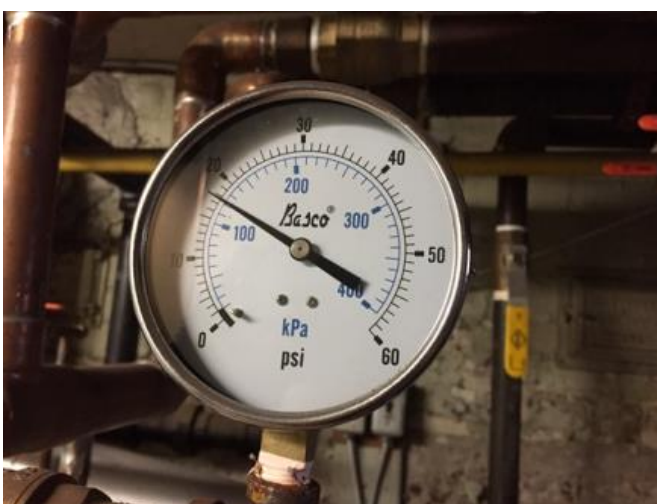
MPL identified a pressure gauge suspected to contain liquid mercury in Room B3 of Building 554. It was observed to be in good condition.

**Photo 6:** View of a potential mercury containing pressure gauge in Building 554.

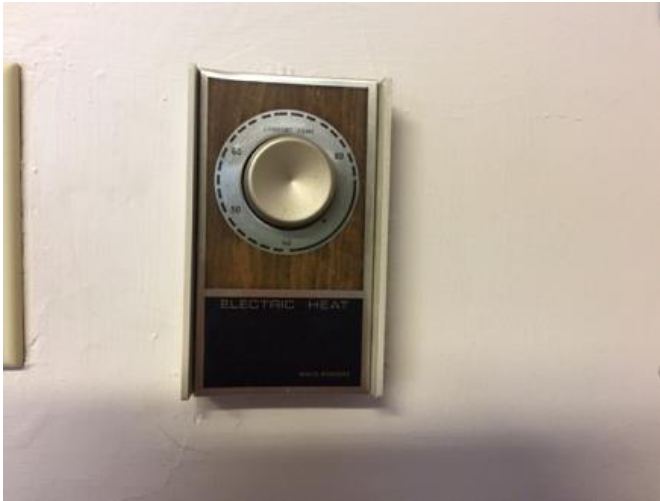
MPL did observed one (1) thermostat suspected to contain liquid mercury in Room 106 of Building 554. It was observed to be in good condition.

**Photo 7:** View of a potential mercury thermostat in Building 554.

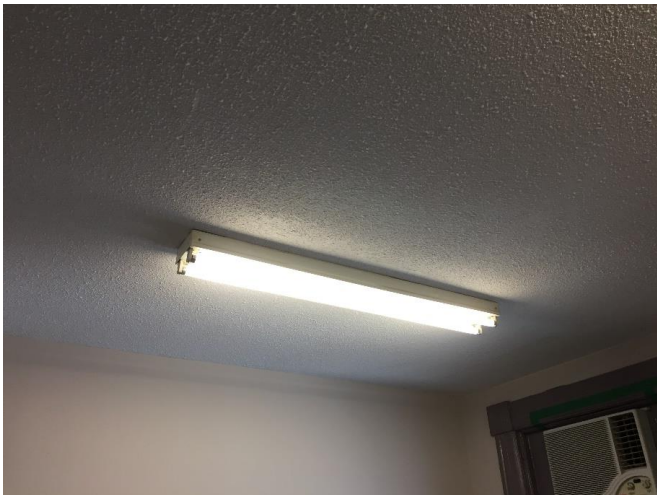
Ceiling texture coating was observed in Room 203 and 206 of Building 556. The laboratory analytical results of ceiling texture coat samples collected from Rooms 203 and 206 indicate that this material **contains 2% Chrysotile asbestos joint compound**. This material is considered to be friable and was observed in good condition.

**Photo 11:** View of asbestos-containing texture coat observed in Room 203 of Building 556.

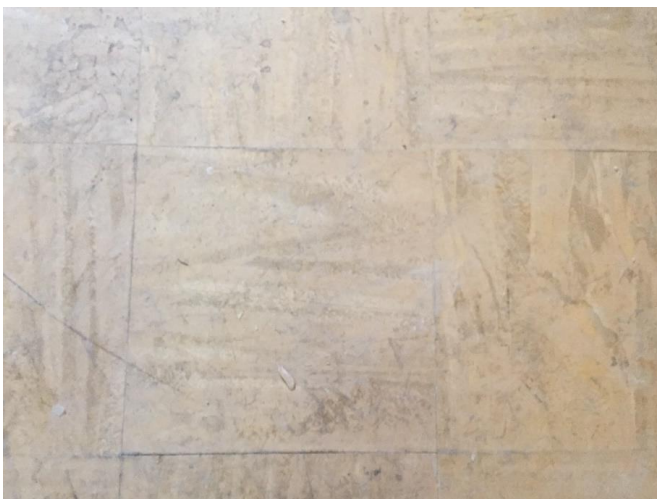
- Vinyl floor tiles (12"x12" – Grey) were observed in Room 303 of Building 556. The laboratory analytical results of vinyl floor tile samples collected indicate that this material **contains 3.0% Chrysotile asbestos**. The associated mastic (black) does not contain asbestos. This material is considered to be non-friable and was observed in good condition.

**Photo 12:** View of asbestos-containing vinyl floor tiles observed in Room 303 of Building 556.

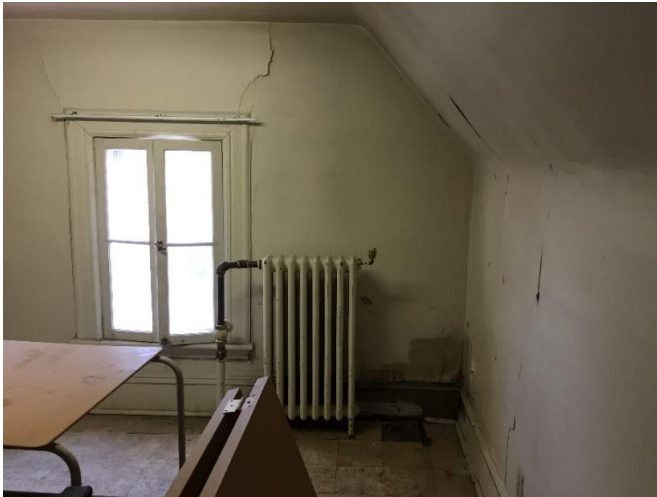
The paint finishes highlighted in pink in the above table are considered lead-containing paints or surface coatings with concentrations greater than 0.1% lead by weight. These paint finishes were observed to be in good condition with the exception of select areas that were observed in poor condition.

**Photo 13:** View of lead-containing paint in Room 303 of Building 556, observed to be in poor condition.

Paints identified to contain lead that are in poor condition must be immediately repaired and/or stabilized following a minimum Type 1/2 lead abatement procedures as per OMOL “Lead on Construction Project” dated April 2011.

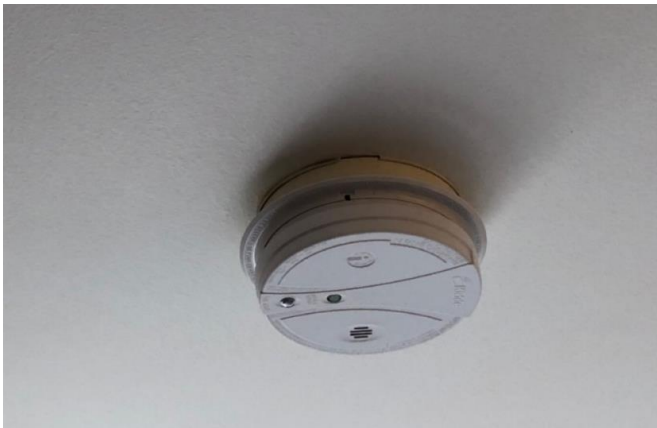
A visual assessment of the subject building was conducted to determine if any electrical components containing radioactive materials were present. MPL observed smoke detectors throughout the subject building which contain small quantities of radioactive material.

**Photo 14:** Typical view of smoke detectors containing radioactive materials.

The radioactive sources in smoke alarms are sealed and contained within a metal case inside the smoke detector and must not be damaged or tampered with. These materials do not pose a hazard as long as they remain contained and properly disposed at the time of removal or replacement.

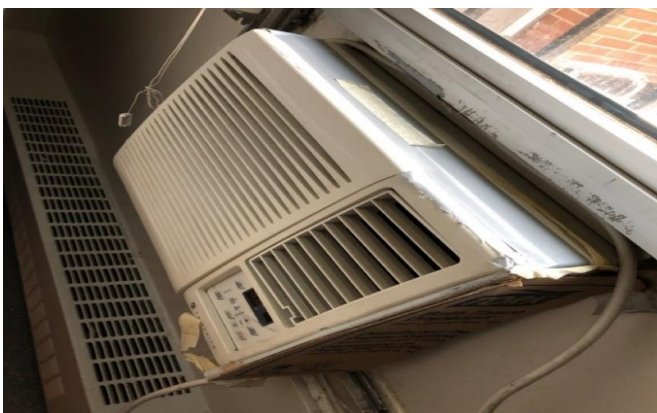
A visual assessment for equipment potentially containing ODSs and other halocarbons was conducted. MPL observed equipment such as refrigerators and window air condition units which are suspected of containing ODSs or other halocarbons.

**Photo 15:** Typical view of ODS containing air-conditioning unit.
