# HAZARDOUS MATERIALS SURVEY AND 2022 REASSESSMENT 555 KING EDWARD AVENUE, OTTAWA, ON

Project No.: 0Z2021101HZ / CCC-230252-00

University of Ottawa

January 10, 2023

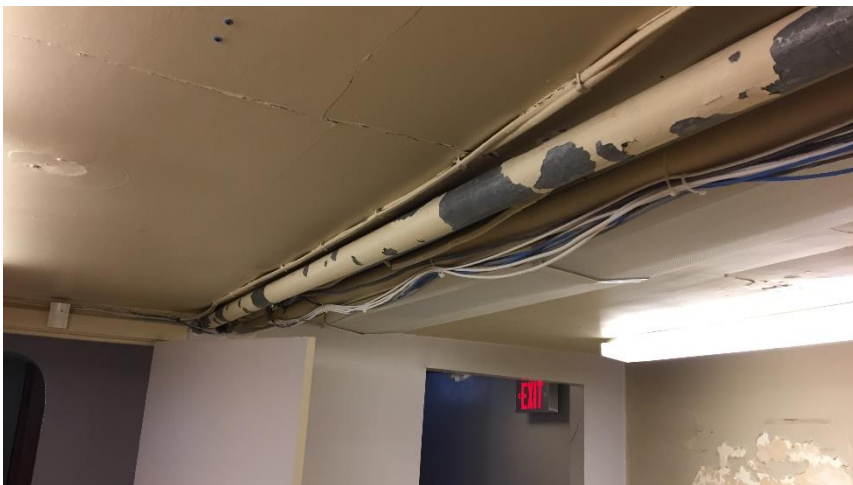
The paint finishes highlighted in pink in the above table are considered lead-containing paints or surface coatings with concentrations greater than 0.1% lead by weight. These paint finishes were observed to be in good condition, with the exception of select areas which were observed in poor condition.

Photo 2: View of the poor condition lead paint (Beige) identified on pipe straights in Room B5.

Paints identified to contain lead that are in poor condition must be immediately repaired and/or stabilized following a minimum Type 1/2 lead abatement procedures as per OMOL "Lead on Construction Project" dated April 2011.

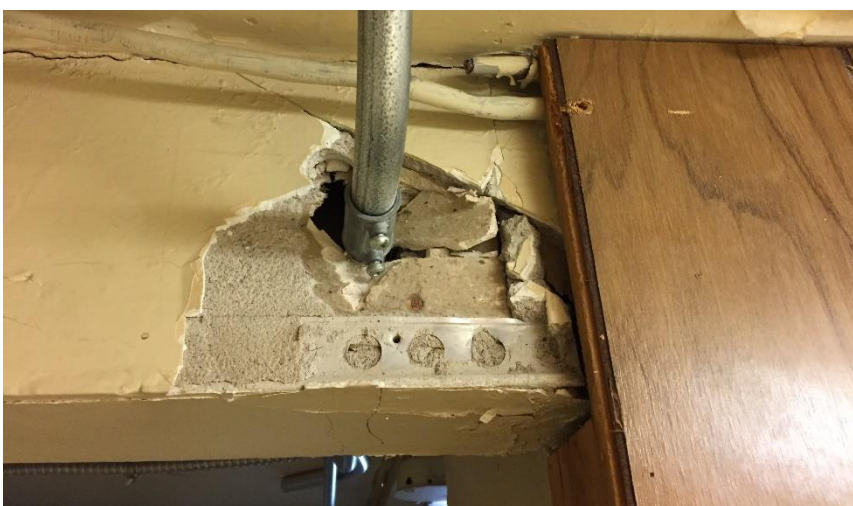
Plaster was observed and sampled in Rooms B1, B1A, B5, B6, B7, 202, and 207. The laboratory analytical results indicate that this material does not contain asbestos.

Photo 3: View of the non-asbestos containing wall plaster observed throughout the subject building.

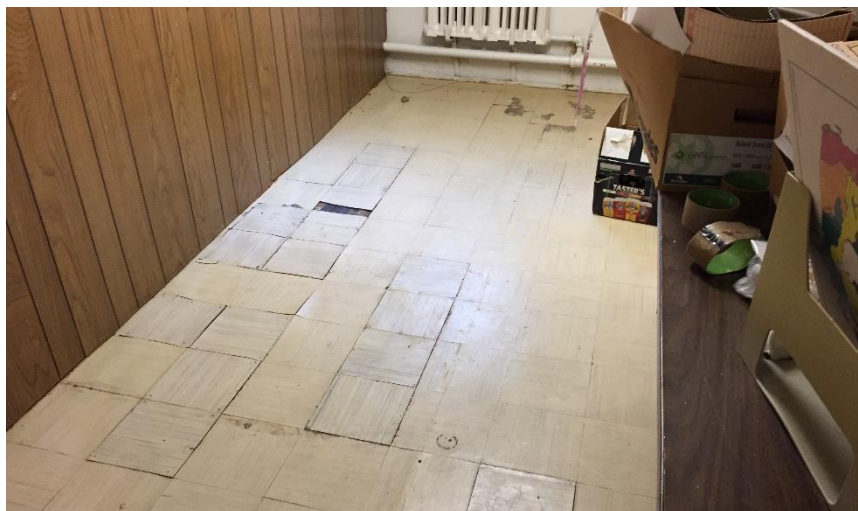
- Previously identified asbestos-containing vinyl floor tiles (12" x 12"- Beige with Brown Lines) were observed throughout the subject building. This material contains 16.5% Chrysotile asbestos. This material is considered to be non-friable and was observed in good condition. Previously identified locations with poor condition asbestos-containing vinyl floor tiles were observed to be removed during the 2022 Reassessment.

Photo 4: View of the asbestos-containing vinyl floor tiles (12"x12" – Beige w/ Brown Lines) observed throughout the basement level.

- Materials identified to contain asbestos that are in good condition and do not pose a risk to workers or occupants can be managed in place. Prior to renovation/demolition activities that may disturb the ACMs, these materials must be removed following appropriate Type 1/2/3 asbestos abatement work procedures as detailed in O. Reg. 278/05 and disposed of as asbestos waste under O. Reg. 347;

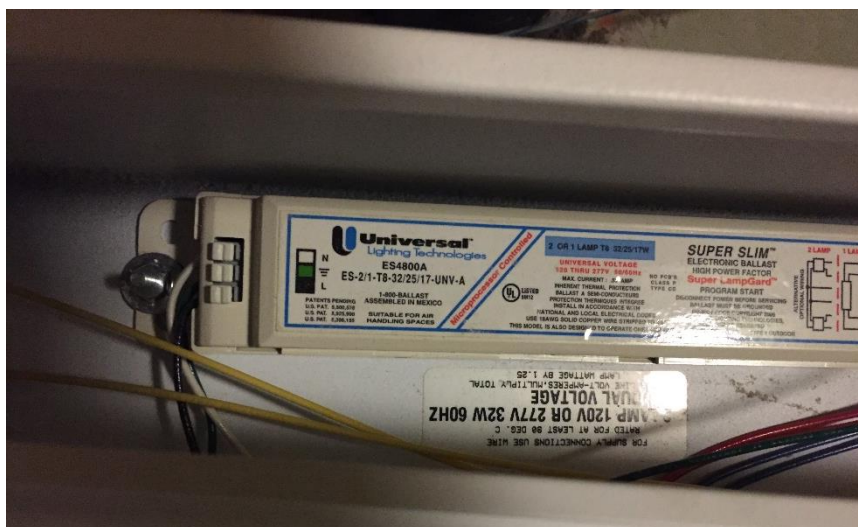
The subject building is illuminated by LED and fluorescent lights. MPL assessed representative ballasts in the building, and these ballasts were identified as non-PCBs content. These light ballasts were observed to be manufactured by Universal Lighting Technologies.

Photo 5: View of the non-PCB light ballasts observed throughout the subject building.

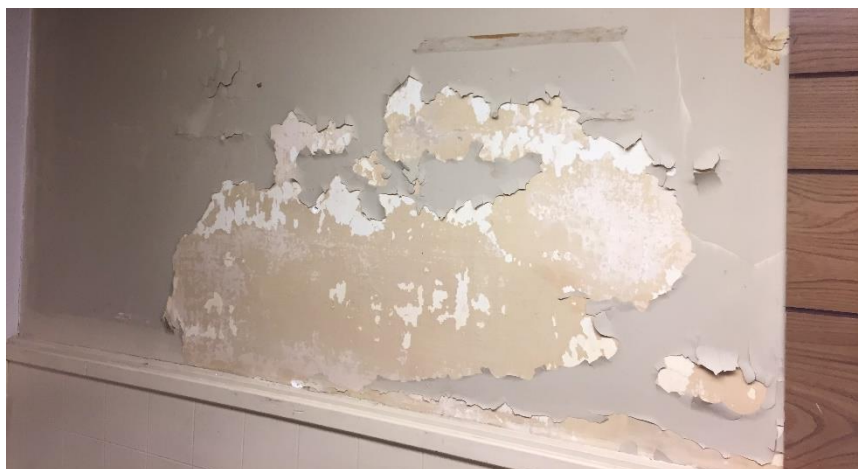
Photo 6: View of the poor condition lead-containing wall paint (Beige) observed in Room B5.

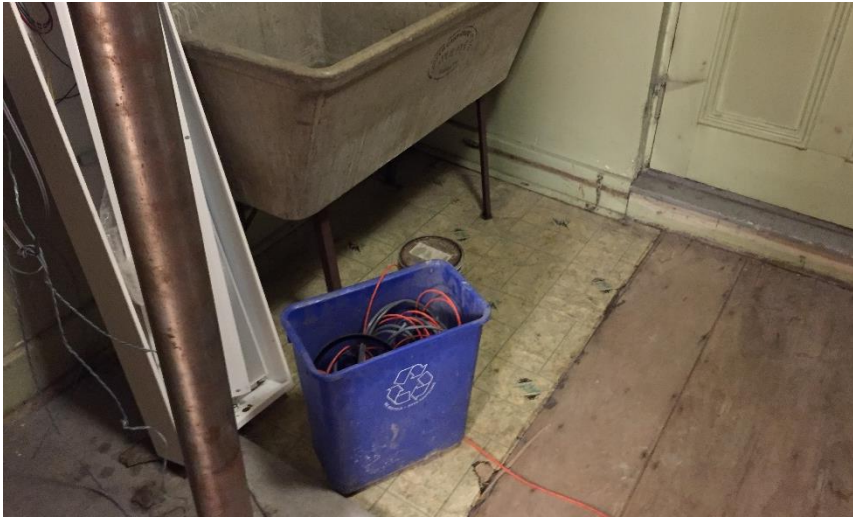
- Vinyl sheet flooring (Grey) was observed and sampled in Room 206. The laboratory analytical results indicate that this material does not contain asbestos. The associated mastic (Yellow) was also determined not to contain asbestos.
- Vinyl sheet flooring (Green with Pattern) was observed and sampled in Room B9. The laboratory analytical results indicate that this material does not contain asbestos.
- Previously identified asbestos-containing vinyl sheet flooring (Yellow Rectangle Pattern) was observed in Room B9. This material contains 0.8% Chrysotile asbestos. Previously identified locations with poor condition asbestos-containing vinyl floor tiles were observed to be removed during the 2022 Reassessment.

Photo 7: View of the asbestos-containing vinyl sheet flooring (Yellow Rectangular Pattern) observed in Room B9.

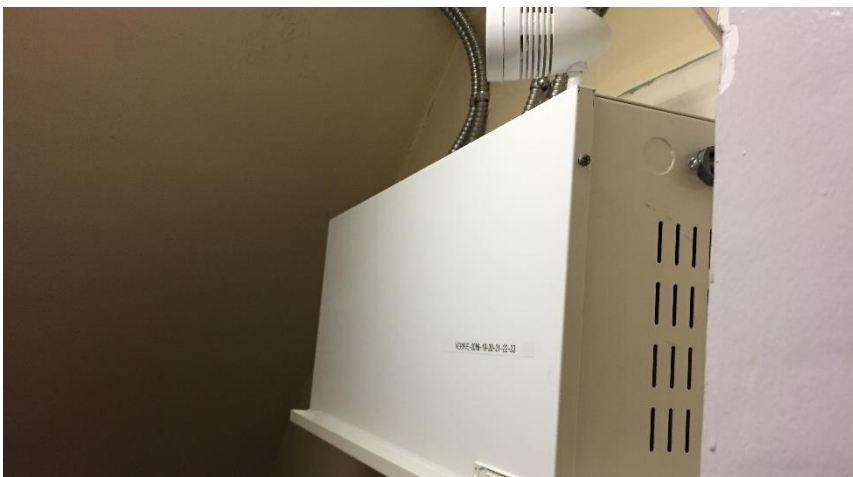
MPL identified lead-containing acid battery packs in Room B2. These battery packs were observed on walls within the subject building.

Photo 8: View of the lead-containing batteries observed in Room B2.

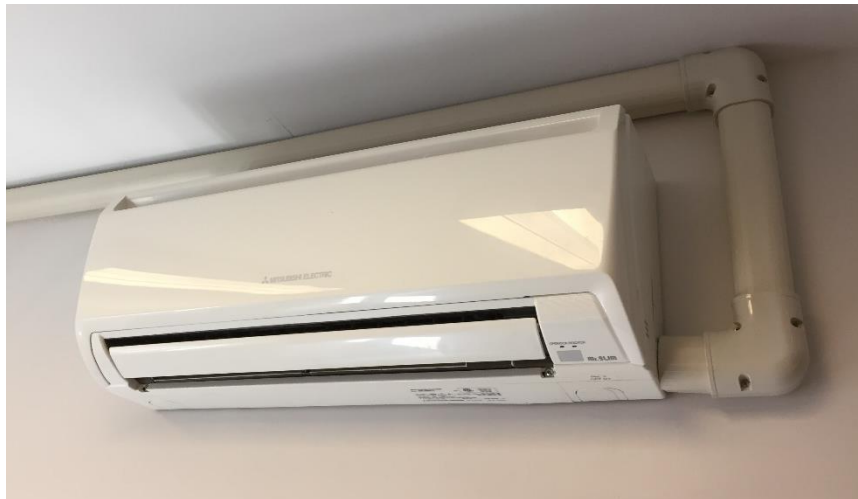
A visual assessment for equipment potentially containing ODSs and other halocarbons was conducted. Equipment containing ODSs or other halocarbons was observed in the subject building.

Photo 10: View of the equipment containing ODSs observed throughout the subject building.

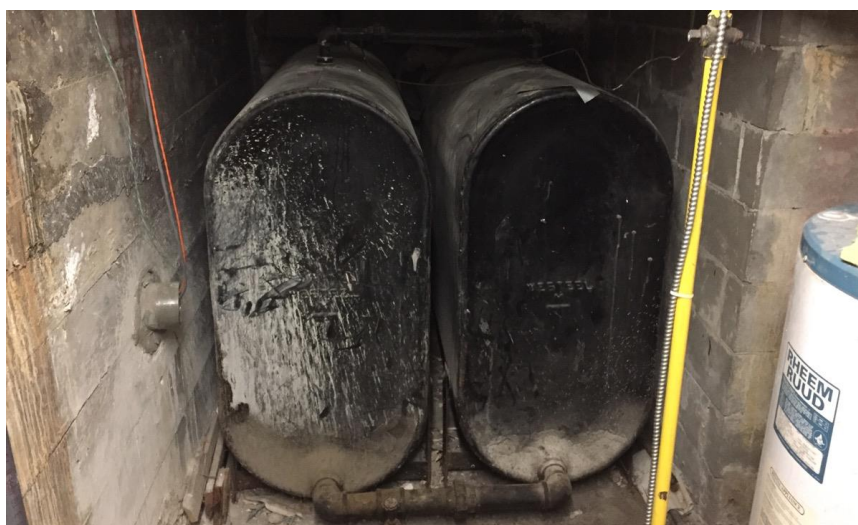
A visual survey of the subject building was conducted to determine if any USTs and ASTs were present. MPL observed two (2) above ground diesel storage tanks in Room B8.

Photo 11: View of the above ground diesel storage tanks identified in Room B8.
