# HAZARDOUS MATERIALS SURVEY AND 2022 REASSESSMENT 559 KING EDWARD AVENUE, OTTAWA, ON

Project No.: OZ2021101HZ / CCC-230252-00

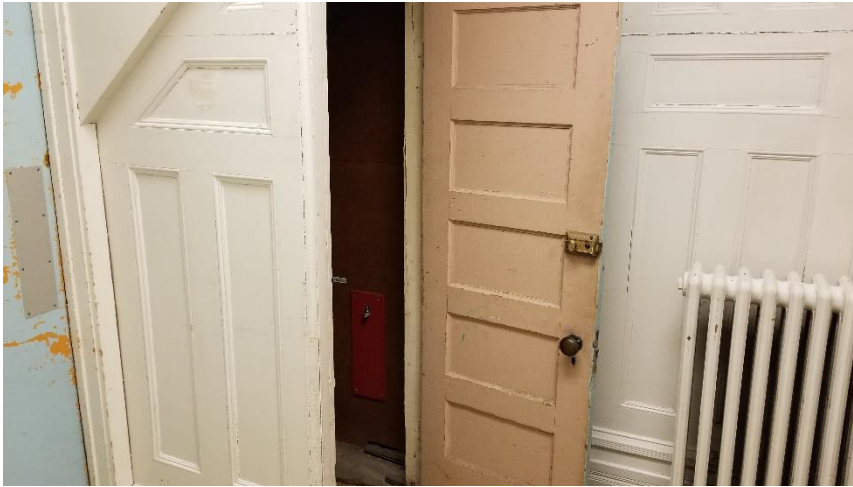
Photo 1: Representative view of the lead-containing light pink door paint identified throughout the first level of subject building in fair condition.

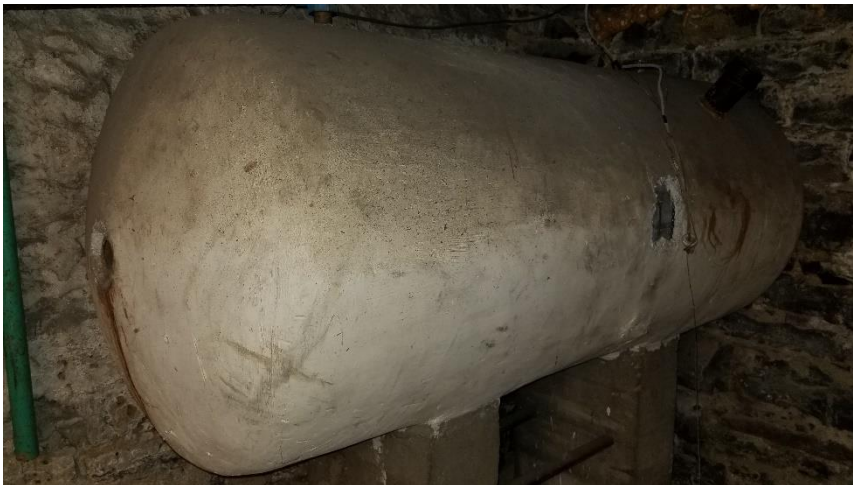
Photo 2: View of the asbestos-containing boiler tank insulation (paring cement) observed in poor condition in Room B5.

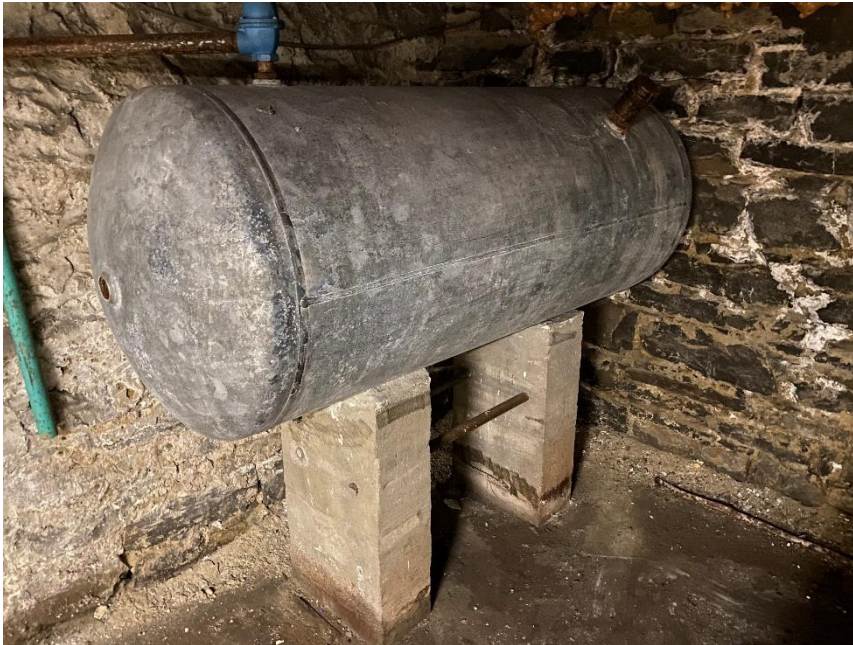
Photo 3: View of the removed asbestos-containing boiler tank insulation (paring cement) observed to have been abated from Room B5.

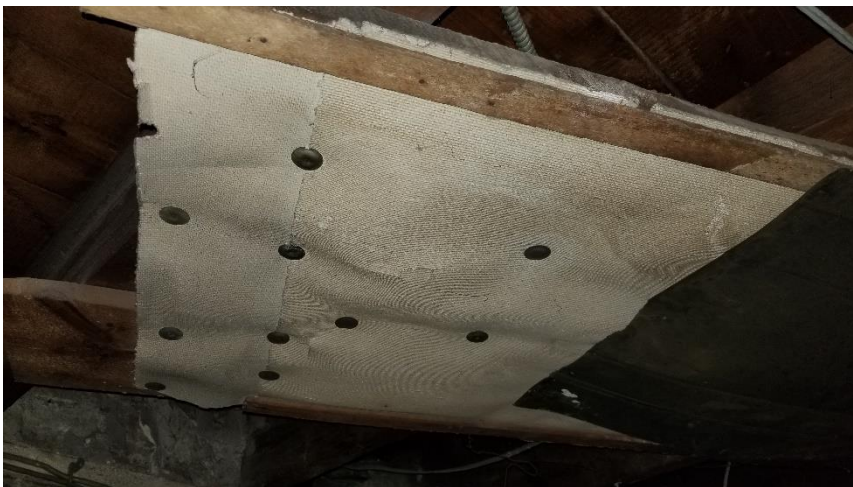
Photo 4: View of the asbestos-containing paper insulation (Grey) observed in poor condition in Room B5.

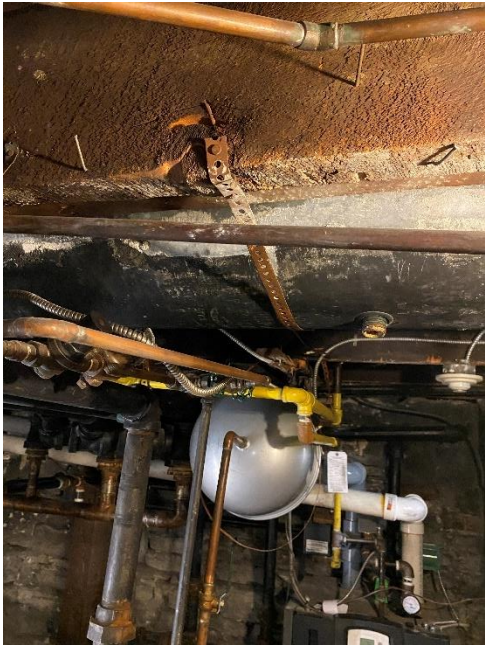
Photo 5: View of the removed asbestos-containing paper insulation (Grey) observed to have been abated from Room B5.

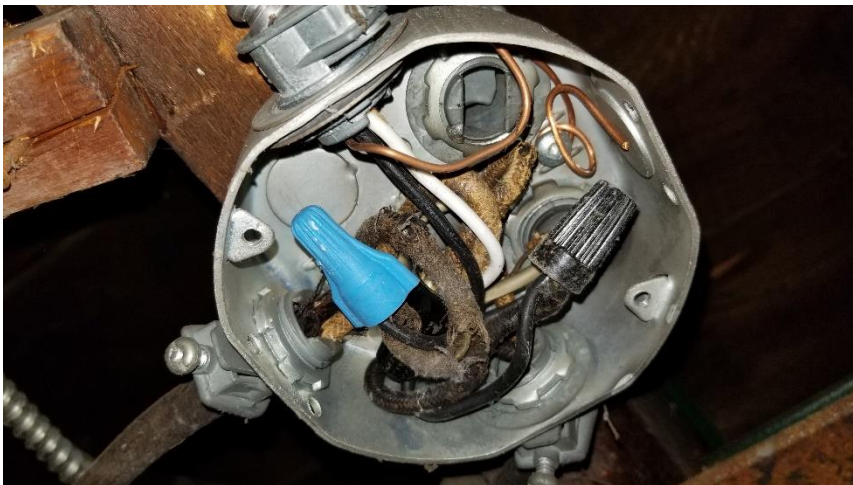
Photo 6: View of the electrical wire fabric cover (Brown) suspected of containing asbestos and PCBs in Room B5.

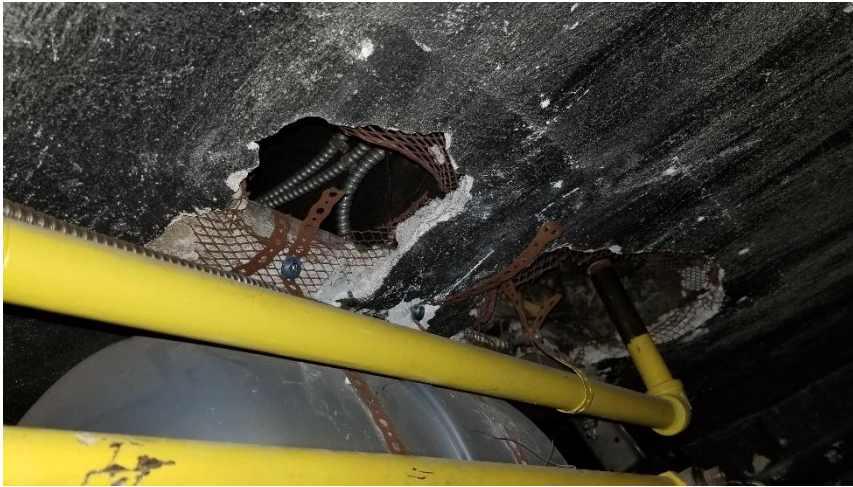
Photo 7: View of the non-asbestos ceiling plaster (Grey) observed in Room B6.

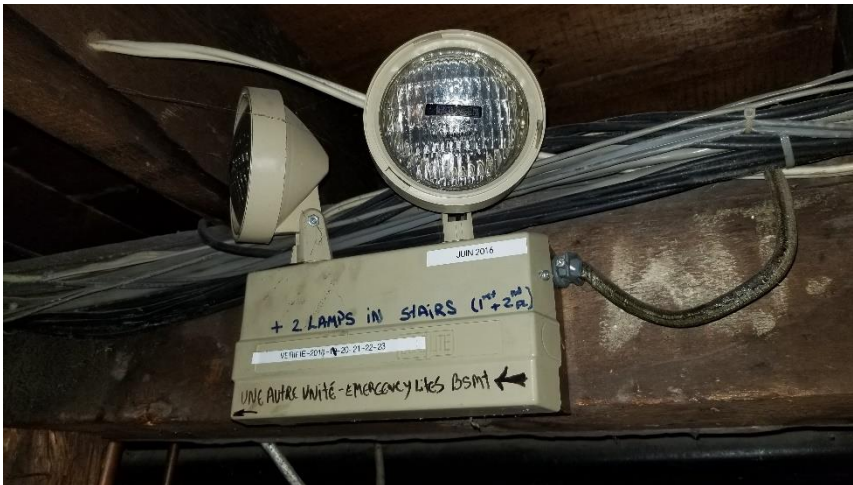
Photo 8: View of the lead-containing battery packs identified in Room B5.

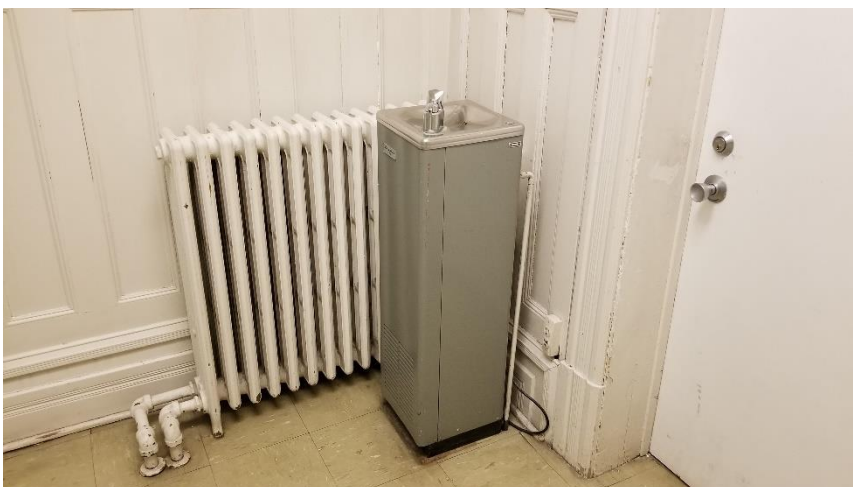
Photo 9: Representative view of equipment observed to contain ODSs in Room 101.

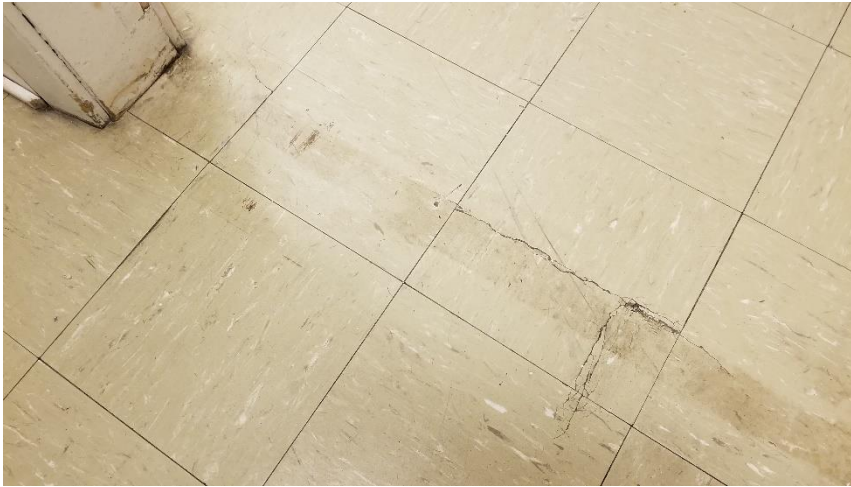
Photo 10: Representative view of the asbestos-containing vinyl floor tiles (12"x12" – Green) observed in fair condition in Room 101.

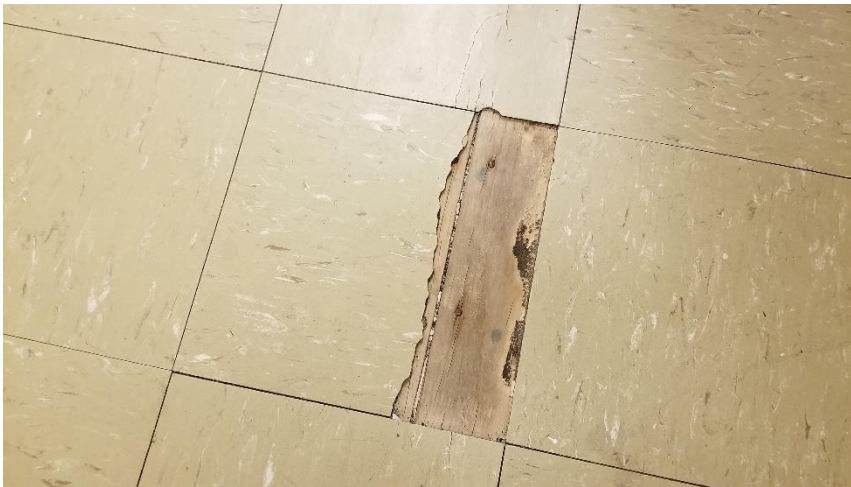
Photo 11: Representative view of the asbestos-containing vinyl floor tiles (12"x12" – Green) observed in poor condition in Room 101.

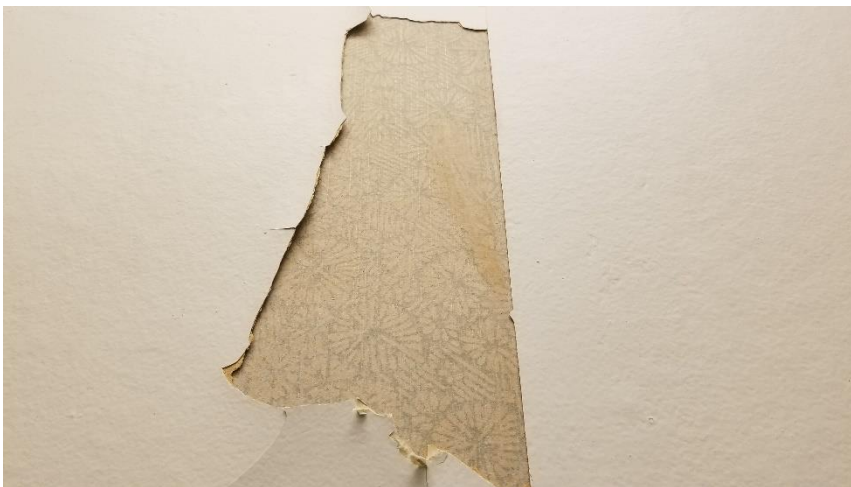
Photo 12: View of the non-asbestos wallpaper (Top Layer) observed throughout the subject building.

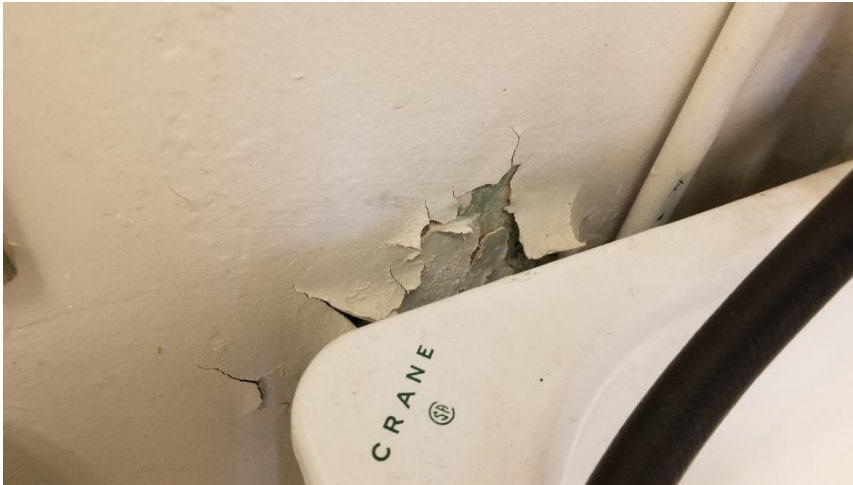
Photo 13: View of the lead-containing wall paint (White) observed in poor condition in Room 103 during the 2022 Reassessment.

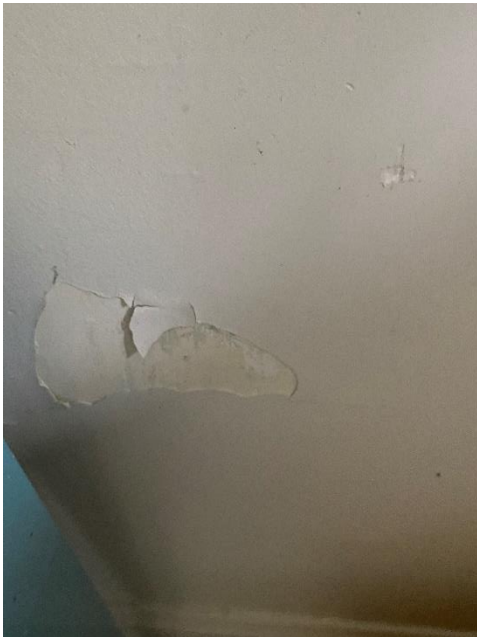
Photo 14: View of the lead-containing ceiling paint (White) observed in poor condition in Room 110 during the 2022 Reassessment.

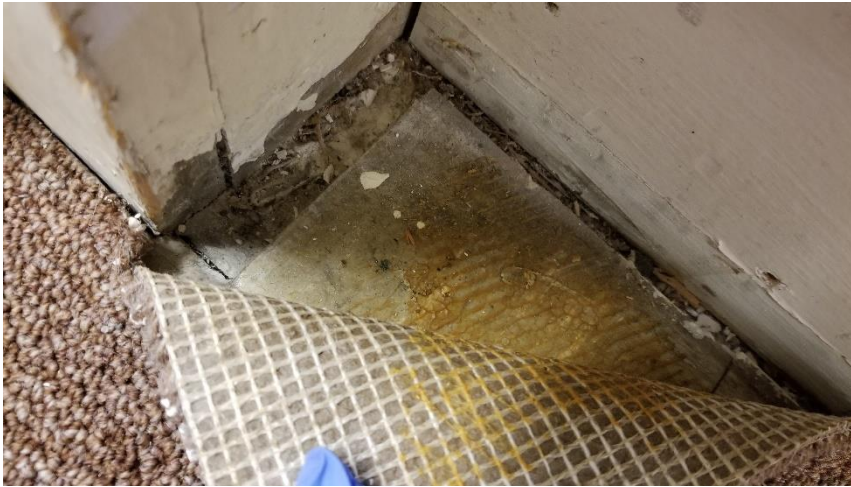
Photo 15: Representative view of the asbestos-containing vinyl floor tiles (12"x12" – Green) observed underneath carpet in Room 109.

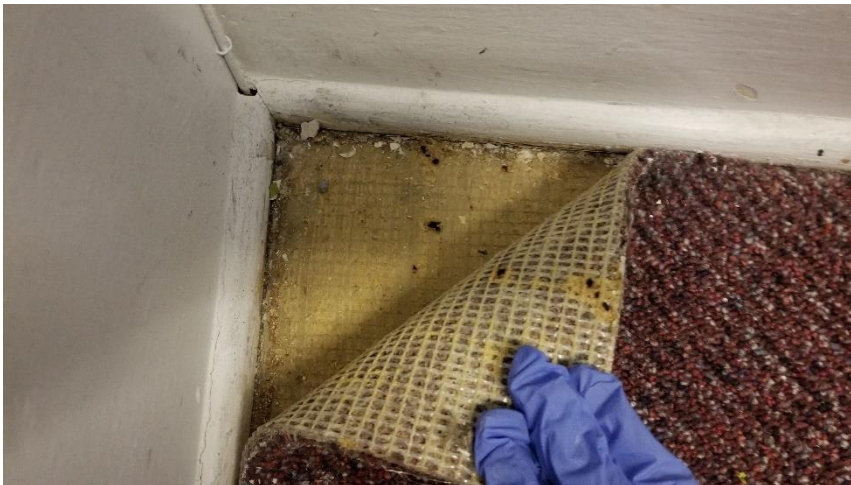
Photo 16: View of the non-asbestos carpet mastic (Yellow) observed throughout the first level of the subject building.

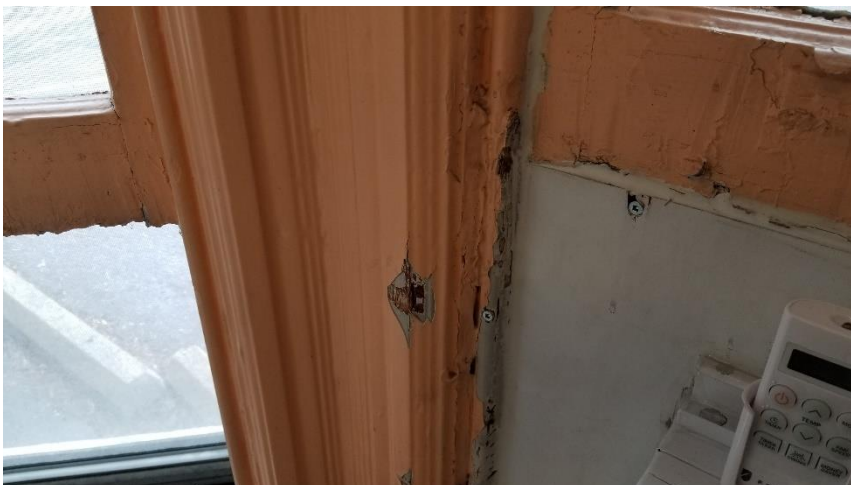
Photo 17: View of the lead-containing frame paint (Peach) observed in poor condition in Room 108.

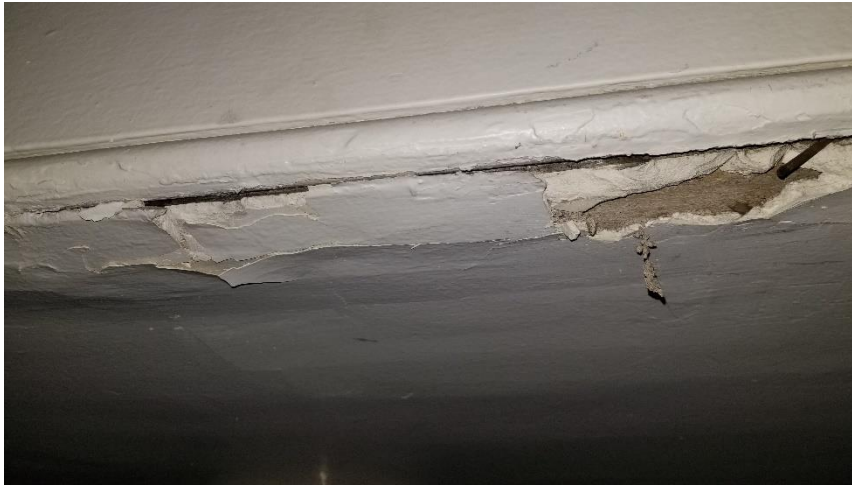
Photo 18: View of the asbestos-containing plaster observed in poor condition in Room 100.

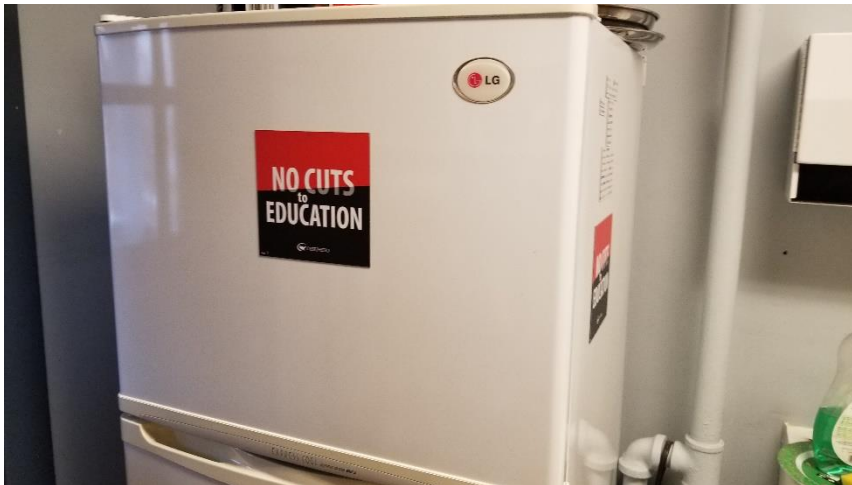
Photo 19: Representative view of equipment observed to contain ODSs in Room 211.

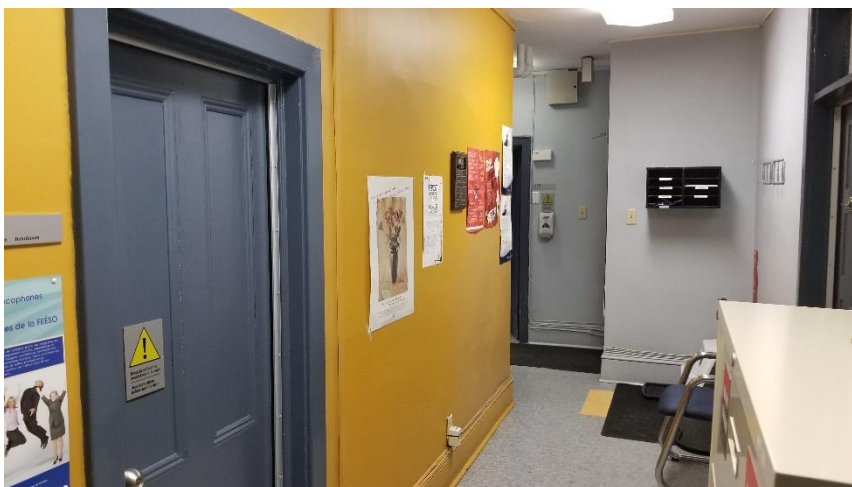
Photo 20: Representative view of the lead-containing paint (Dark Yellow) observed in good condition throughout the second floor.

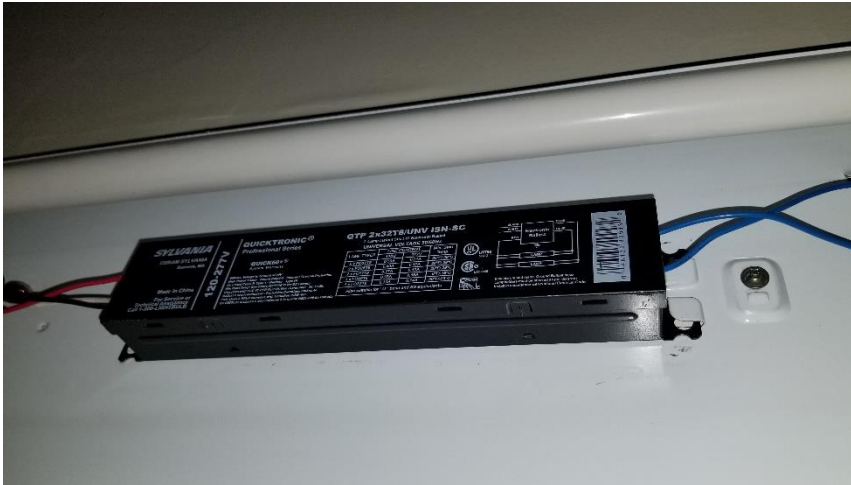
Photo 21: Representative view of the non-PCB light ballasts manufactured by Sylvanna observed throughout the building.

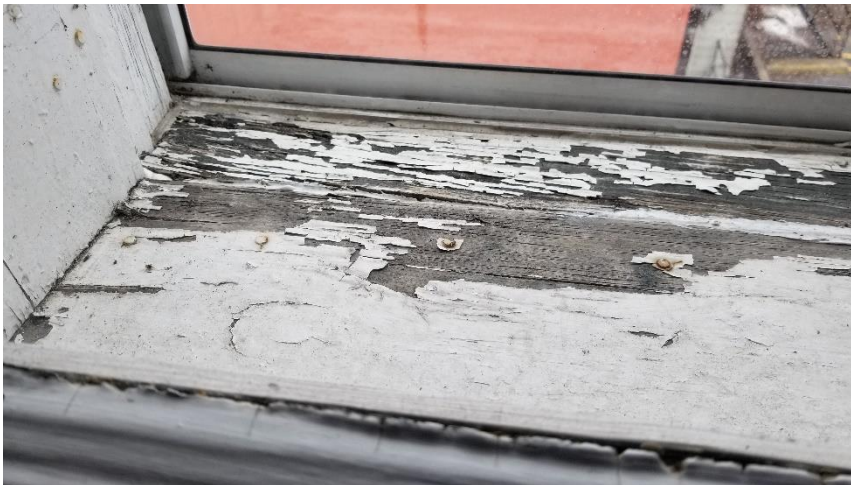
Photo 22: View of the lead-containing window frame paint (White) observed in poor condition in Room 307.

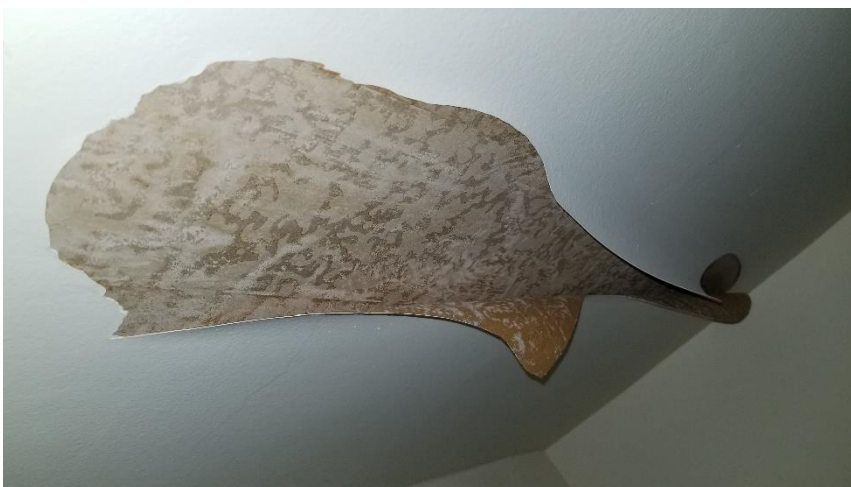
Photo 23: View of the lead-containing ceiling paint (White) observed in poor condition in Room 307C.

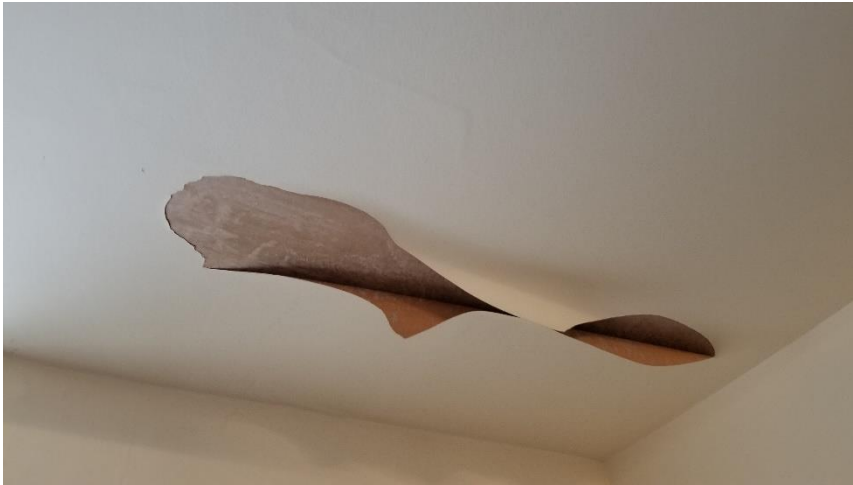
Photo 24: View of the lead-containing ceiling paint (White) observed in poor condition in Room 307.
