HAZARDOUS MATERIALS SURVEY AND 2022 REASSESSMENT 598 KING EDWARD AVENUE, OTTAWA, ON

Project No.: 0Z2021101HZ / CCC-230252-00

University of Ottawa

McIntosh Perry Limited (MPL)

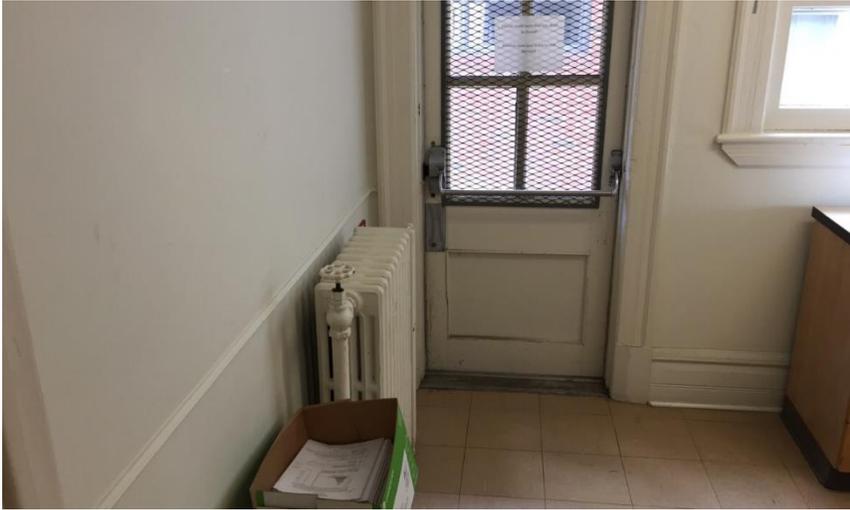
Photo 1: Representative view of the finishes observed throughout the subject building.

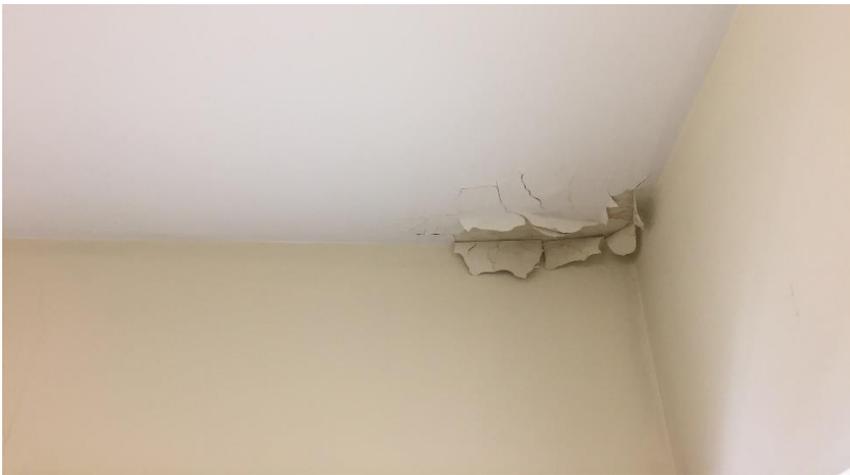
The paint finishes highlighted in pink in the above table are considered lead-containing paints or surface coatings with concentrations greater than 0.1% lead by weight. These paint finishes were observed to be in good condition, with the exception of select areas which were observed in poor condition.

Photo 2: View of the lead-containing paint wall paint (Beige) observed in poor condition in Room 106.

Paints identified to contain lead that are in poor condition must be immediately repaired and/or stabilized following a minimum Type 1/2 lead abatement procedures as per OMOL "Lead on Construction Project" dated April 2011.

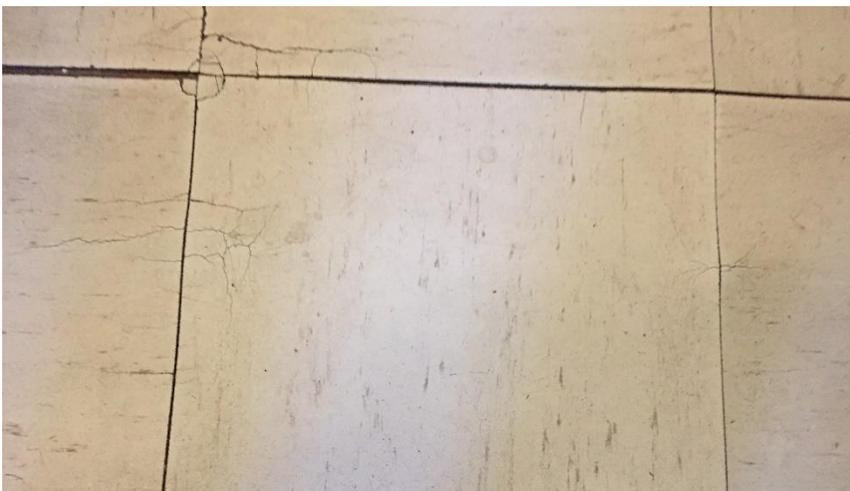
- Vinyl floor tiles (12" x 12"- Beige with Dark Streaks) were observed and sampled in Room 107. The laboratory analytical results indicate that this material does not contain asbestos.

Photo 3: View of the non-asbestos containing vinyl floor tiles (12"x12" Beige with Dark Streaks) observed in Room 107.

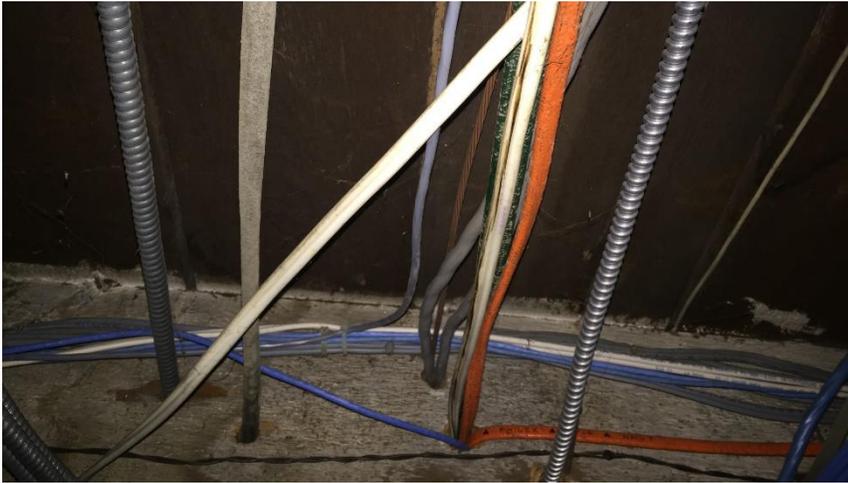
Photo 4: View of the electrical wire woven fabric suspected to contain asbestos and PCBs throughout Room B1 and B2.

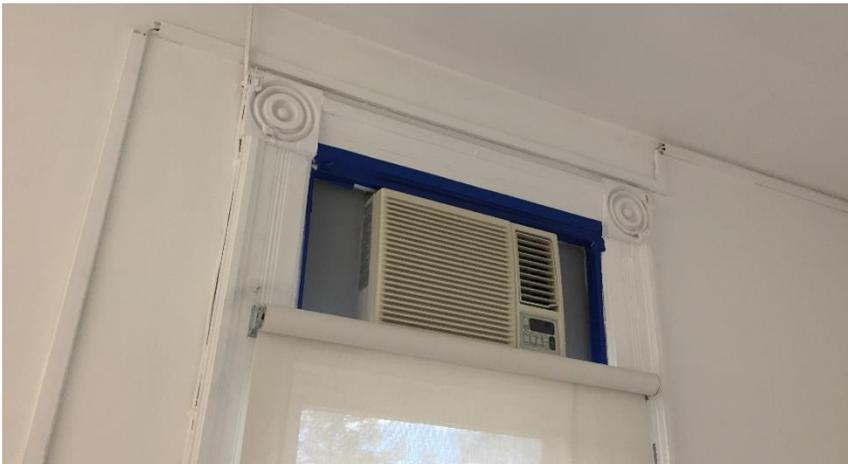
A visual assessment for equipment potentially containing ODSs and other halocarbons was conducted. Equipment containing ODSs or other halocarbons was observed in the subject building.

Photo 5: View of the equipment observed throughout the subject building which contains ozone depleting substances.

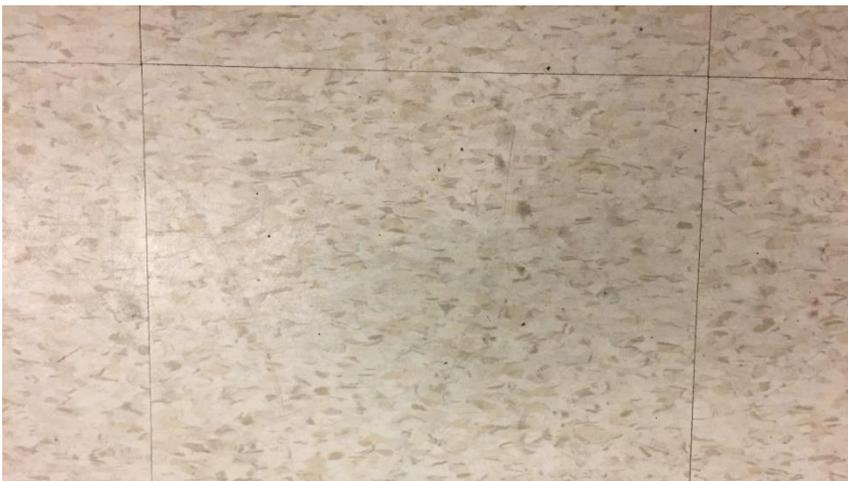
- Vinyl floor tiles (12" x 12"- Beige Camouflage) were observed and sampled in Room 204. The laboratory analytical results indicate that this material does not contain asbestos.

Photo 6: View of the non-asbestos containing vinyl floor tiles (12"x12" Beige Camouflage) observed in Room 204.

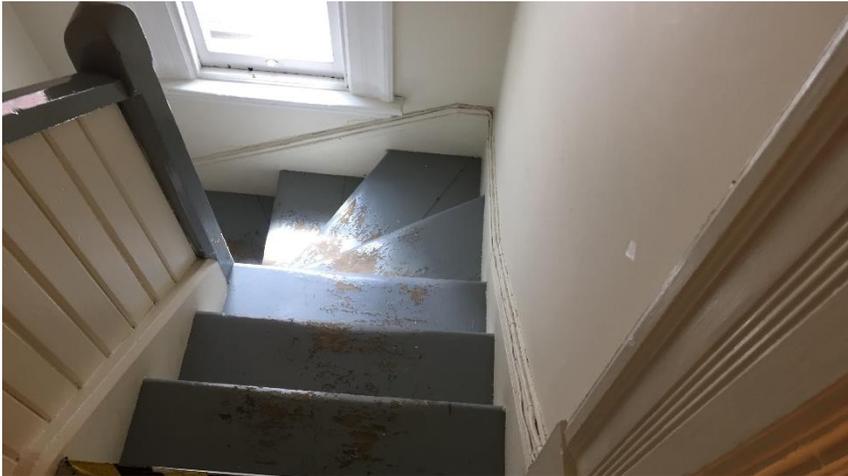
Photo 7: View of the poor condition lead paint (Grey) observed on the stairs in Room 210.

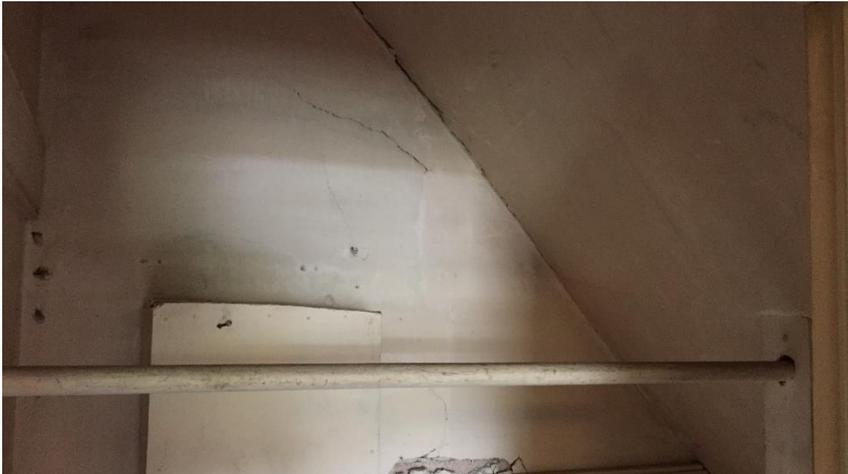
Plaster was observed and sampled in Rooms B3, 106A, 108, 300, and 300A. The laboratory analytical results indicate that this material does not contain asbestos.

Photo 8: View of the non-asbestos containing plaster observed throughout the subject building.

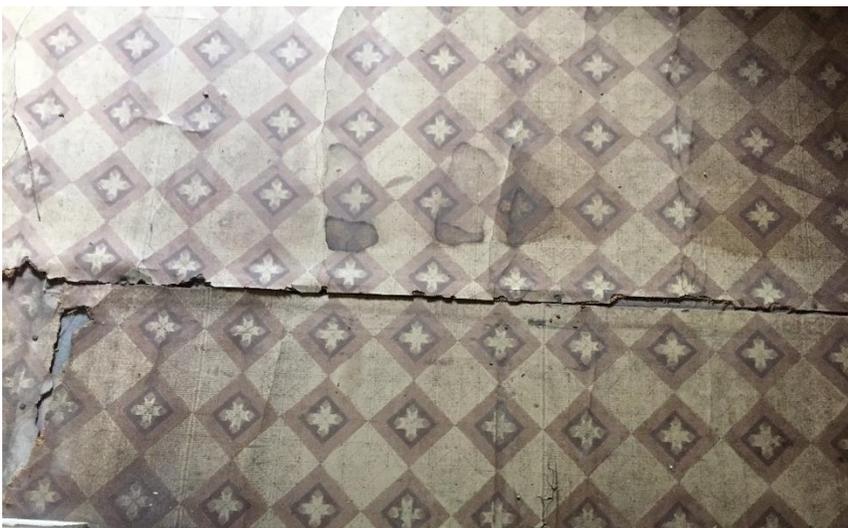
- Vinyl sheet flooring (Beige and Red) was observed and sampled in Room 301. The laboratory analytical results indicate that this material does not contain asbestos.
- Vinyl sheet flooring (Beige with Red and Black) was observed and sampled in Room 300. The laboratory analytical results indicate that this material does not contain asbestos.

Photo 9: View of the non-asbestos containing vinyl sheet flooring (Beige and Red) observed in Room 301.
