HAZARDOUS MATERIALS SURVEY AND 2022 REASSESSMENT 600 KING EDWARD AVENUE, OTTAWA, ON

Project No.: Z2021101-HZ / CCC-230252-00

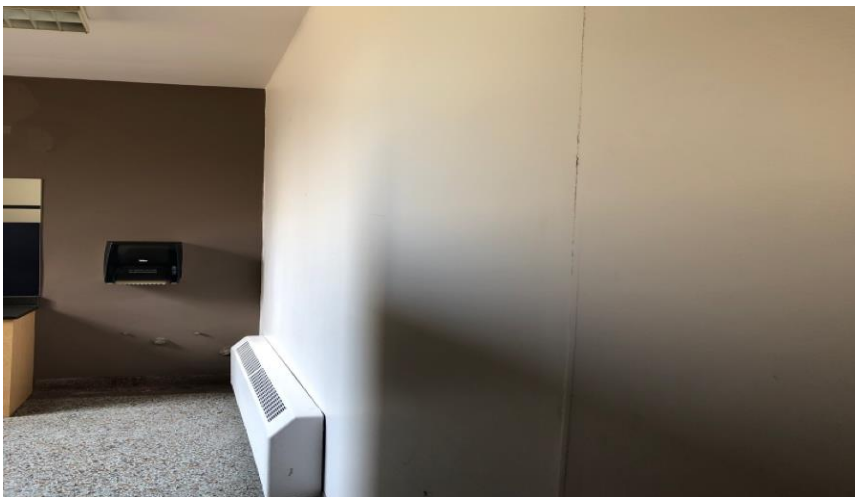
Photo 3: View of asbestos-containing drywall joint compound observed to be in fair condition in Room 202

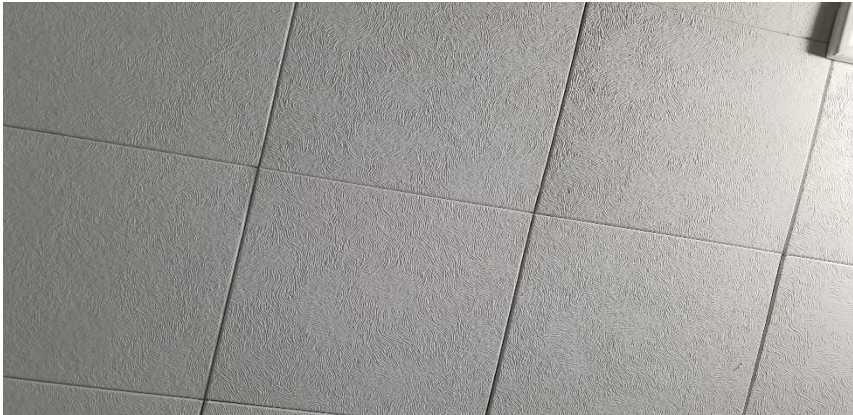
Photo 4: View of non-asbestos ceiling tiles (1' x 1') observed in Room 102.

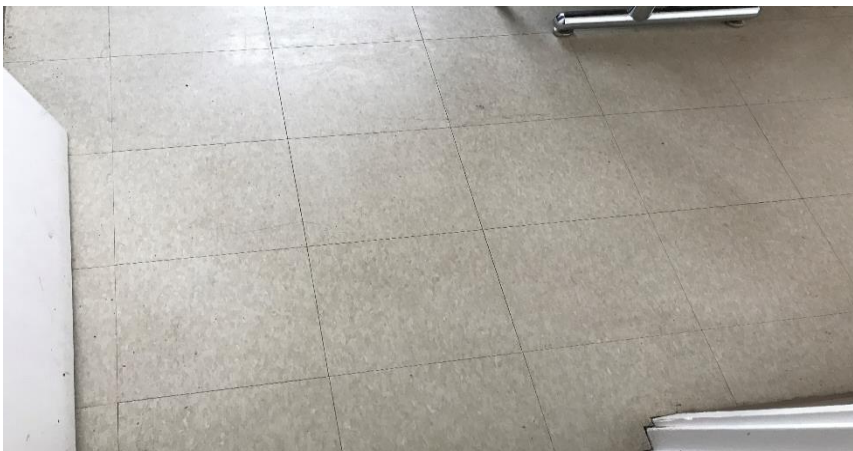
Photo 5: View of asbestos containing 12"x12" vinyl floor tile in Room 201

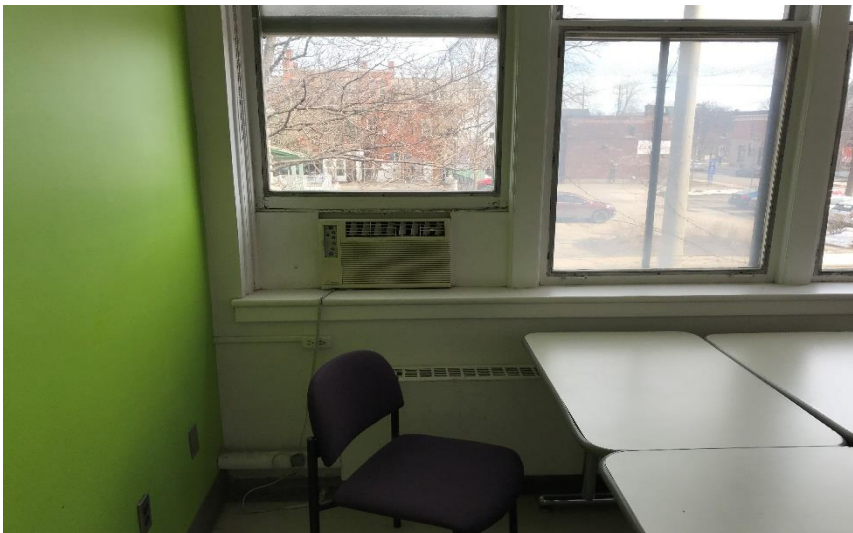
Photo 6: View of air conditioning containing ozone depleted substance in Room 201

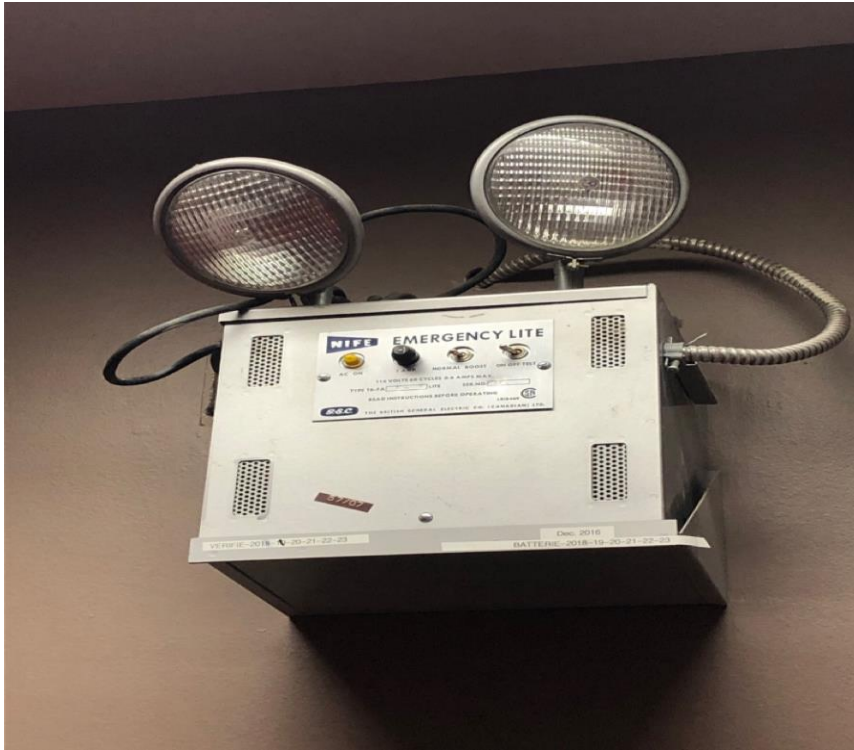
Photo 7: View of lead containing Emergency light in Room 207

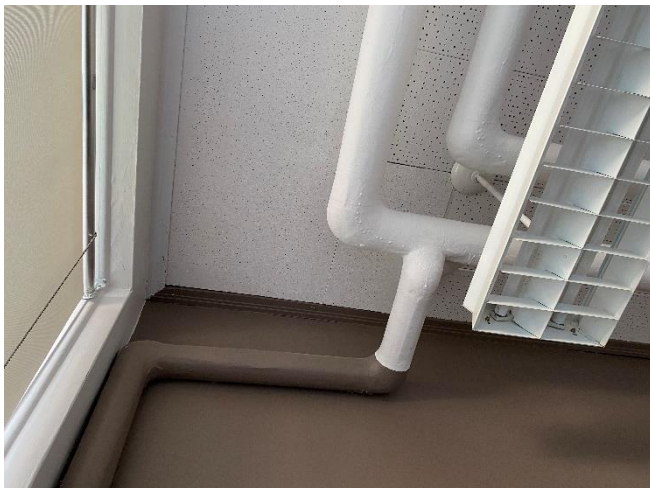
Photo 8: View of asbestos-containing mechanical pipe insulation on fittings/elbow/straight observed to be in good condition in Room 102B during the 2022 Reassessment.

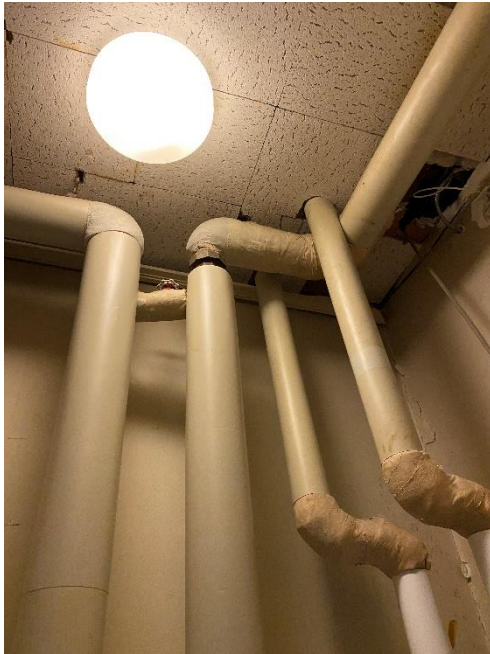
Photo 9: View of asbestos-containing mechanical pipe insulation on fittings/elbow/straight observed to be in good condition in Room 110 during the 2022 Reassessment.

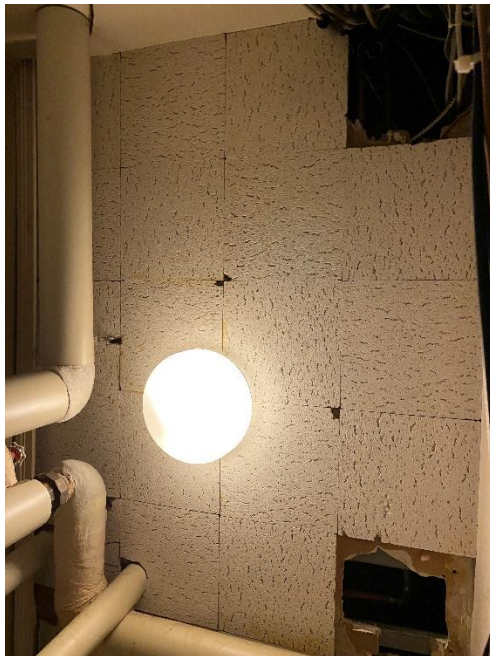
Photo 10: View of asbestos-containing drywall joint compound on ceiling observed to be in poor condition in Room 110 during the 2022 Reassessment.

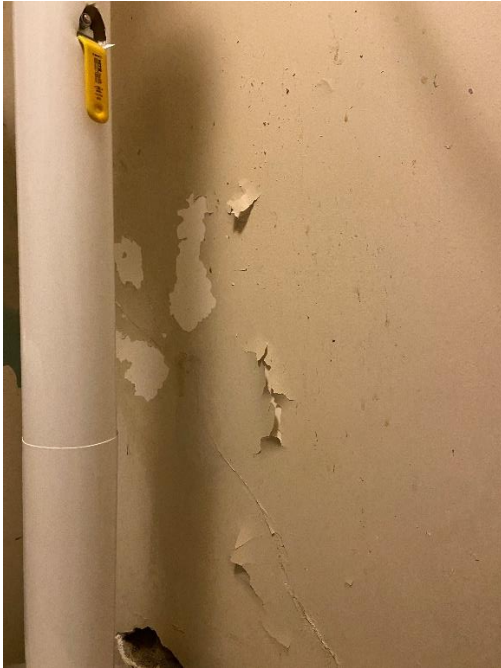
Photo 11: View of asbestos-containing plaster wall observed to be in poor condition in Room 110 during the 2022 Reassessment.

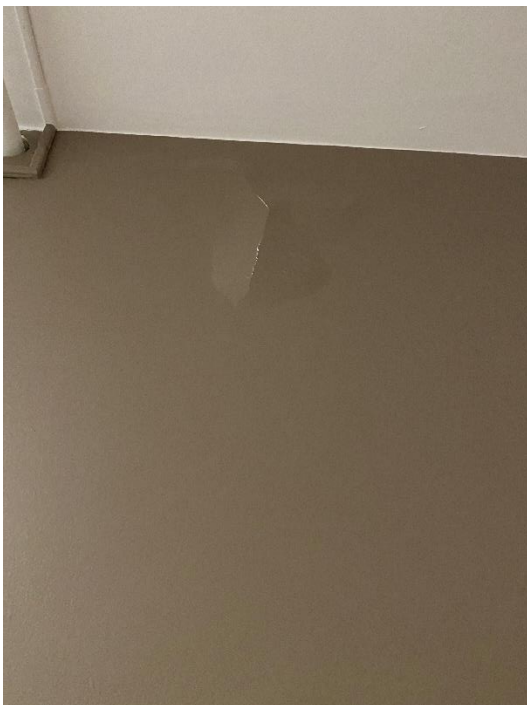
Photo 12: View of asbestos-containing plaster wall observed to be in poor condition in Room 204 during the 2022 Reassessment.

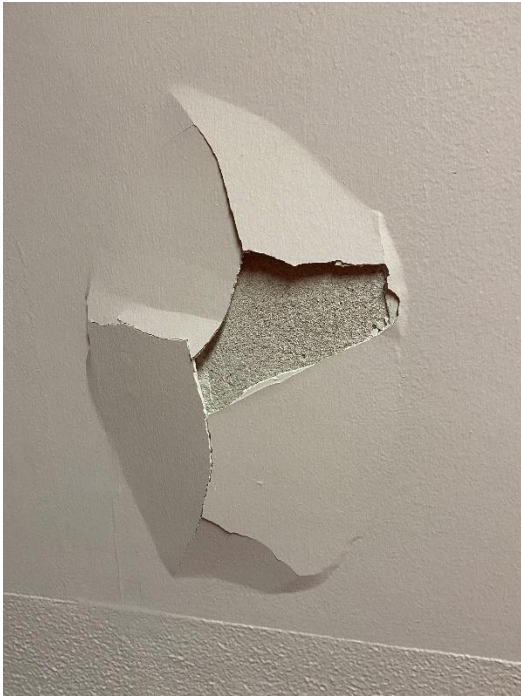
Photo 13: View of asbestos-containing plaster wall observed to be in poor condition in Room 207 during the 2022 Reassessment.

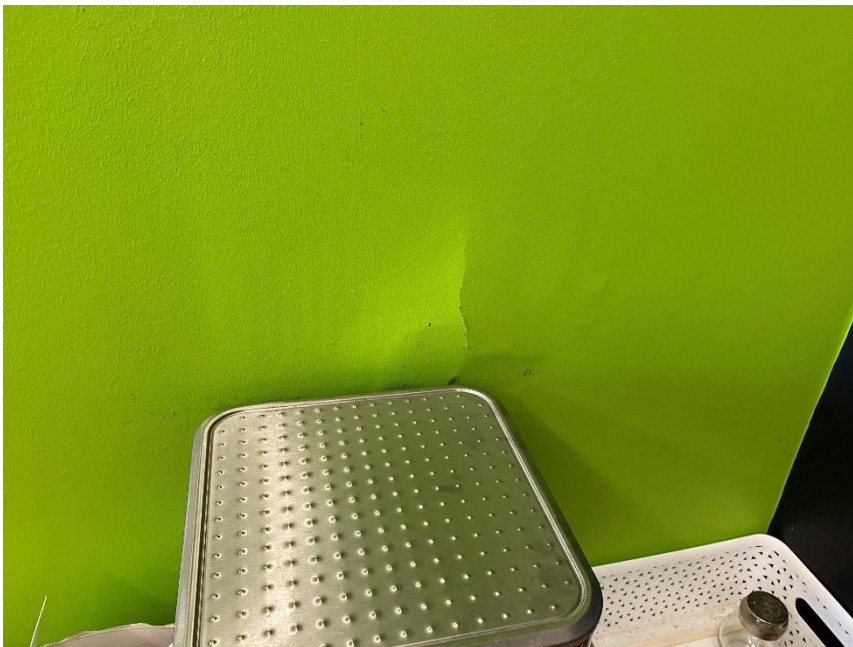
Photo 14: View of asbestos-containing plaster wall observed to be in poor condition in Room 304 during the 2022 Reassessment.

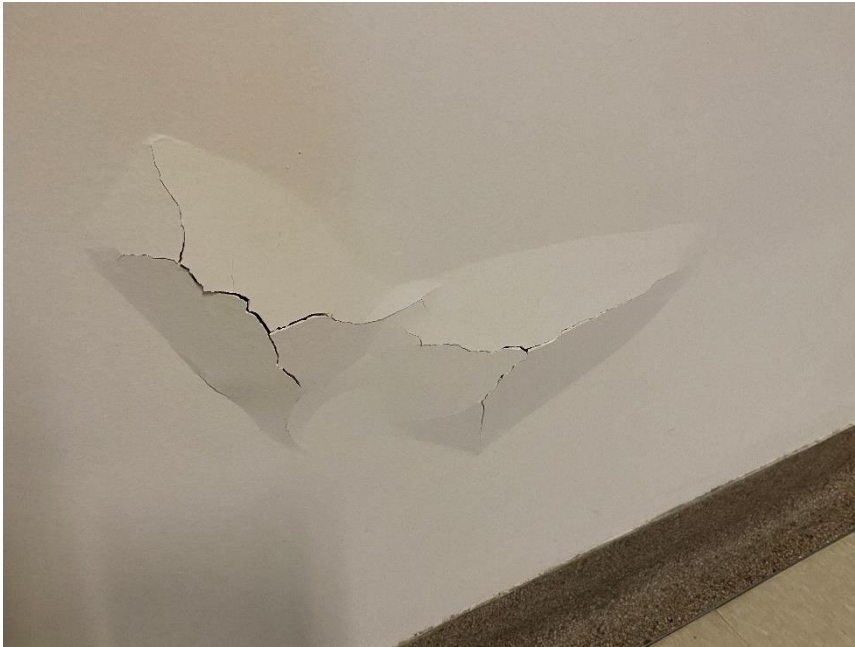
Photo 15: View of asbestos-containing plaster wall observed to be in poor condition in the Hallway adjacent to Room 304 during the 2022 Reassessment.

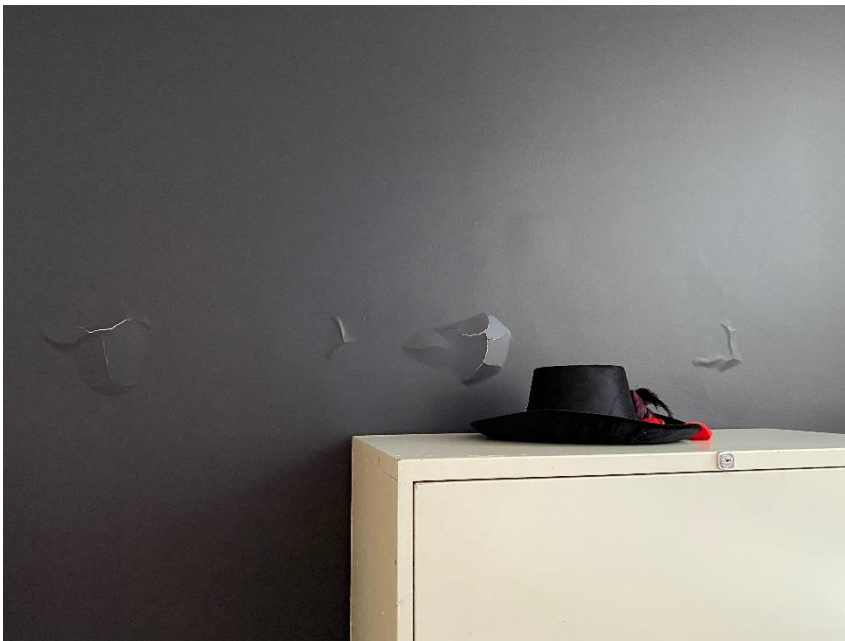
Photo 16: View of asbestos-containing plaster wall observed to be in poor condition in Room 307A during the 2022 Reassessment.
