HAZARDOUS MATERIAL SURVEY AND 2022 REASSESSMENT 600 PETER MORAND CRESCENT, OTTAWA, ON

Project No.: Z2021101HZ / CCC-230252-00

University of Ottawa

September 16, 2022

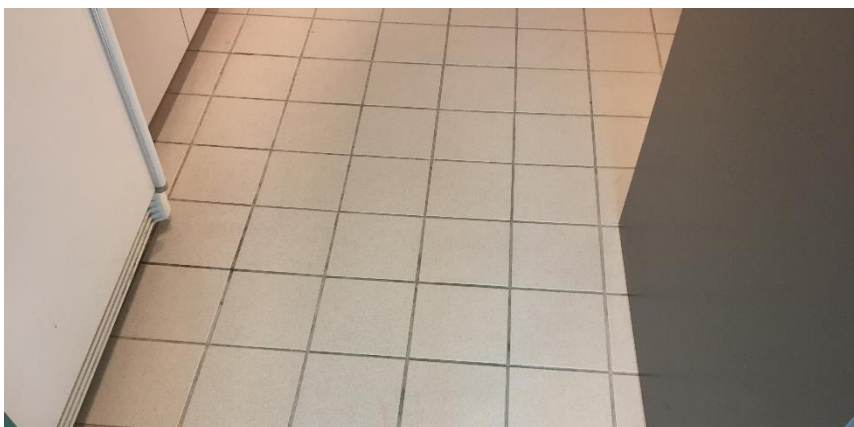
To avoid damage and compromising the integrity of the structure, no bulk samples of the ceramic wall/floor tile grout were collected. Prior to renovation/demolition, ceramic tile grout should be examined and tested for asbestos content. Ceramic wall/floor tile grout should therefore be considered to contain asbestos until bulk samples and analysis proves otherwise.

Photo 3: Typical view of ceramic floor tile grout suspected of containing asbestos.

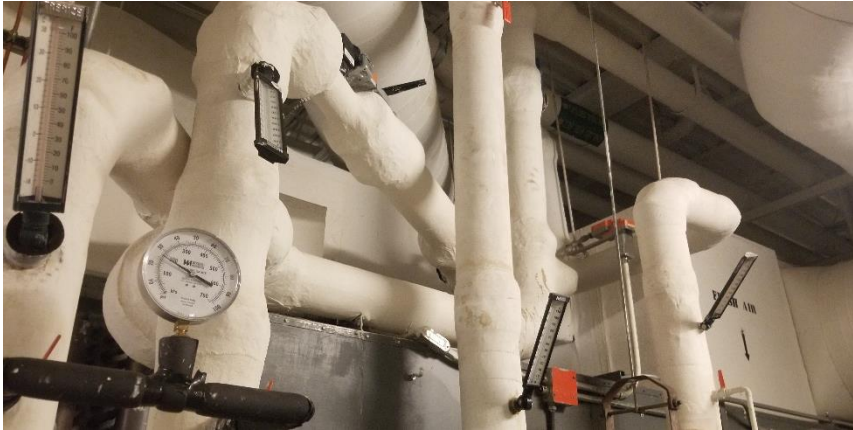
MPL observed pressure gauges containing liquid mercury within the subject building.

Photo 4: View of mercury-containing pressure gauges and thermometers observed in Room 400.

Please refer to Appendix F – Hazardous Materials Checklist for equipment conditions, quantities (where applicable), and recommended actions.

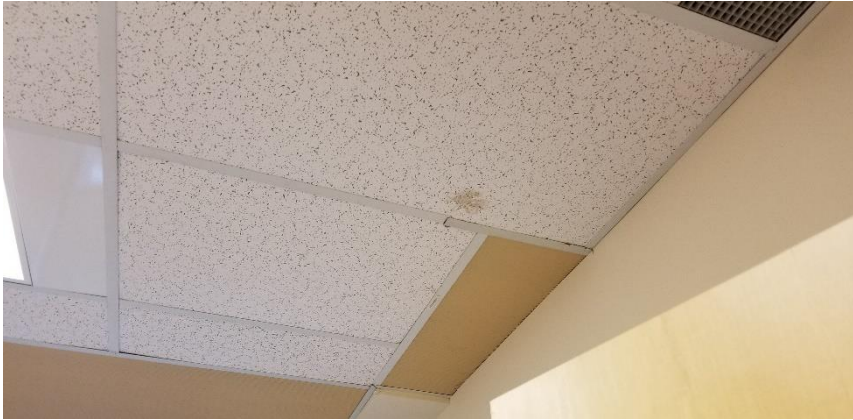
Photo 7: View of water damaged ceiling tiles observed in Room 301E.
