# HAZARDOUS MATERIALS SURVEY AND 2022 REASSESSMENT 601 CUMBERLAND STREET, OTTAWA, ON

Project No.: Z2021101HZ / CCC-230252-00

University of Ottawa

November 30, 2022

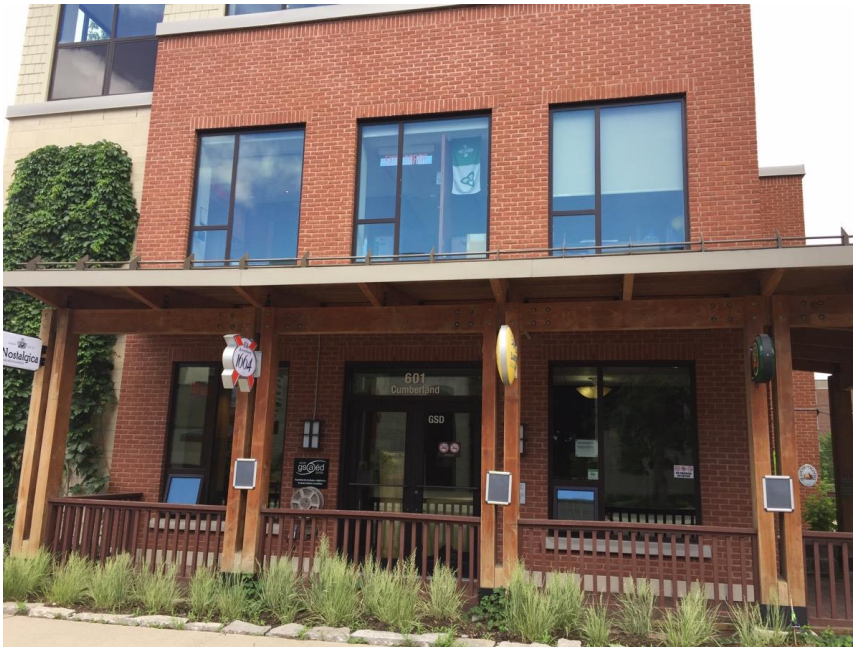
**Photo 1:** View of the exterior of the building

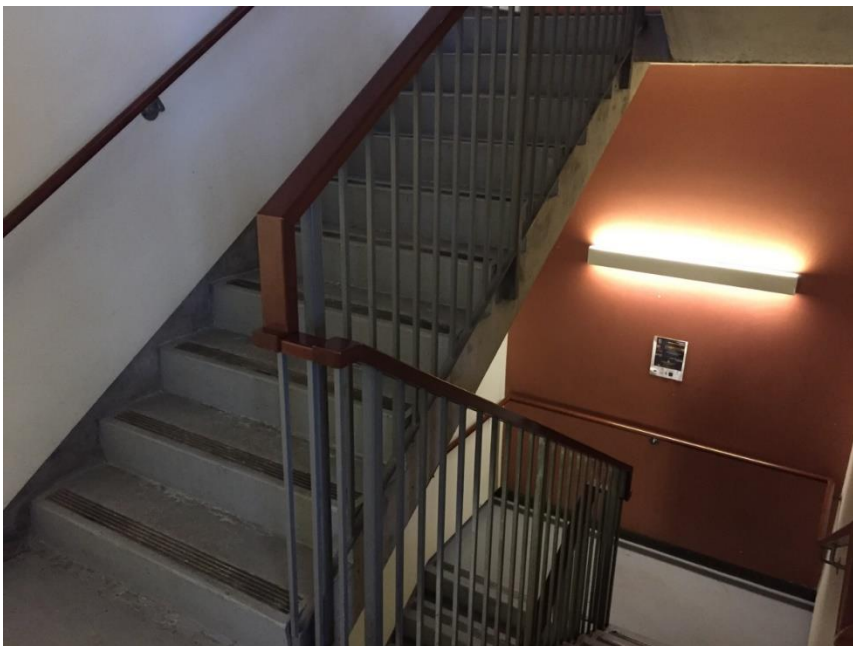
**Photo 2:** View of interior finishes observed throughout the building

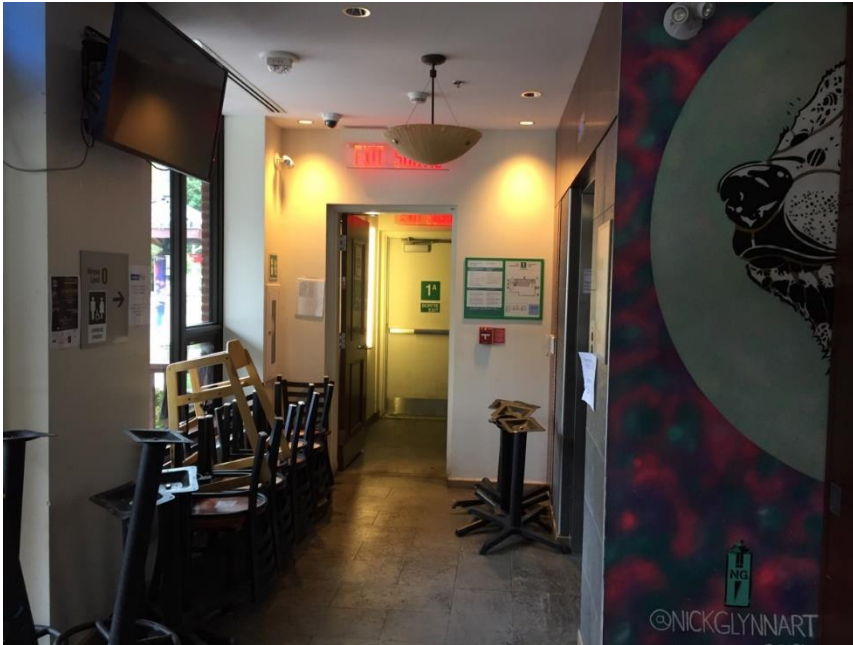
**Photo 3:** View of interior finishes observed throughout the building

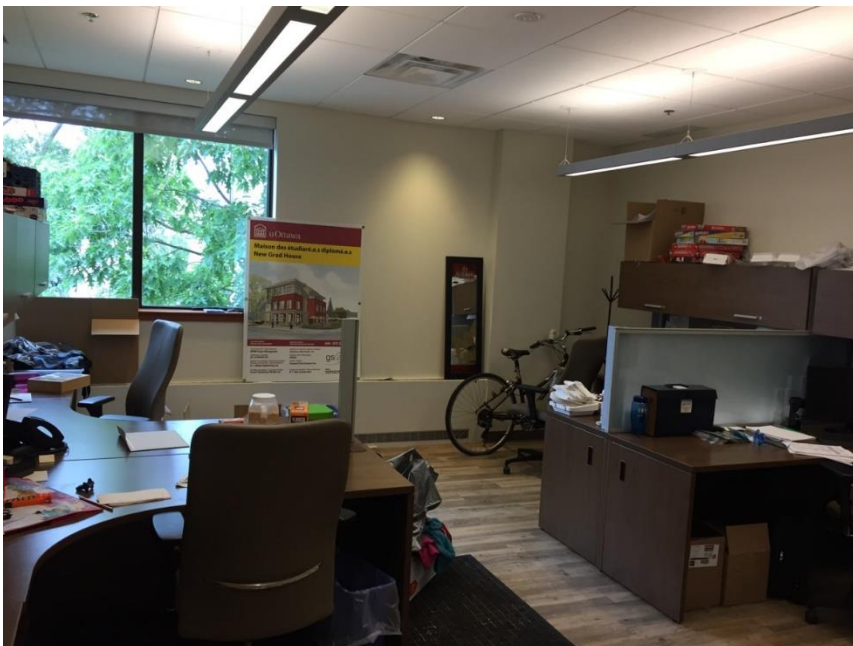
**Photo 4:** View of interior finishes observed throughout the building and suspended ceiling tiles

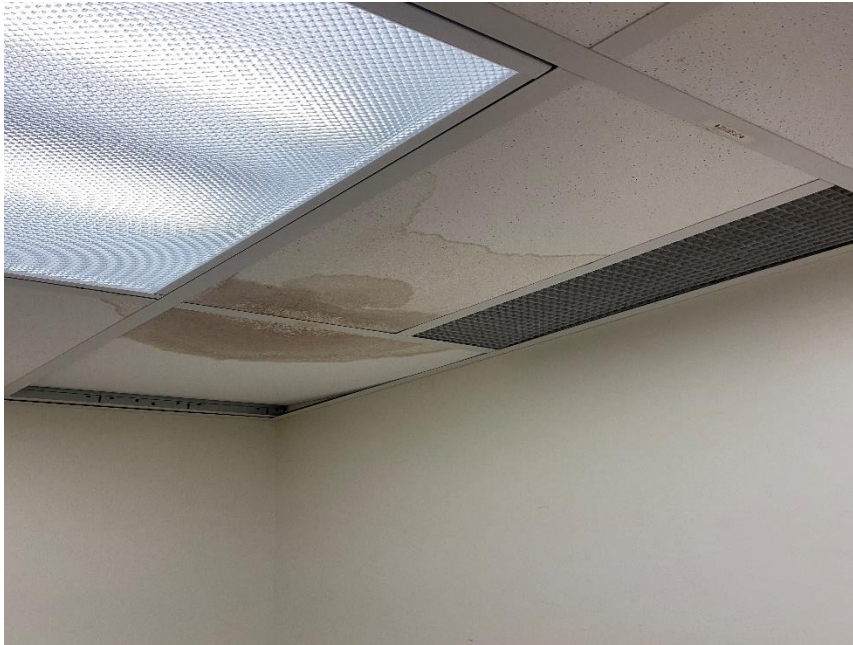
- Water damaged suspended ceiling tiles (non-ACM) were observed in Rooms 006 and 008B.
- No mould affected materials were observed during the site survey.

**Photo 5:** View of water damage observed on suspended ceiling tile.

Water stained/damaged ceiling tiles observed throughout the subject building should be replaced as part of regular maintenance and the underlying cause of the water leakage should be identified and repaired.

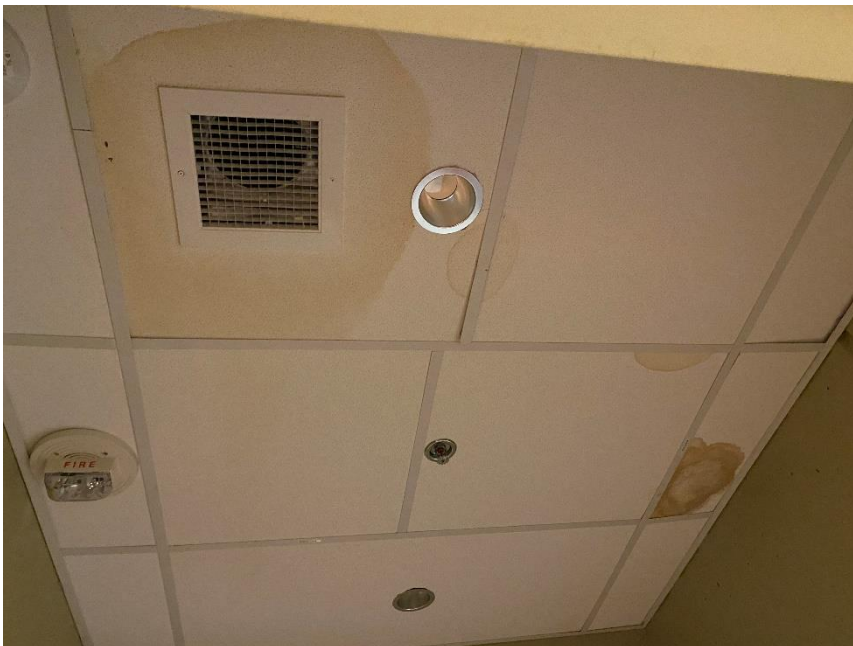
**Photo 6:** View of water damage observed on suspended ceiling tile.

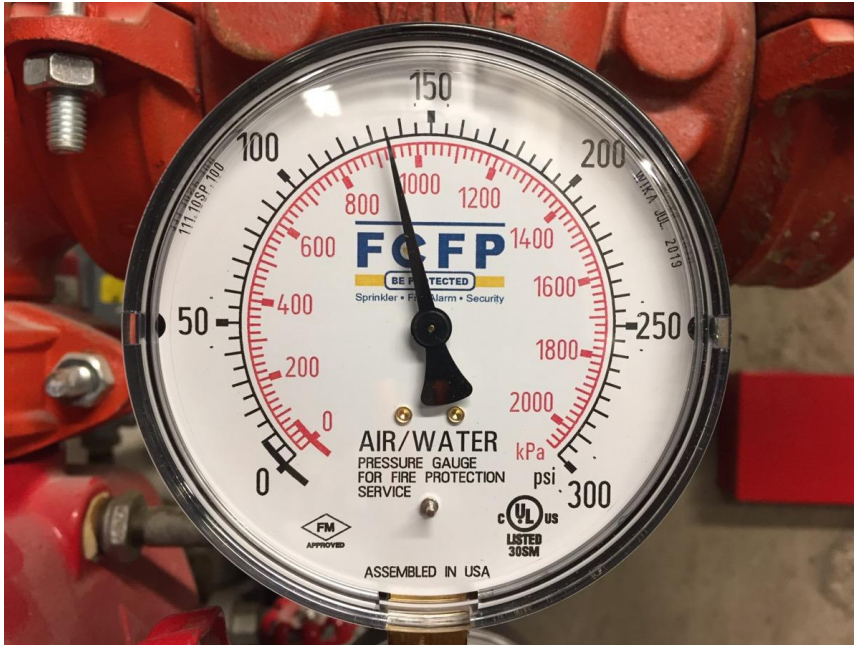
**Photo 7:** View of suspected mercury containing pressure gauge observed in the subject building
