# HAZARDOUS MATERIALS SURVEY AND 2022 REASSESSMENT 603 KING EDWARD AVENUE, OTTAWA, ON

Project No.: Z2021101-HZ / CCC-230252-00

University of Ottawa

December 2, 2022

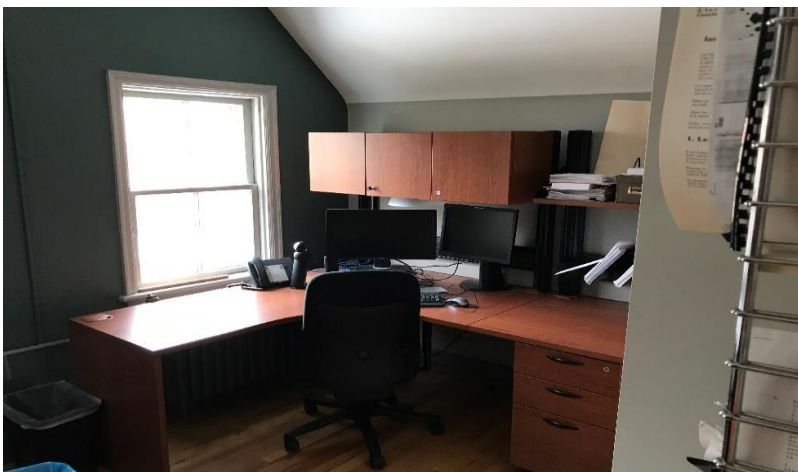
**Photo 2:** View of asbestos-containing plaster finishes in Room 201.

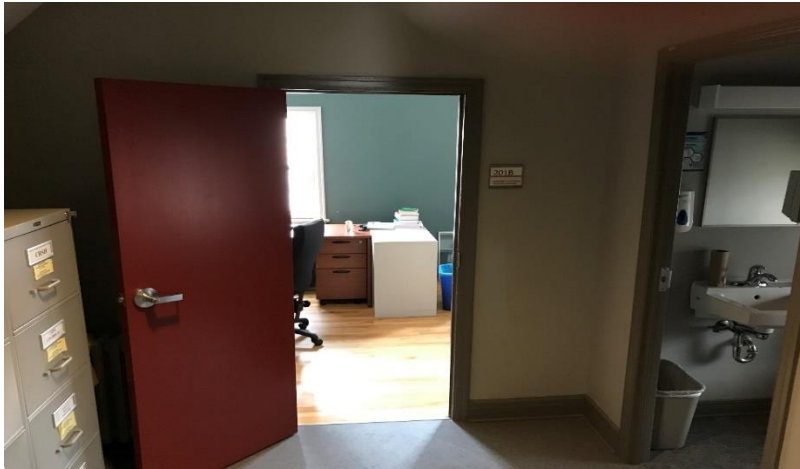
**Photo 3:** View of red door paint that contains low lead concentration.

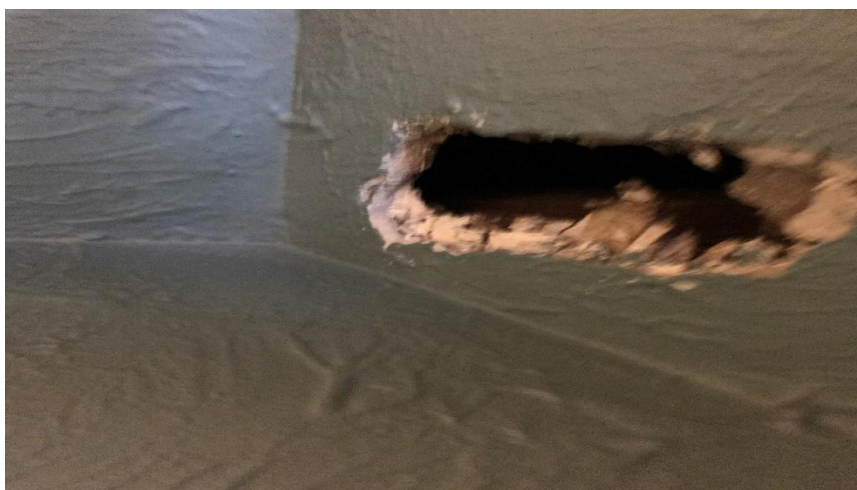
**Photo 5:** View of asbestos-containing plaster observed to be in poor condition in Room 204A.

**Damage repaired as of 2022 Reassessment.**

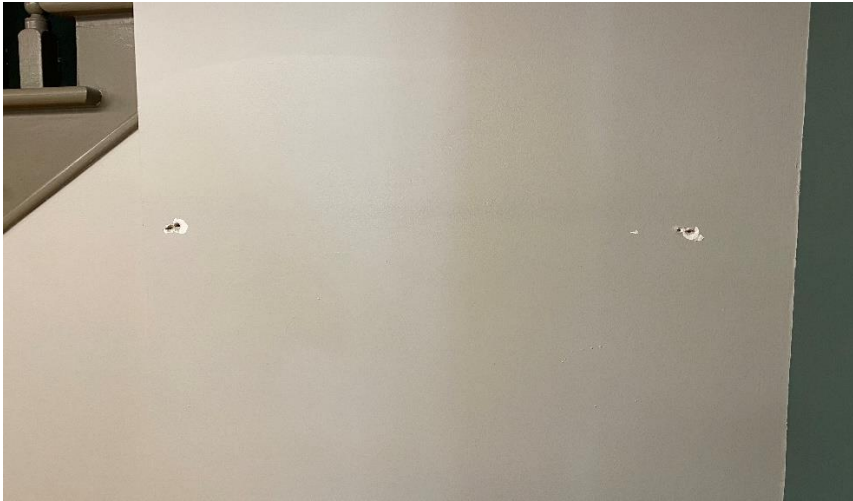
- ACM Plaster was observed to be in Fair Condition in Room 102 and 202.
- No mould affected or water damaged materials were observed during the site survey.

**Photo 5:** View of asbestos-containing plaster observed to be in fair condition in Room 102.

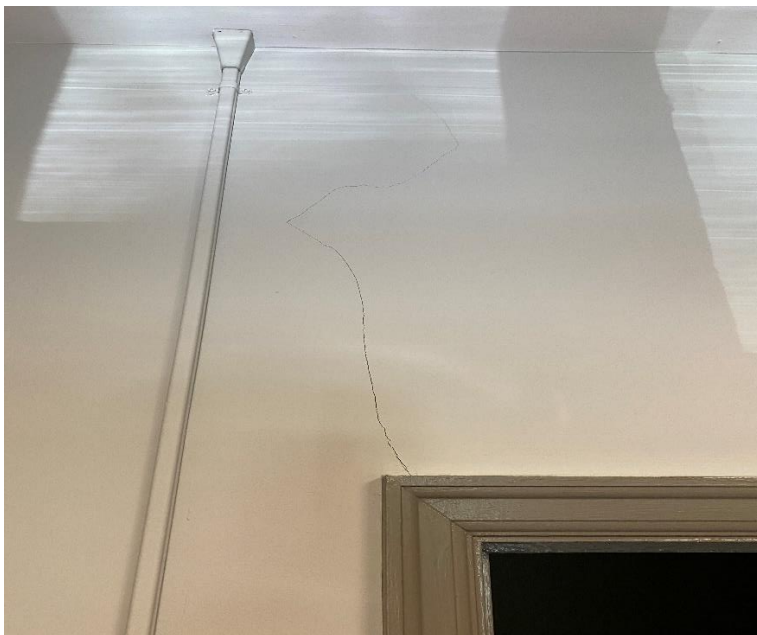
Ceiling/Wall plaster was observed throughout the subject building. The laboratory analytical results of ceiling/wall plaster samples collected from Room 101, 103D, 201, 201A, 204 and 204A indicate that this material contains 1% Chrysotile asbestos. Since plaster is a homogeneous material, all areas must be treated as asbestos-containing unless additional bulk sampling and analysis proves otherwise. This material was observed in Fair Condition in Room 102 and 202 during the 2022 Reassessment Survey.

**Photo 5:** View of asbestos-containing plaster observed to be in fair condition in Room 202.

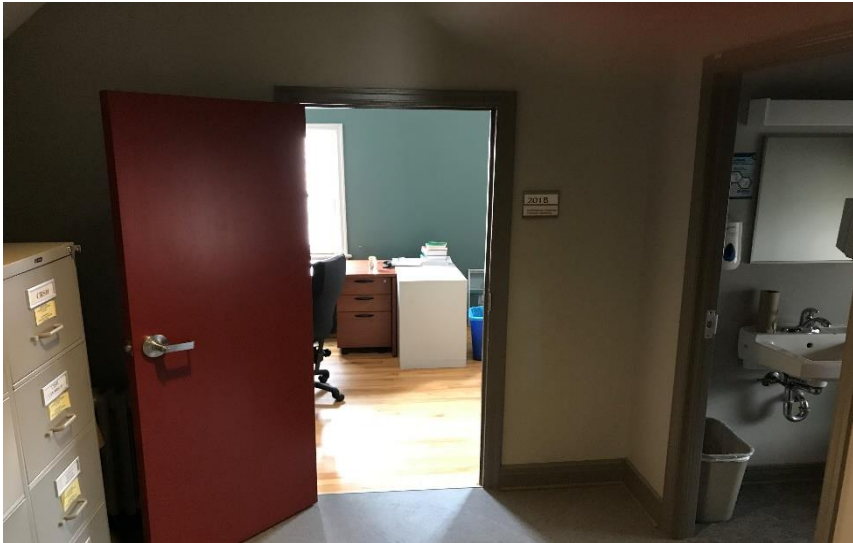
**Photo 6:** View of red door in Room 201B with low lead concentration.
