# HAZARDOUS MATERIALS SURVEY AND 2022 REASSESSMENT 631 KING EDWARD AVENUE, OTTAWA, ON

Project No.: 0Z2021101HZ / CCC-230252-00

University of Ottawa

McIntosh Perry Limited (MPL)

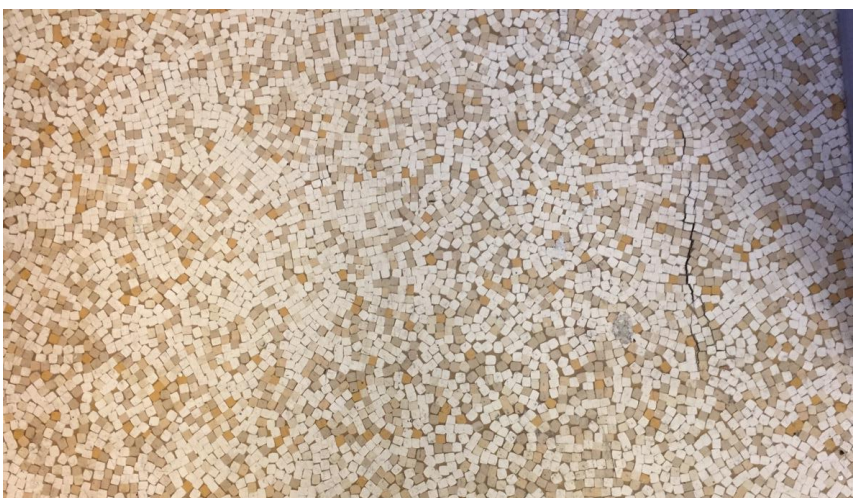
Previously identified asbestos-containing vinyl sheet flooring (White with Brown Squares) was observed in Room 103. This material contains 3.2% Chrysotile asbestos. This material is considered to be non-friable and was observed in good condition.

Photo 3: View of the asbestos-containing vinyl sheet flooring (White with Brown Squares) observed in Room 103.

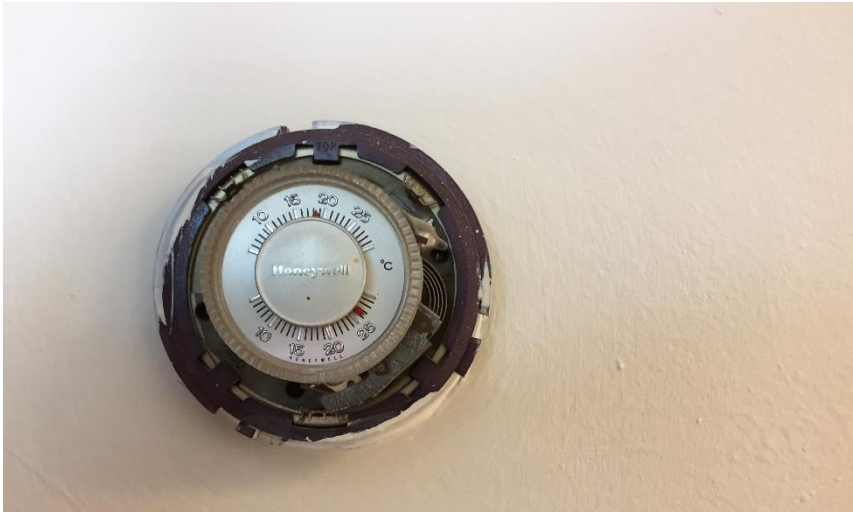
MPL observed a thermostat manufactured by Honeywell containing liquid mercury in Room 103.

Photo 4: View of the Honeywell thermostat containing liquid mercury, observed in Room 103.

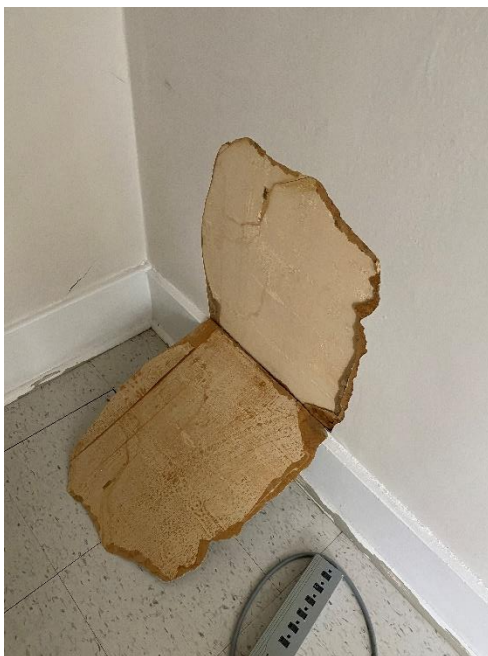
Previously identified asbestos-containing drywall joint compound was observed throughout the subject building. This material contains 2% Chrysotile asbestos. Asbestos-containing joint compound was also identified in plaster samples collected in Room 103. This material contains 2% Chrysotile asbestos and is suspected to have been used for minor repair work on damaged plaster finishes. Since drywall joint compound is a homogeneous material, all areas must be treated as asbestos-containing unless additional bulk sampling and analysis proves otherwise. This material was observed in good condition, except for select areas which were observed in fair and poor condition during the 2022 Reassessment.

Photo 5: View of the poor condition asbestos-containing drywall joint compound observed in Room 308B during the 2022 Reassessment.

- Asbestos-containing materials identified to be in poor condition must be repaired/removed immediately, following Type 1/2/3 asbestos abatement work procedures as detailed in O. Reg. 278/05 and disposed of as asbestos waste under O. Reg. 347;

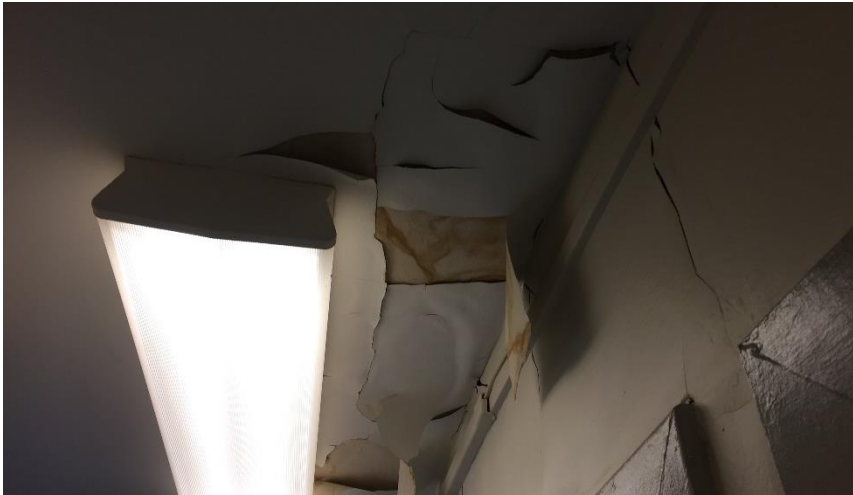
The paint finishes highlighted in blue in the above table were determined to contain low concentrations of lead which are less than or equal to 0.1%. These paint finishes were observed to be in good condition, with the exception of select areas which were observed in poor condition.

A visual survey of the subject building was conducted to determine if any water damaged was present. MPL identified select areas throughout the subject building, where materials were affected by water damage.

Photo 6: View of the poor condition lead paint (White) and water damaged drywall observed in Room 301

Paints identified to contain lead that are in poor condition must be immediately repaired and/or stabilized following a minimum Type 1/2 lead abatement procedures as per OMOL "Lead on Construction Project" dated April 2011.

Water stained/damaged building materials (i.e. drywall with joint compound) that are also determined to contain asbestos must be repaired/replaced following appropriate asbestos abatement procedures as outlined in O.Reg. 278/05.

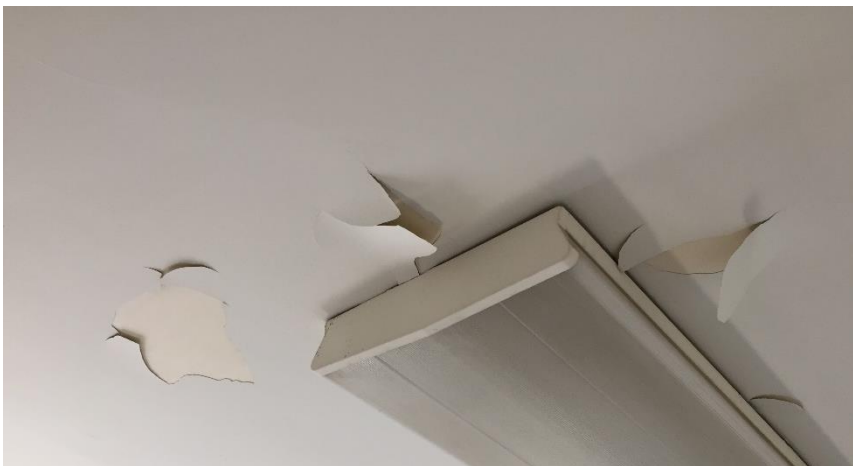
Photo 7: View of the poor condition lead paint (White) observed in Room 307

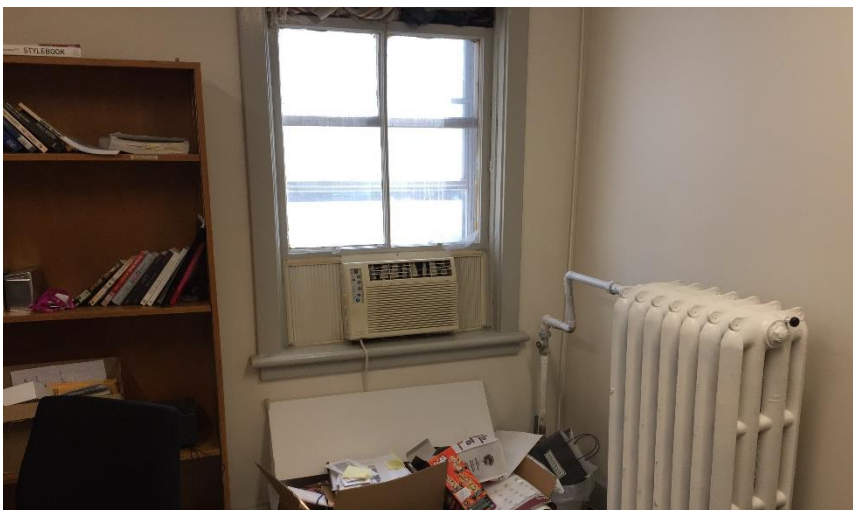
A visual assessment for equipment potentially containing ODSs and other halocarbons was conducted. Equipment containing ODSs or other halocarbons was observed in the subject building.

Photo 8: View of the equipment containing ozone depleting substances, observed throughout the subject building.

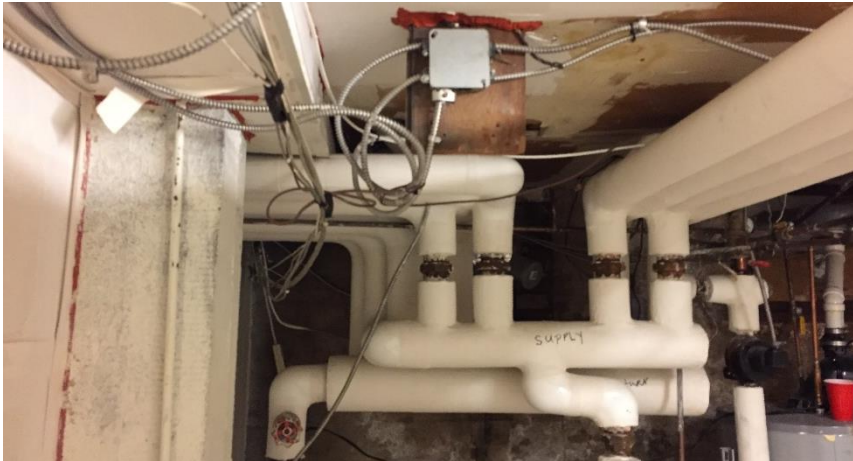
Photo 9: View of the fiberglass insulation observed in Room 005.

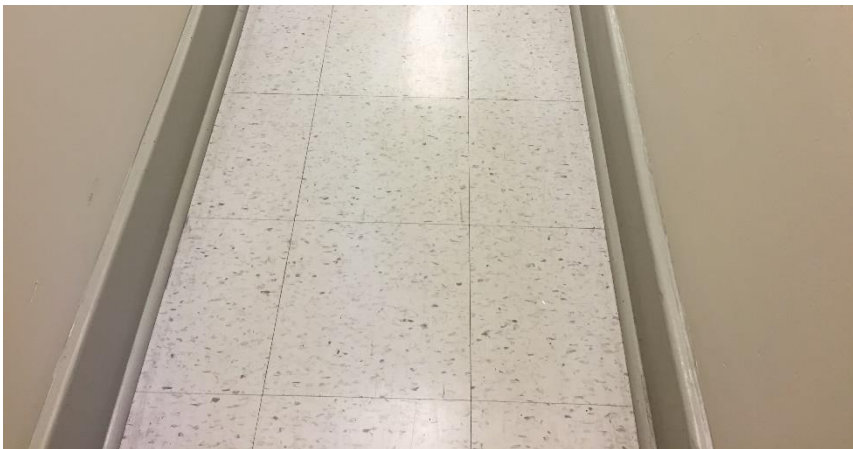
- Vinyl floor tiles (12" x 12"- White with Light and Dark Grey Flakes) were observed and sampled in Room 102. The laboratory analytical results indicate that this material does not contain asbestos. The associated mastic (Black) was also determined not to contain asbestos.

Photo 10: View of the non-asbestos containing vinyl floor tiles (12"x12" White with Light and Dark Grey Flakes) observed throughout the subject building.
