HAZARDOUS MATERIALS SURVEY AND 2022 REASSESSMENT POWER PLANT - 720 KING EDWARD AVENUE, OTTAWA, ON

Project No.: OZ2021101HZ / CCC-230252-00

University of Ottawa

January 6, 2023

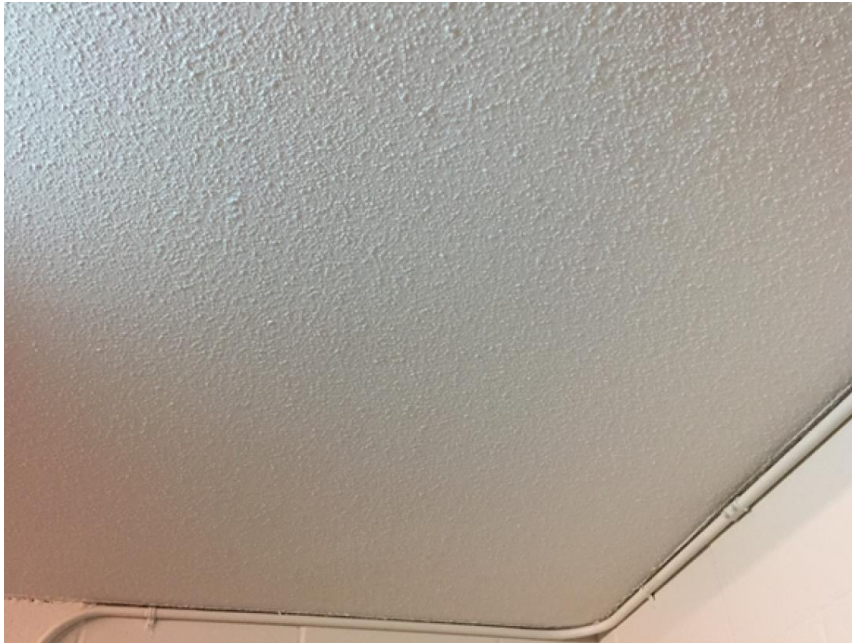
Samples 1.1-1.3

Ceiling texture coat (White) was observed and sampled in Rooms M03 and M10. This material contains 2% Chrysotile asbestos. This material is considered friable and was observed in good condition.

Photo 1: View of asbestos-containing textured ceiling observed in Room M03, M10, M11, and M12 of Subject Building.

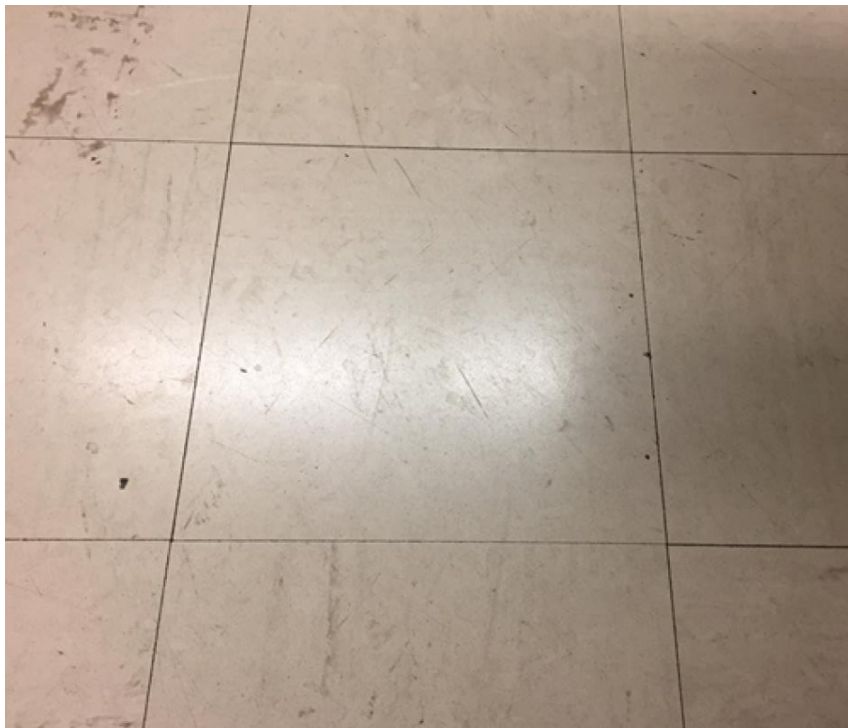
Samples 2.1-2.3

- Vinyl floor tiles (12" x 12" – Beige w/ Grey Streaks) were observed and sampled in Room M12. This material contains 2% Chrysotile asbestos. This material is considered non-friable and was observed in good condition. The associated mastic (Black) was determined not to contain asbestos.
- Vinyl floor tiles (12" x 12" – White w/ Grey Mix) were observed and sampled in Room M006. The laboratory analytical results of the samples collected indicate that this material does not contain asbestos. The associated mastic (Black) was also determined not to contain asbestos.

Photo 2: View of asbestos-containing vinyl floor tiles observed in Room M12 of Subject Building.

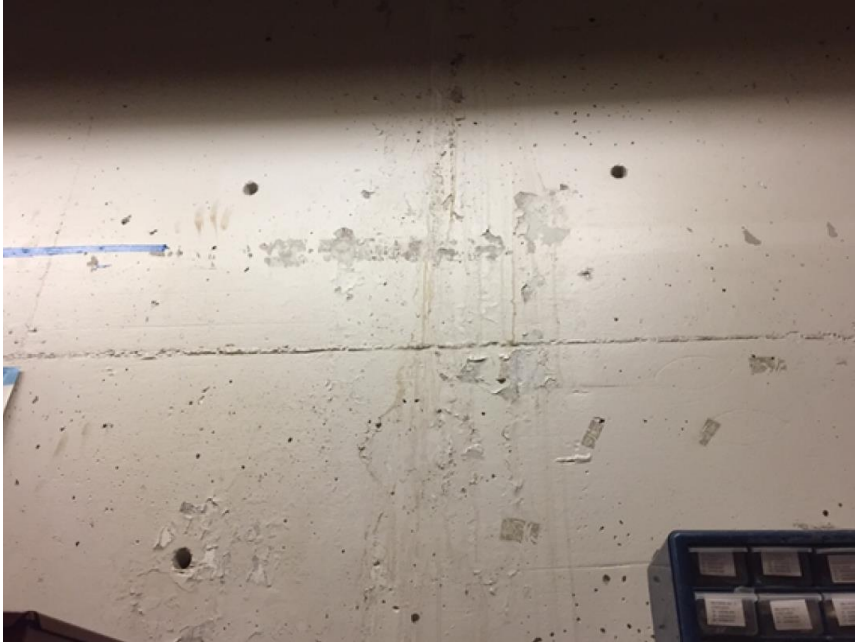
The paint finishes highlighted in pink in the above table are considered lead-containing paints or surface coatings with concentrations greater than 0.1% lead by weight. These paint finishes were observed to be in good condition, with the exception of select areas which were observed in poor condition.

Photo 3: View of poor condition white wall paint observed in Room M13.
Sample PB1

Paints identified to contain lead that are in poor condition must be immediately repaired and/or stabilized following a minimum Type 1/2 lead abatement procedures as per OMOL "Lead on Construction Project" dated April 2011.

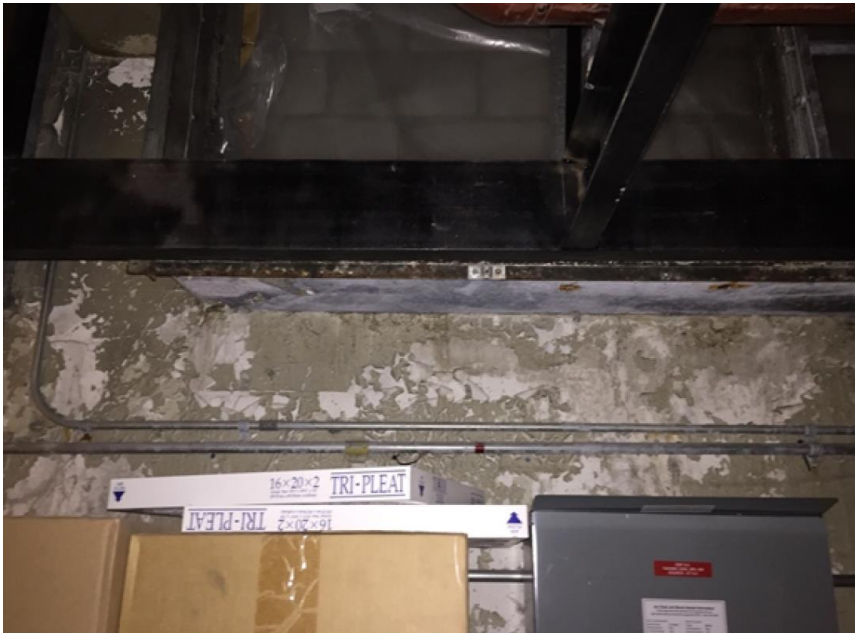
Photo 4: View poor condition grey wall paint observed in Room M09.
Sample PB6

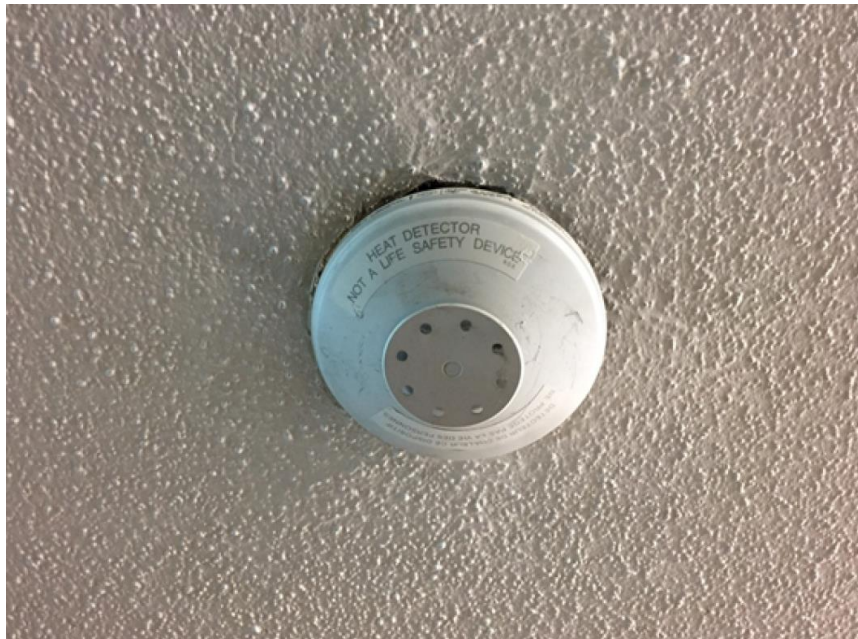
Photo 5: View of Radioactive Smoke Detector observed in Room M03 of Subject Building.

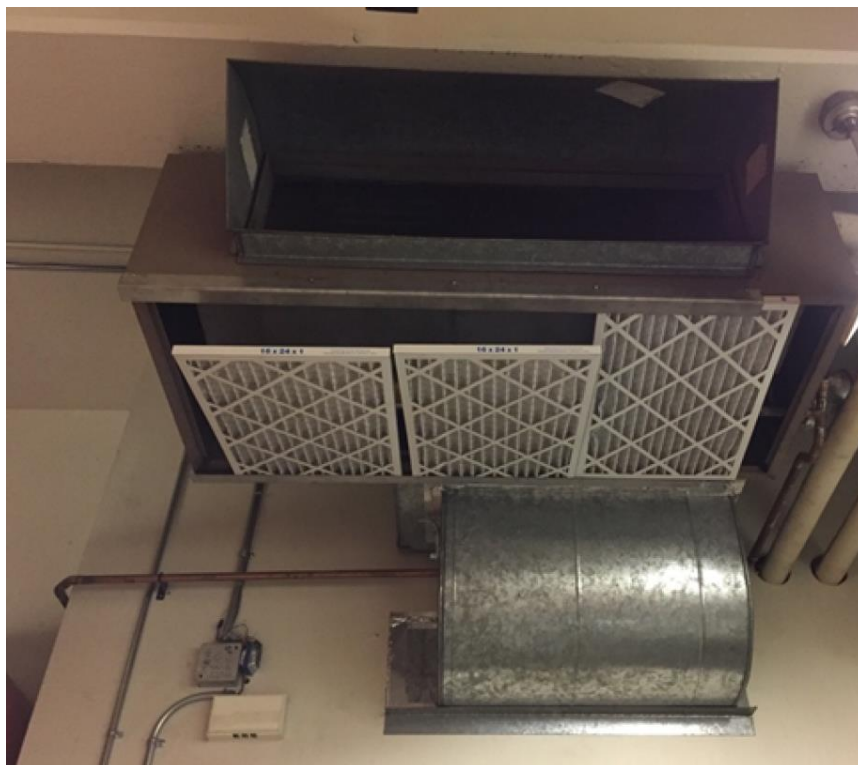
Photo 6: View of ODS Air Conditioning Unit observed in Room M13A of Subject Building.

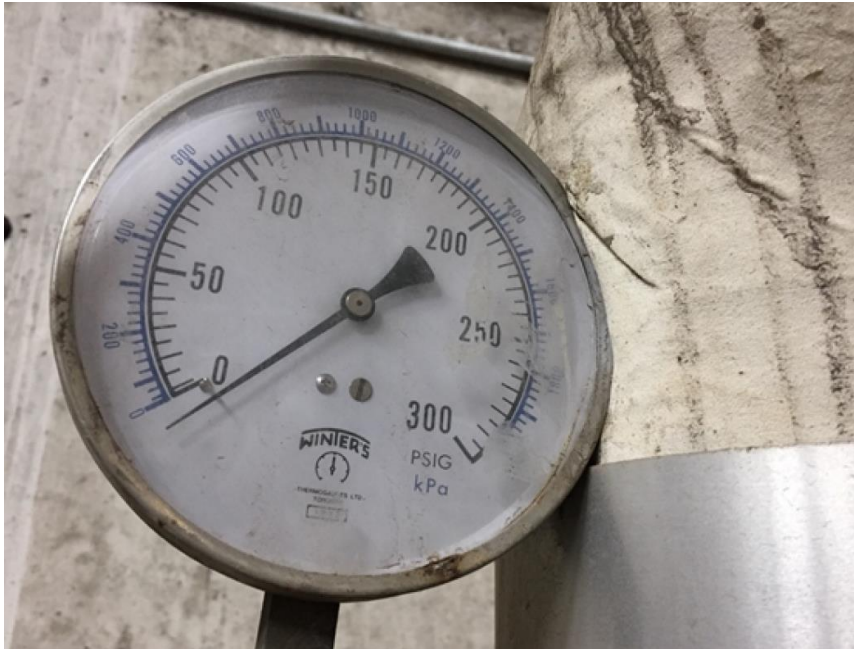
Photo 7: View of Winters' Pressure Gauge observed in Room 008 of Subject Building.
