HAZARDOUS MATERIALS SURVEY AND 2022 REASSESSMENT 850 PETER MORAND CRESCENT, OTTAWA, ON

Project No.: Z2021101HZ / CCC-230252-00

November 30, 2022

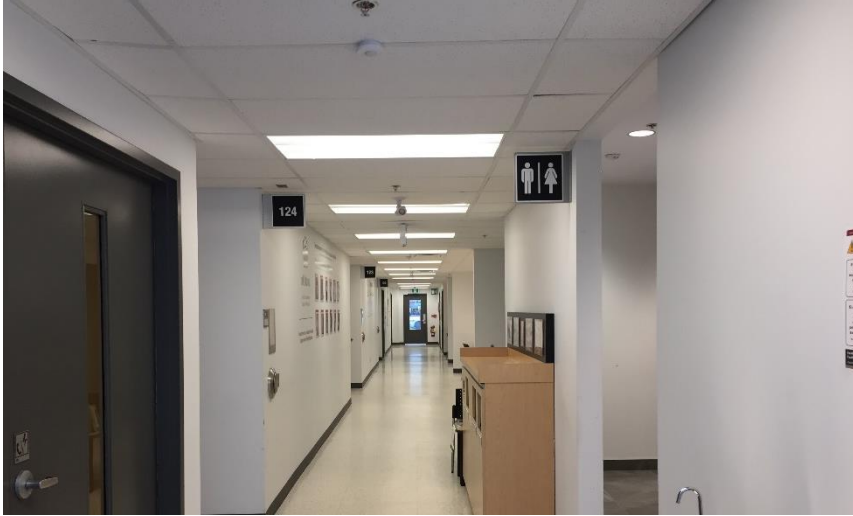
Photo 1: View of typical finishes observed in 850 Peter Morand Crescent.

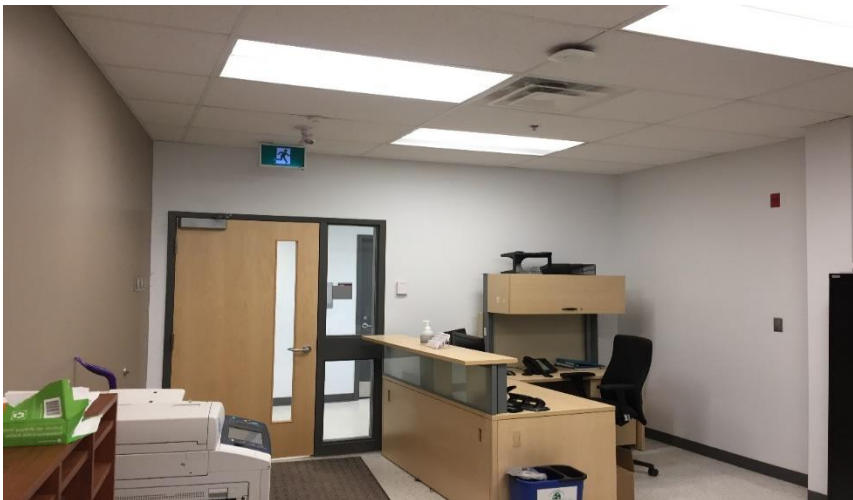
Photo 2: View of typical finishes observed in 850 Peter Morand Crescent.

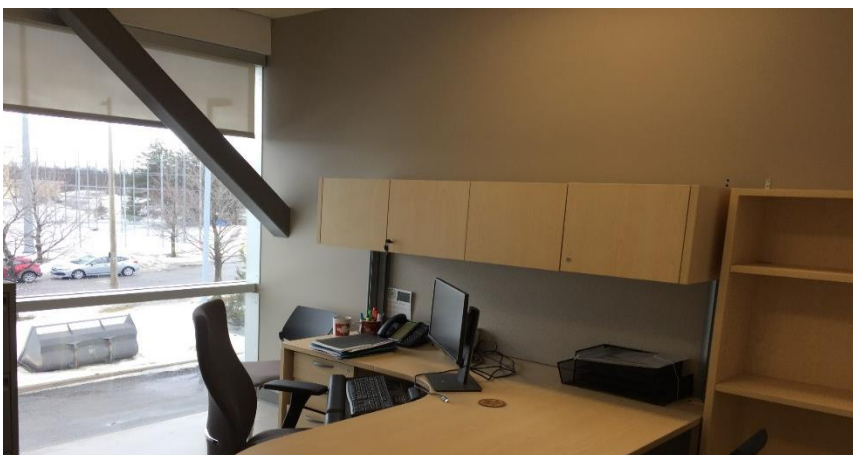
Photo 3: View of typical finishes observed in 850 Peter Morand Crescent.

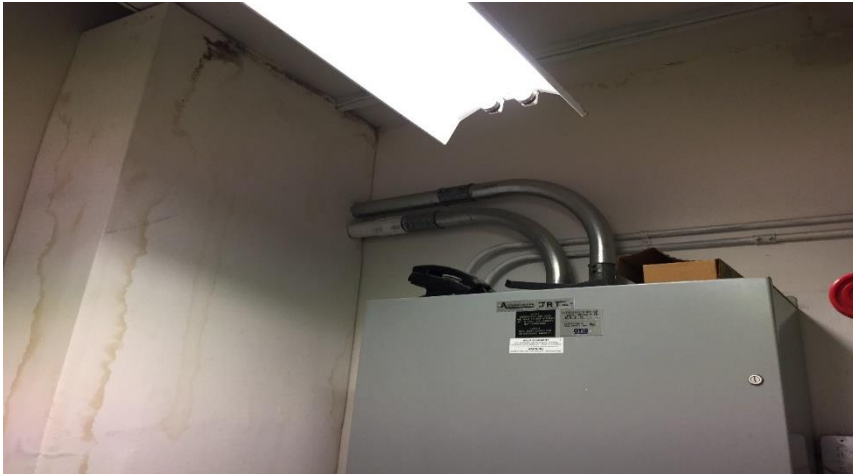
- Water damage and mould were observed on drywall in Room 100D.

A visual survey of the subject building was conducted to determine if any mould was present. MPL observed mould growth in select areas of the subject building.

A visual survey of the subject building was conducted to determine if any water damaged was present. MPL identified select areas throughout the subject building, where materials were affected by water damage.

Photo 4: View of suspect mould growth observed on drywall in Room 100D.

Mould and Water stained/damaged drywall must be removed following Level I mould remediation procedures, as per EACC Guidelines.

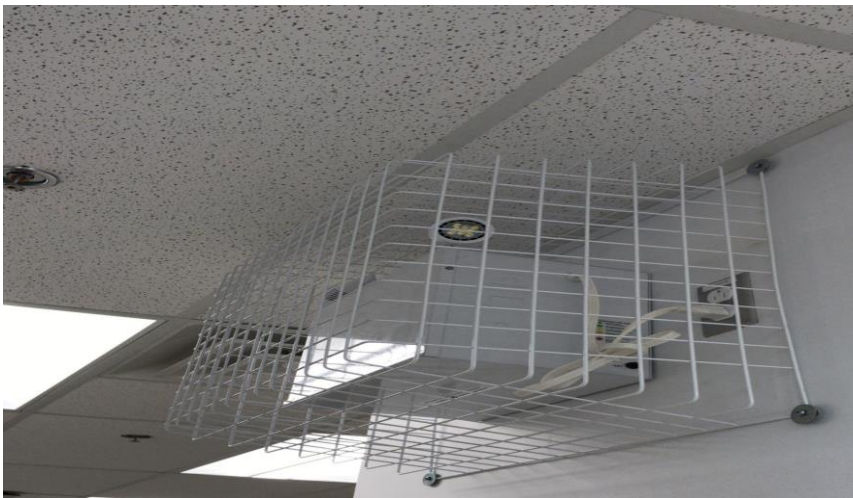
MPL identified lead-containing acid battery packs throughout the subject building. These battery packs were observed on walls and above exits throughout the surveyed building.

Photo 5: Typical view of emergency lights

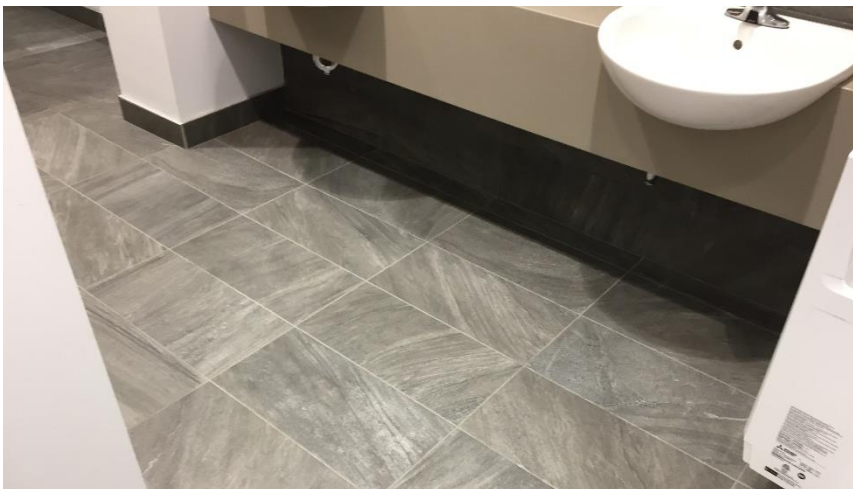
To avoid damage and compromising the integrity of the structure, no bulk samples of the ceramic wall/floor tile grout were collected. Prior to renovation/demolition, ceramic wall/floor tile grout should be examined and tested for asbestos content. Ceramic wall/floor tile grout should therefore be considered to contain asbestos until bulk samples and analysis proves otherwise.

Photo 6: Typical view of ceramic floor tile grout observed throughout the subject building suspected of containing asbestos.
