HAZARDOUS MATERIALS SURVEY AND 2022 REASSESSMENT 90 UNIVERSITY PRIVATE, OTTAWA, ON

Project No.: Z2021102HZ / CCC-230252-00

September 7, 2022

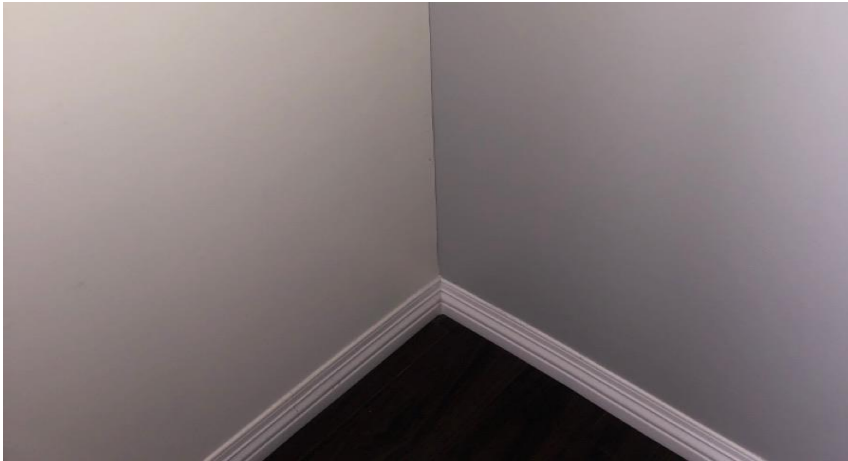
Photo 4: Typical view of light grey wall paint and white trim paint suspected of containing lead.

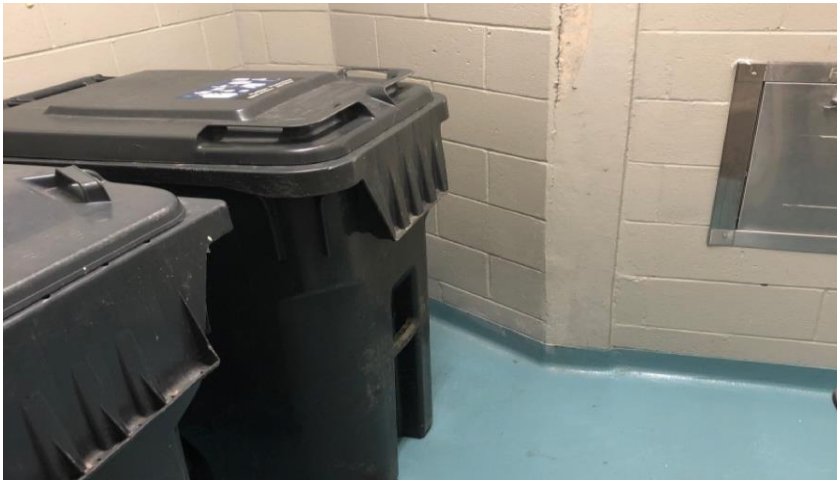
Photo 5: Typical view of teal floor paint and beige wall paint suspected of containing lead.

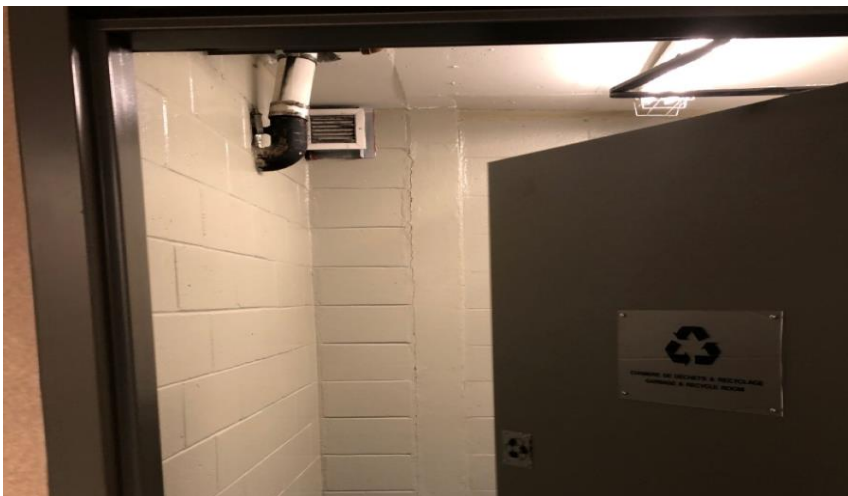
Photo 6: Typical view of light brown door and doorframe paint suspected of containing lead.
