HAZARDOUS MATERIALS SURVEY AND 2022 REASSESSMENT 133-135 SERAPHIN MARION (ACADEMIC HALL), OTTAWA, ON

Project No.: Z1021101HZ / CCC-230252-00

January 16, 2023

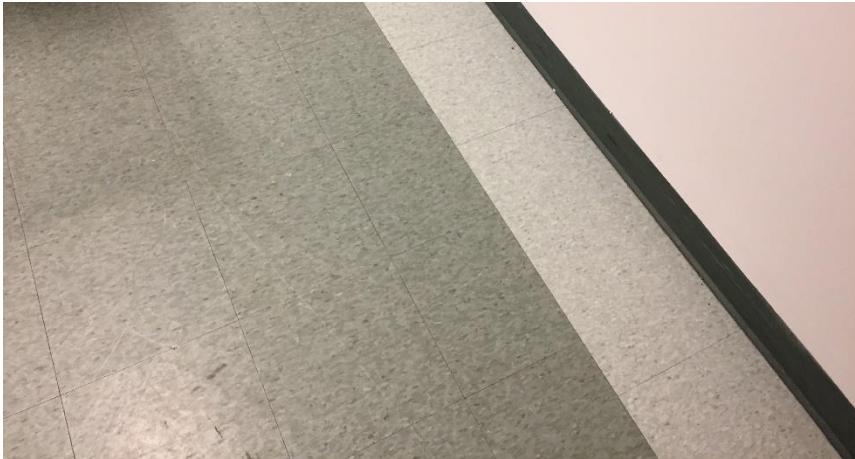
- Vinyl floor tiles (12" x 12"- Green) were observed in Room 309. The laboratory analytical results of the vinyl floor tile samples collected from Room 309 indicate that this material does not contain asbestos. The associated mastic (black) was found not to contain asbestos.

Photo 1: View of non-asbestos containing vinyl floor tile (12" x 12" -green) observed in Room 309.

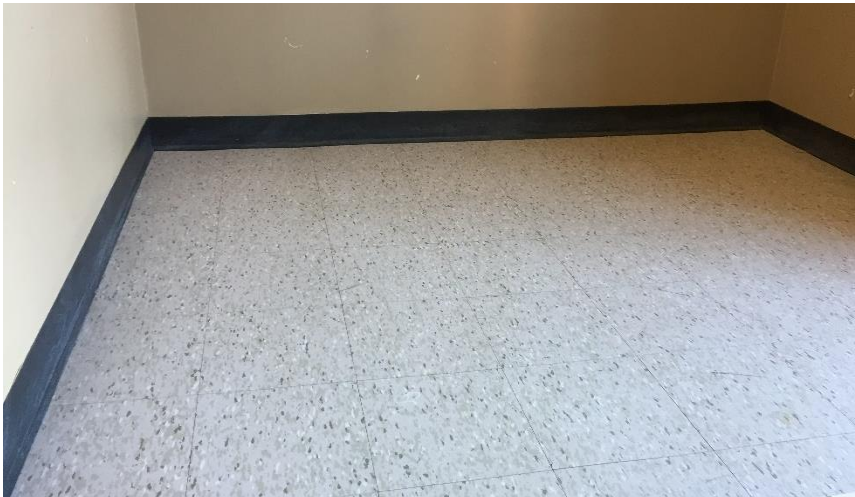
- Vinyl floor tiles (12" x 12"- Purple with Grey and White) were observed in Room 103. The laboratory analytical results of the vinyl floor tile samples collected from Room 103 indicate that this material does not contain asbestos. The associated mastic (black) and caulking was found not to contain asbestos.

Photo 2: View of asbestos containing vinyl floor tile observed in Room 103.

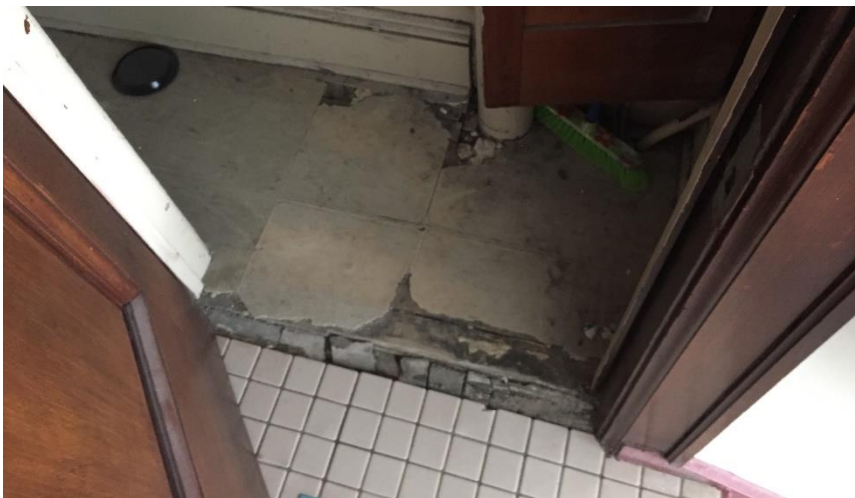
- Vinyl floor tiles (12" x 12" – Grey with Brown Marks) were observed in Room 110A. The laboratory analytical results of vinyl floor tile samples collected from Room 110A indicate that this material contains 2% Chrysotile asbestos. This material is considered to be non-friable and was not observed to be present during the 2022 Reassessment.

Photo 3: View of asbestos-containing vinyl floor tile observed to be in poor condition within Room 110A.

- Asbestos-containing materials identified to be in poor condition must be repaired/removed immediately, following Type 1/2/3 asbestos abatement work procedures as detailed in O. Reg. 278/05 and disposed of as asbestos waste under O. Reg. 347;

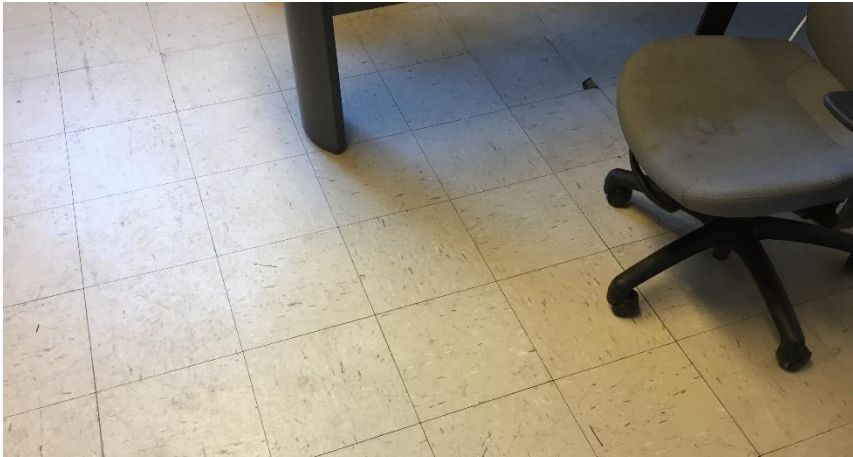
- Vinyl floor tiles (12" x 12" – Brown with White and Brown Streaks) were observed in Room 107. The laboratory analytical results of vinyl floor tile samples collected from Room 107 indicate that this material contains 1% Chrysotile asbestos. This material is considered to be non-friable and was observed in fair condition.

Photo 4: View of Asbestos-containing vinyl floor tiles in Room 107.

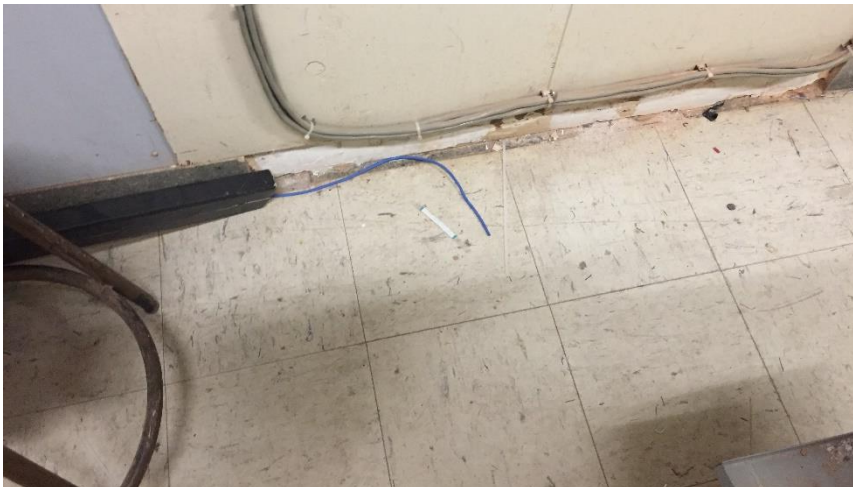
- Vinyl floor tiles (12" x 12" – Light Brown with Black and Grey Streaks) were observed in Room 017. The laboratory analytical results of vinyl floor tile samples collected from Room 017 indicate that this material contains 2% Chrysotile asbestos. This material is considered to be non-friable and was observed in good condition. The associated mastic (black) and leveller was found not to contain asbestos.

- Vinyl floor tiles (12" x 12" – Light Grey with Grey Streaks) were observed in Room 017. The laboratory analytical results of vinyl floor tile samples collected from Room 017 indicate that this material contains 1% asbestos. This material is considered to be non-friable and was observed in good condition. The associated mastic (Black) was found not to contain asbestos.

- Vinyl floor tiles (12" x 12" – Dark Grey with White and Grey Streaks) were observed in Room 017. The laboratory analytical results of vinyl floor tile samples collected from Room 017 indicate that this material contains 1% Chrysotile asbestos. This material is considered to be non-friable and was observed in good condition. This material is considered to be non-friable and was observed in good condition. The associated mastic (black) was found not to contain asbestos.

Photo 5: View of asbestos-containing vinyl floor tiles in Room 017.

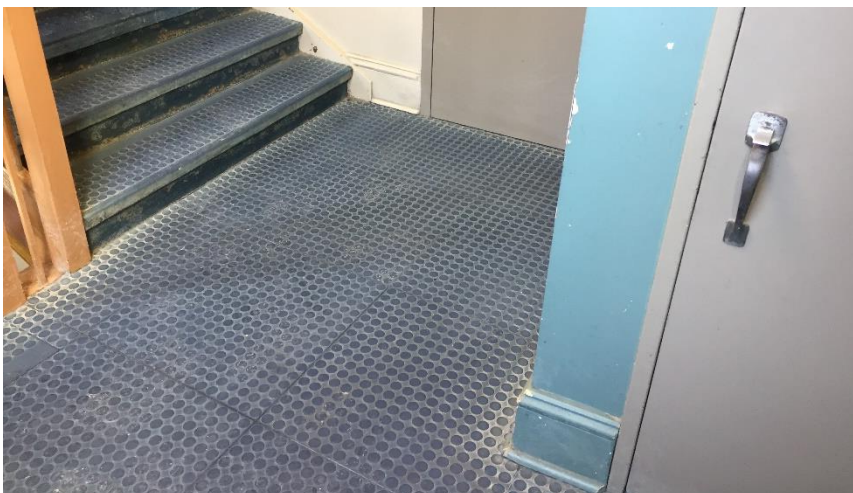
- Vinyl sheet flooring (Blue with Circles) was observed in Room 101. The laboratory analytical results of the vinyl sheet flooring samples collected from the Room 101 indicate that this material does not contain asbestos. The associated mastic/backing material (beige) was also found not to contain asbestos.

Photo 6: View of non-asbestos containing vinyl sheet flooring in Room 101.

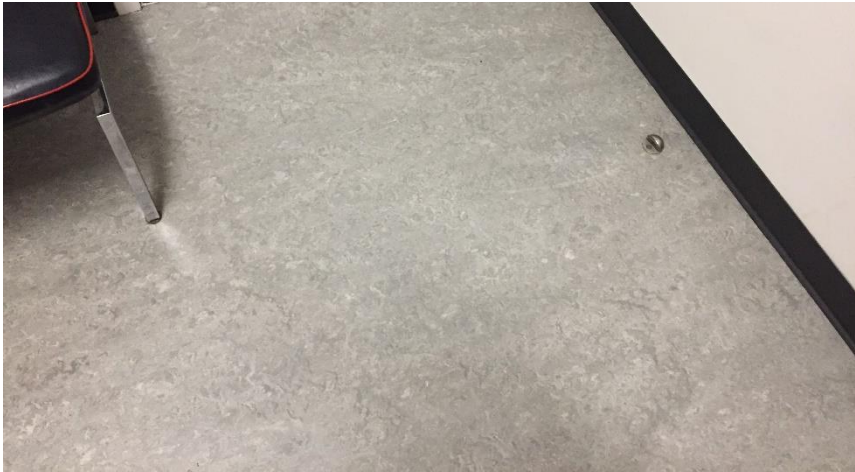
- Vinyl sheet flooring (Grey and White Swirls) was observed in Room 302. The laboratory analytical results of the vinyl sheet flooring samples collected from the Room 302 indicate that this material does not contain asbestos. The associated mastic/backing material (beige) was also found not to contain asbestos.

Photo 7: View of non-asbestos containing vinyl sheet flooring in Room 302.

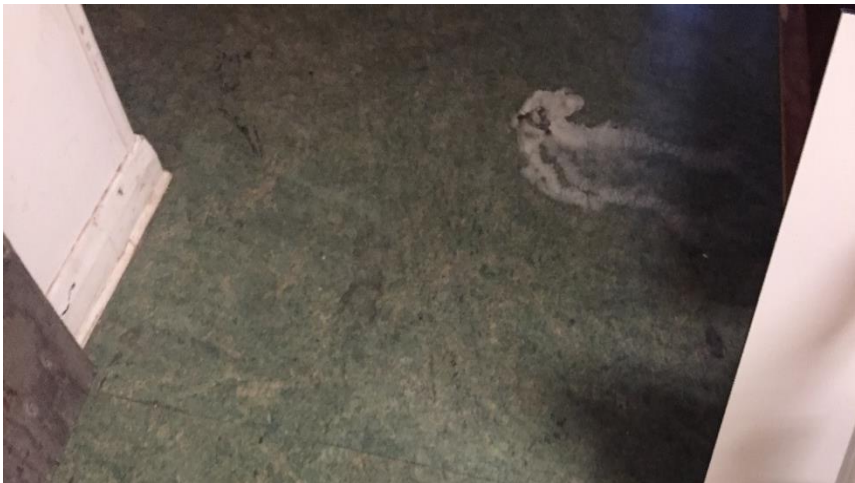
- Vinyl sheet flooring (Green and Brown) was observed in Room 400. The laboratory analytical results of the vinyl sheet flooring samples collected from the Room 400 indicate that this material does not contain asbestos. However, loose fibres (white) were present in the sample collected. This material

was found to contain 45% Chrysotile asbestos. As such, the vinyl sheet flooring in this room shall be considered as a friable asbestos-containing material and is in good condition. Prior to renovation/demolition, additional sampling should be completed to confirm the presence of asbestos and to delineate the locations of this material.

Photo 8: View of vinyl sheet flooring associated with asbestos-containing loose fibres in Room 400.

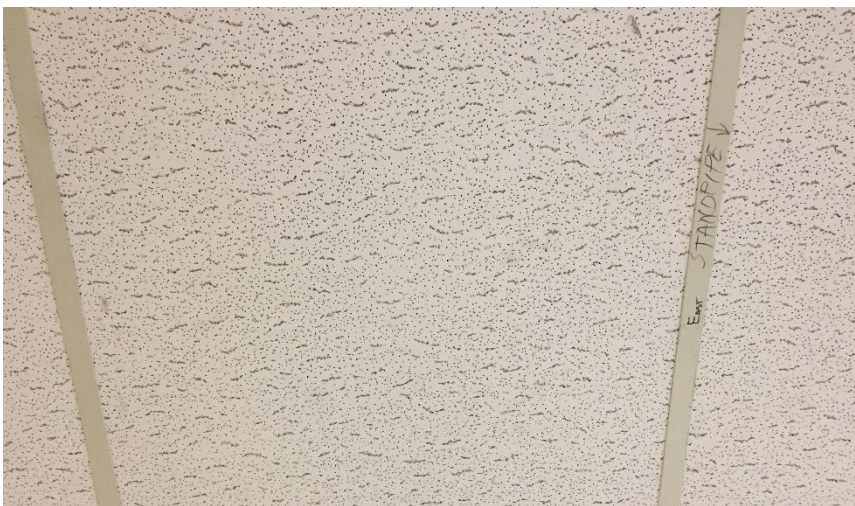
- Suspended ceiling tiles (2'x4' - Fissures and Pinholes) were observed in Room 001. The laboratory analytical results of ceiling tile samples collected from Room 001 indicate that this material does not contain asbestos;

- Suspended ceiling tiles (2'x4' - Equal Amount Fissures and Pinholes) were observed in Room 001. The laboratory analytical results of ceiling tile samples collected from Room 001 indicate that this material does not contain asbestos;

Photo 9: View of non-asbestos containing suspended ceiling tiles in Room 001.

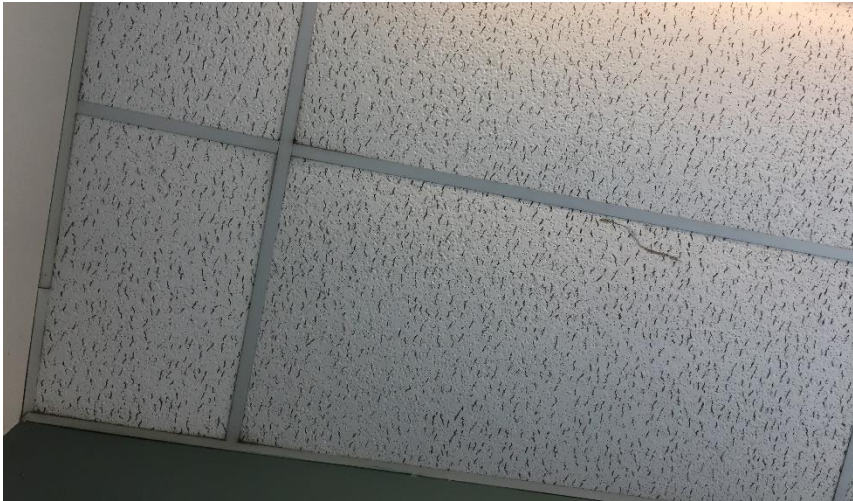
- Suspended ceiling tiles (1'x1'-Fissures) were observed in Room 002 and 300. The laboratory analytical results of ceiling tile samples collected from Room 001 and 300 indicate that this material does not contain asbestos;

Photo 10: View of non-asbestos containing suspended ceiling tiles in Room 300.

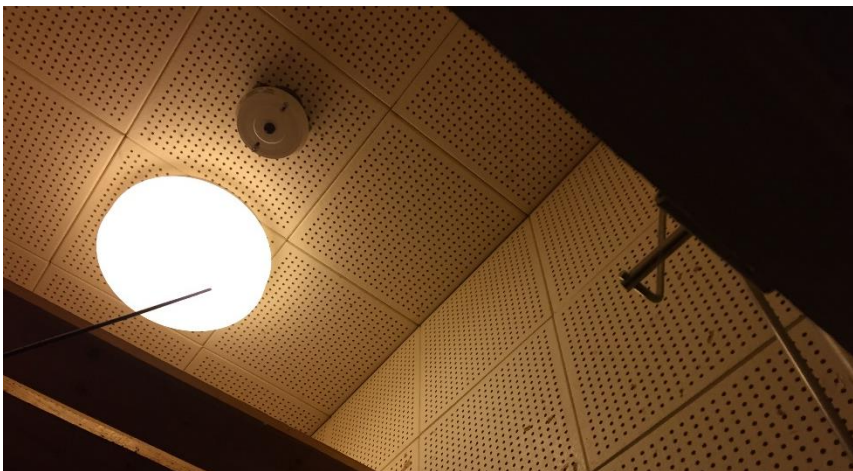
- Acoustic ceiling tiles (White with Scattered Holes) were observed in Room 307. The laboratory analytical results of ceiling tile samples collected from Room 307 indicate that this material does not contain asbestos; and

- Acoustic ceiling tiles (Beige with Linear Holes) were observed in 307. The laboratory analytical results of ceiling tile samples collected from Room 307 indicate that this material does not contain asbestos.

Photo 11: View of non-asbestos containing acoustic ceiling tile in Room 307.

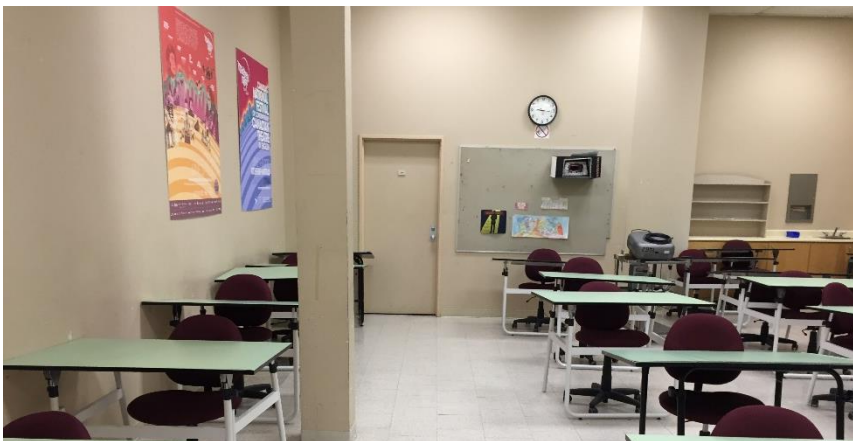
Drywall joint compound was observed throughout the subject building. The laboratory analytical results of drywall joint compound samples collected from Room 202 and Room 222 indicate that this material contains 2% Chrysotile. Since drywall joint compound is a homogeneous material, all areas must be treated as asbestos-containing unless additional bulk sampling and analysis proves otherwise. This material was observed in good, fair and poor condition during the 2022 Reassessment.

Photo 12: View of asbestos-containing drywall joint compound in Room 202.

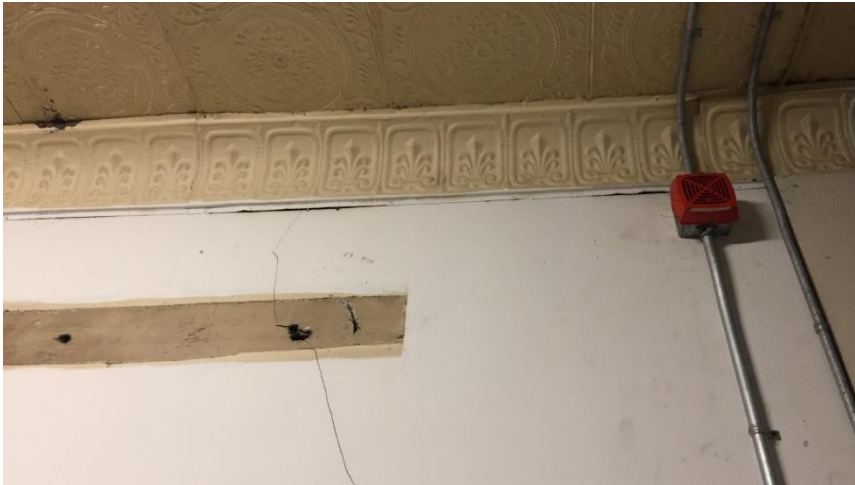
Ceiling/Wall plaster was observed throughout the subject building. The laboratory analytical results of ceiling/wall plaster samples collected from Room 400 indicate that this material contains between 7-10% Chrysotile. Since plaster is a homogeneous material, all areas must be treated as asbestos-containing unless additional testing confirms otherwise. This material is considered to be friable and was observed in to be in

good, fair and poor condition throughout the subject building during the 2022 Reassessment. It should be noted that vermiculite is present in plaster finishes Room 112. Prior to renovation/demolition, additional sampling should be completed to confirm the presence of asbestos in the vermiculite following TEM analysis and to delineate the locations of this material.

Photo 13: View of damaged asbestos-containing wall/ceiling plaster from Room 400.

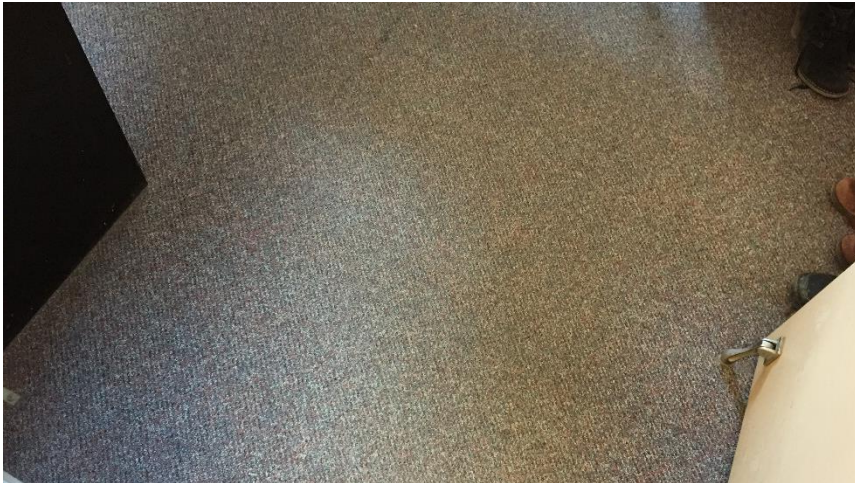
- Carpet mastic (Yellow) was observed and sampled in Room 112, 116, 139 and 209. The laboratory analytical results of the carpet mastic samples indicate that this material does not contain asbestos.
- Carpet Mastic (Brown/Beige) was observed and sampled in Room 313. The laboratory analytical results of the mastic samples indicate that this material does not contain asbestos

Photo 14: View of non-asbestos containing carpet mastic in Room 209.

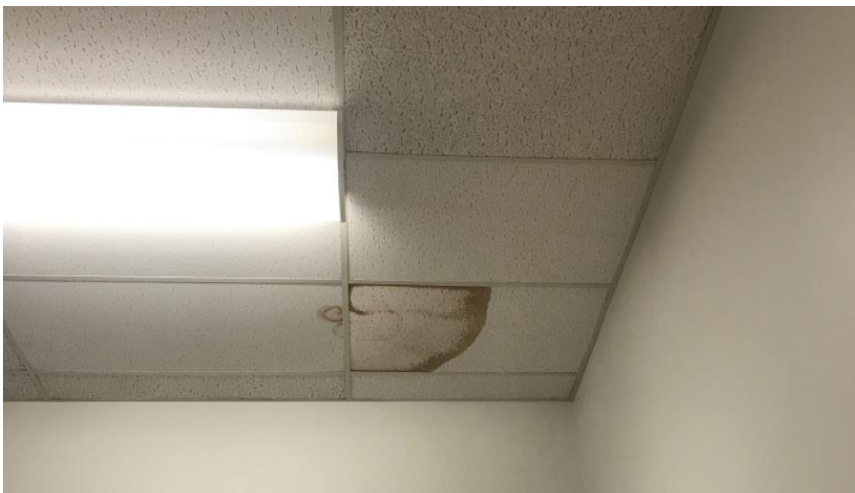
Photo 15: View of water damaged suspended ceiling tile observed in Room 225.

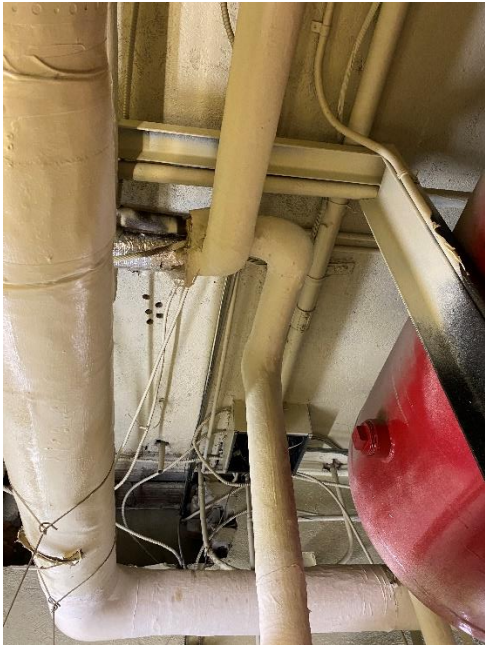
Mechanical pipe straight insulation suspected to contain asbestos was observed in Room 015A of the subject building during the 2022 Reassessment.

Mechanical pipe elbows/fittings insulation suspected to contain asbestos were observed in Room 015A of the subject building during the 2022 Reassessment.

Photo 16: View of mechanical pipe straight and elbow insulation suspected to contain asbestos observed in Room 015A.

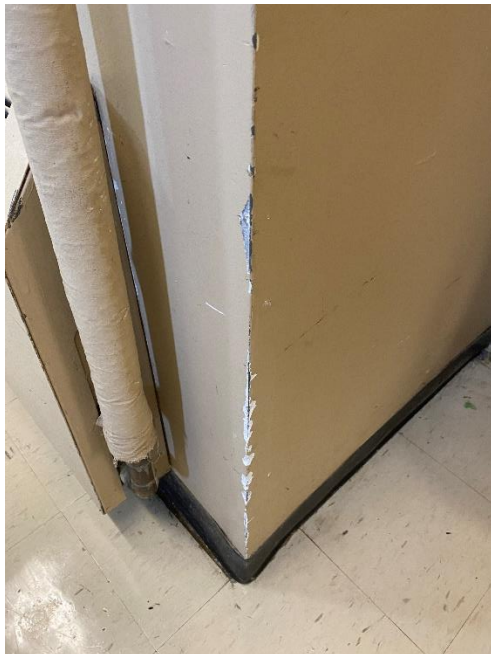
Photo 17: View of asbestos-containing plaster wall observed to be in fair condition in Room 012.

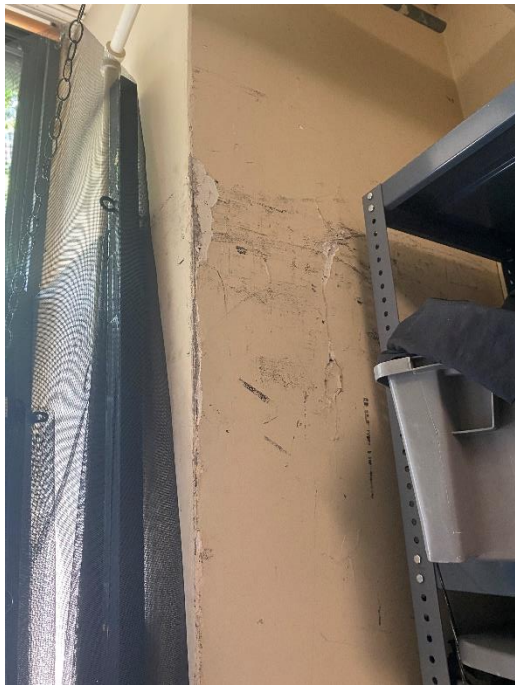
Photo 18: View of asbestos-containing plaster wall observed to be in fair condition in Room 012.

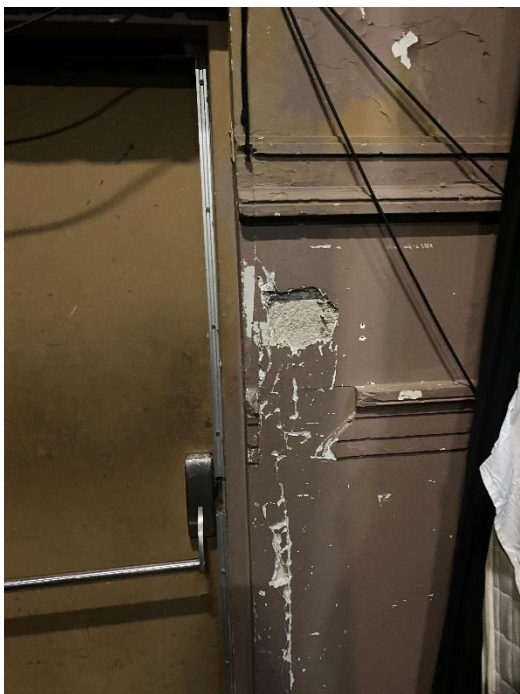
Photo 19: View of asbestos-containing plaster wall observed to be in poor condition in Room 112.

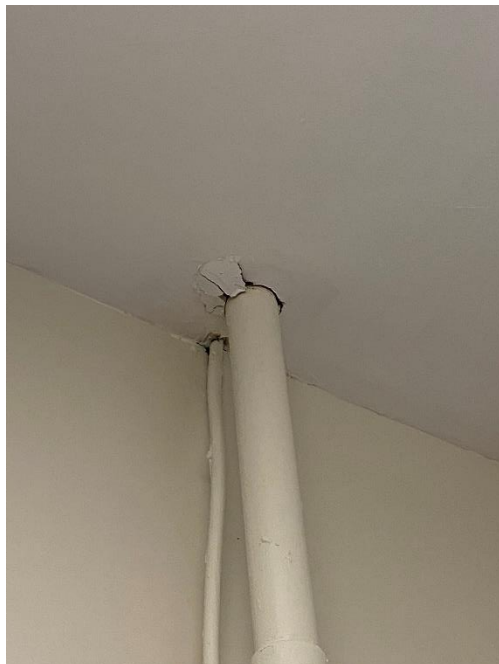
Photo 20: View of asbestos-containing plaster ceiling observed to be in fair condition in Room 129.
