HAZARDOUS MATERIALS SURVEY AND 2023 REASSESSMENT 109 OSGOODE, OTTAWA, ON

Project No.: 0Z2021101HZ / CCC-230252-00

University of Ottawa

McIntosh Perry Limited (MPL)

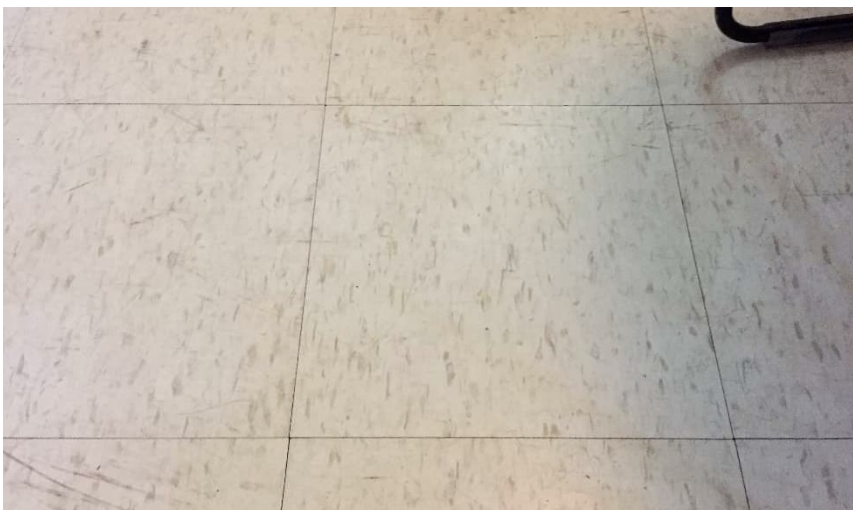
- Vinyl floor tiles (12" x 12" – White with Beige Flakes) were observed and sampled in Room 12. The laboratory analytical results of the samples collected indicate that this material does not contain asbestos. The associated mastic (Black) was also determined not to contain asbestos.
- Vinyl floor tiles (12" x 12" – Grey) were observed and sampled in Room 001. The laboratory analytical results indicate that this material does not contain asbestos.
- Vinyl floor tiles (12" x 12" – Beige) were observed and sampled in Room 002A. The laboratory analytical results of the samples collected indicate that this material does not contain asbestos.

Photo 2: View of the non-asbestos-containing vinyl floor tiles (12"x12" - White with Beige Flakes) observed in Room 12.

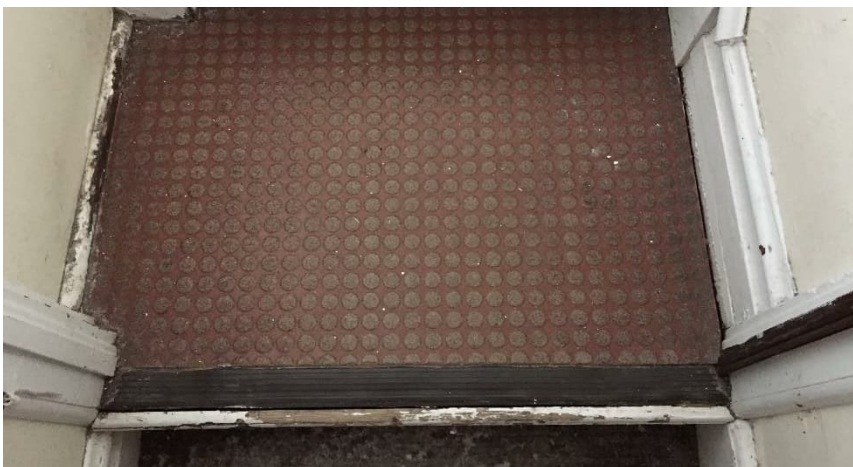
Photo 3: View of the non-asbestos-containing vinyl sheet flooring (Brown Pattern) observed in Room 1A.

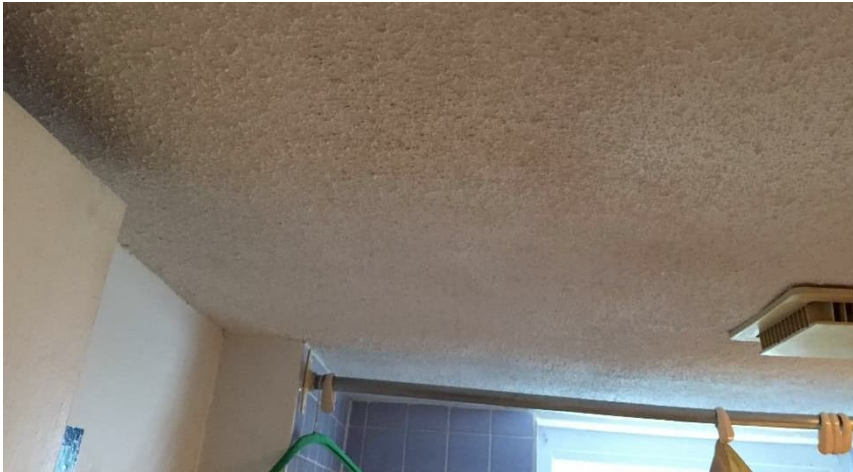
The ceiling texture coat (White) was observed and sampled in Rooms 06, 10, and 11. The laboratory analytical results indicate that this material does not contain asbestos. The associated drywall joint compound was also determined not to contain asbestos.

Photo 4: View of the non-asbestos-containing ceiling texture coat observed throughout the subject building.

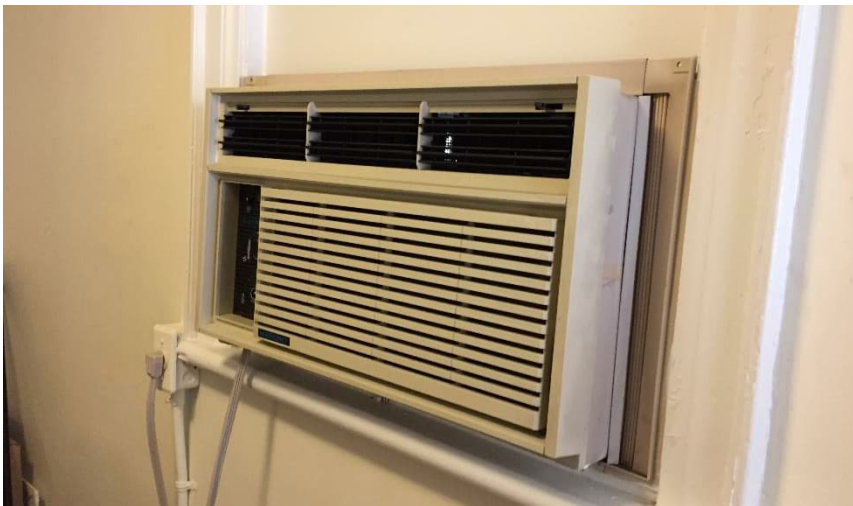
A visual assessment for equipment potentially containing ODSs and other halocarbons was conducted. Equipment containing ODSs or other halocarbons was observed throughout the subject building.

Photo 5: View of the ODS-containing equipment observed throughout the subject building.

Please refer to Appendix F – Hazardous Materials Checklist for equipment conditions, approximate quantities (where applicable), and recommended actions.

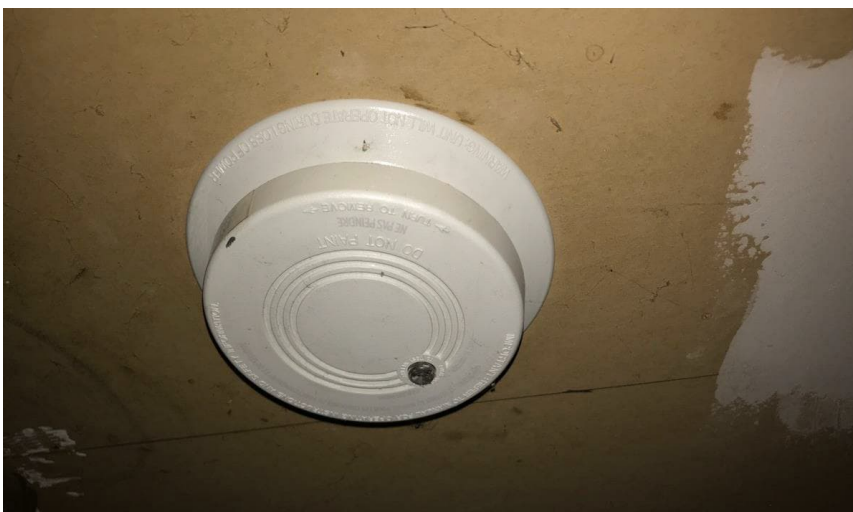
Kidde brand smoke detectors containing small quantities of radioactive material were observed throughout the subject building.

Photo 6: Representative view of the smoke detectors containing radioactive materials observed throughout the subject building.

The radioactive sources in smoke alarms are sealed and contained within a metal case inside the smoke detector and must not be damaged or tampered with. These materials do not pose a hazard as long as they remain contained and properly disposed of at the time of removal or replacement.

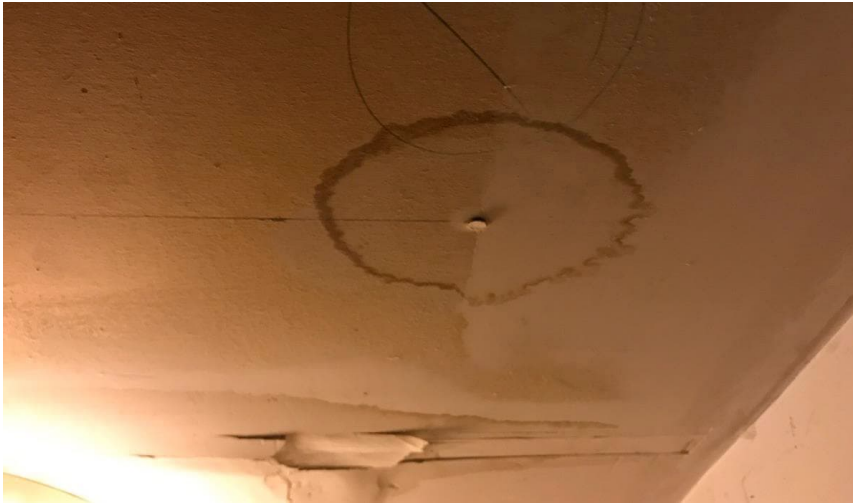
A visual survey of the subject building was conducted to determine if water damage was present. **Select areas with water damage during the 2022 Reassessment were observed.**

Photo 7: View of the water damaged drywall ceiling observed in Room 03.

Water-stained/damaged drywall observed throughout the subject building should be replaced as part of regular maintenance, and the water leakage's underlying cause should be identified and repaired.

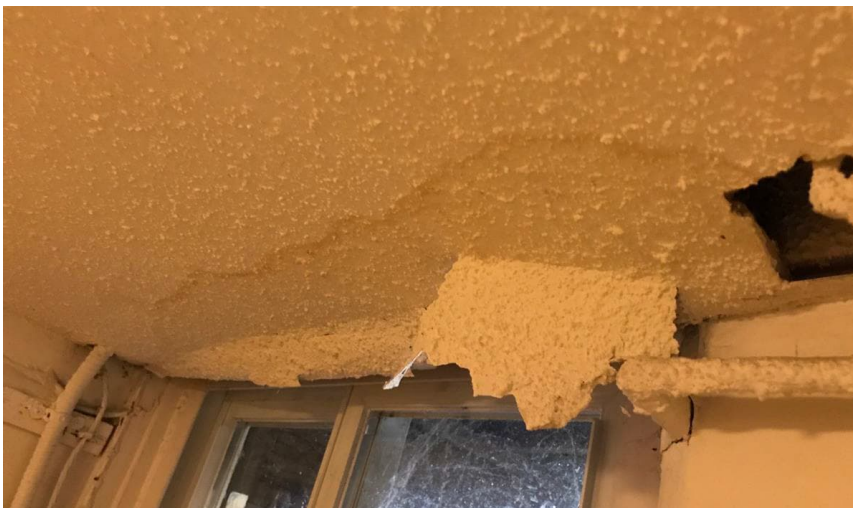
Photo 8: View of the water damaged ceiling observed in Room 06.
