# HAZARDOUS MATERIALS SURVEY AND 2023 REASSESSMENT 116 HENDERSON AVENUE, OTTAWA, ON

Project No.: Z2021102HZ/ CCC-230252-00

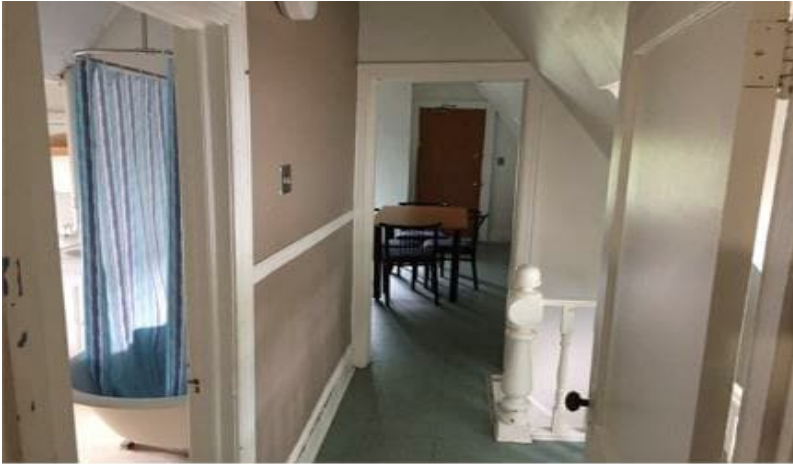
**Photo 1:** View of typical finishes observed at the building located at 116 Henderson Avenue.

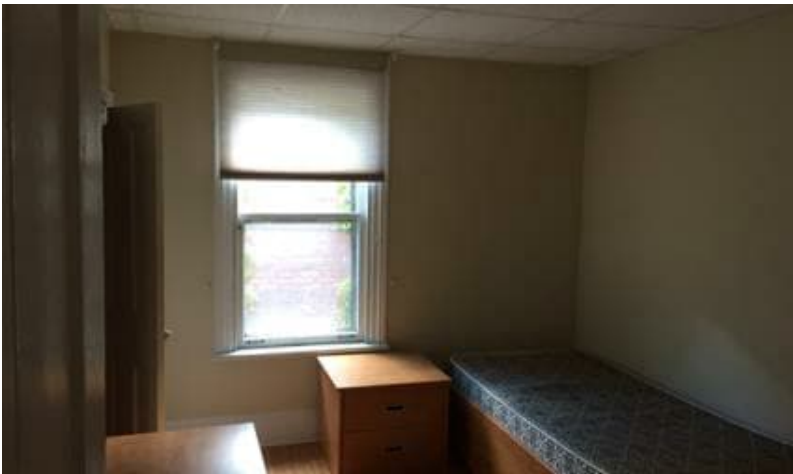
**Photo 2:** View of typical finishes observed at the building located at 116 Henderson Avenue.

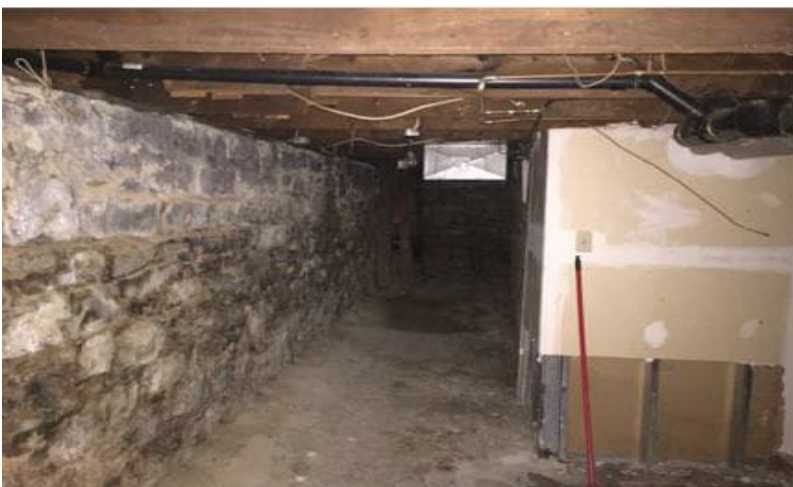
**Photo 3:** View of typical finishes observed at the building located at 116 Henderson Avenue.

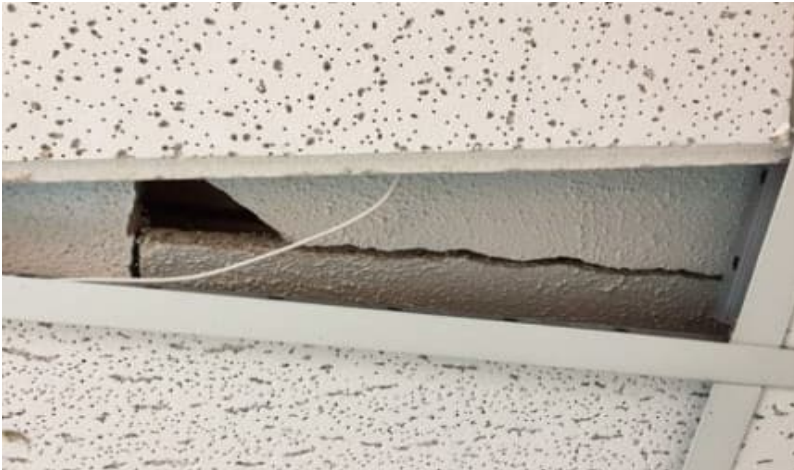
**Photo 4:** View of suspended ceiling tiles with a ceiling texture coat above, as observed in Room A on the second floor.

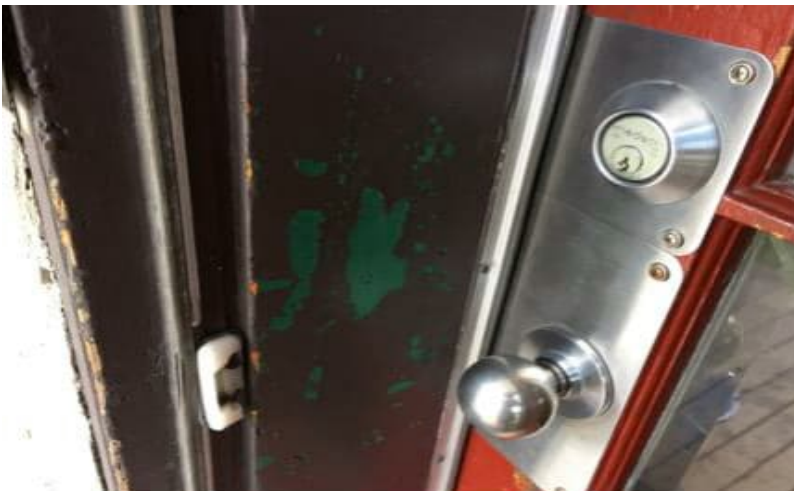
**Photo 5:** View of lead-containing dark grey paint observed to be in poor condition on the front door.

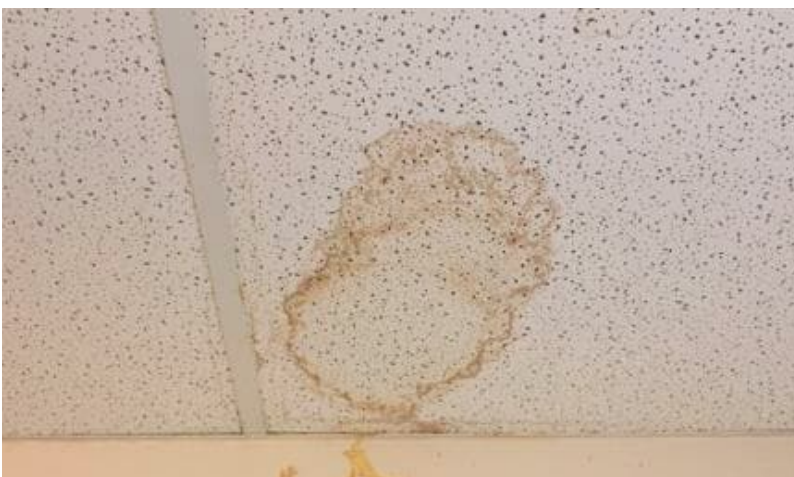
**Photo 6:** View of water damaged ceiling tile observed in the kitchen.

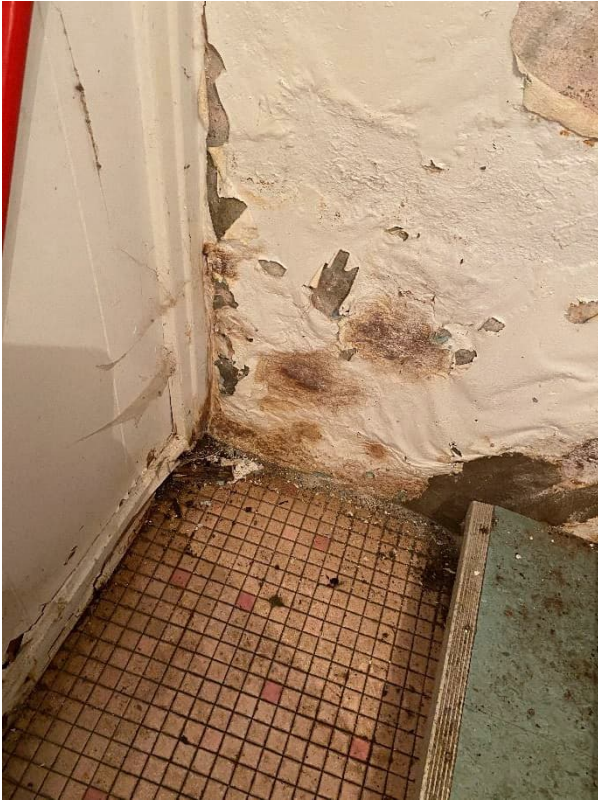
**Photo 7:** View of water damaged plaster wall observed in the basement.

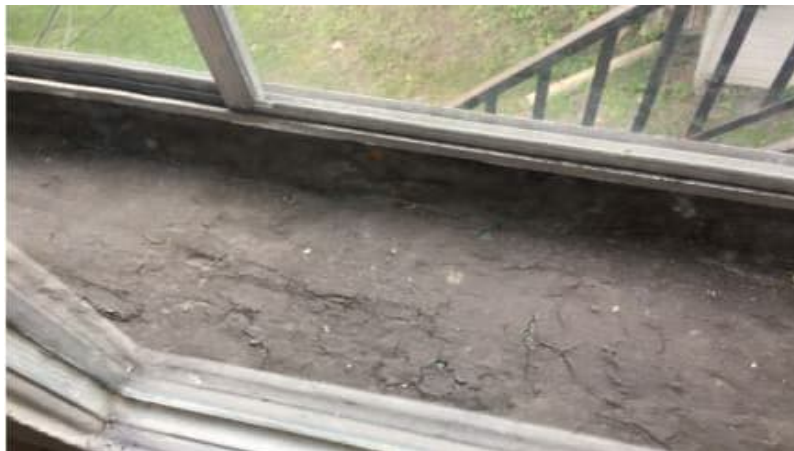
**Photo 8:** View of lead-containing brown paint observed to be in poor condition in the kitchen.

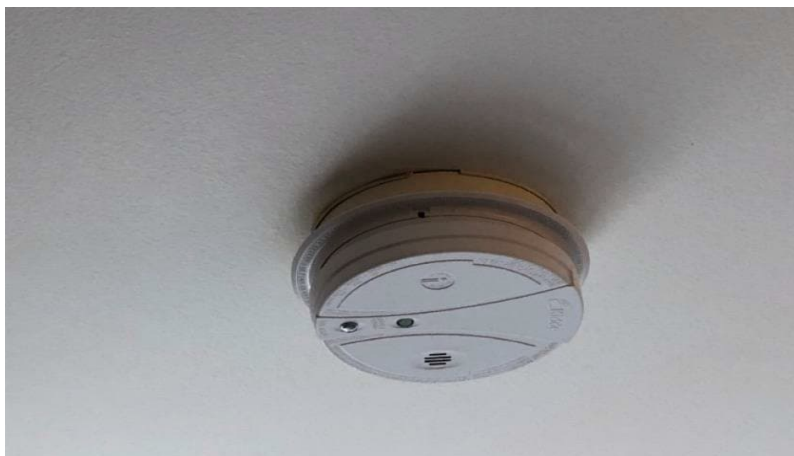
**Photo 9:** Typical view of smoke detectors containing radioactive materials.
