# HAZARDOUS MATERIALS SURVEY AND 2023 REASSESSMENT 120 HENDERSON AVENUE, OTTAWA, ON

Project No.: Z2021102HZ / CCC-230252-00

University of Ottawa

McIntosh Perry Limited (MPL)

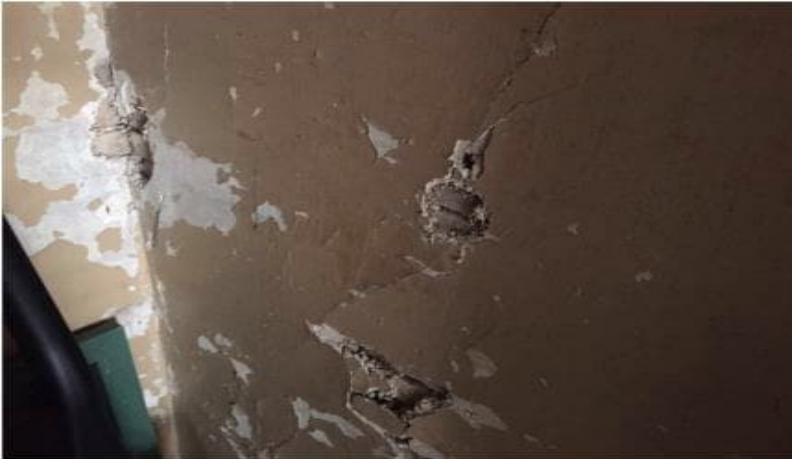
Previously identified ceiling/Wall plaster was observed throughout the subject building. The laboratory analytical results of plaster samples collected indicate that this material **contains 0.5% Chrysotile asbestos**. Since plaster is a homogeneous material, all areas must be treated as asbestos-containing unless additional bulk sampling and analysis until proven otherwise. This material is considered to be friable and was observed to be in good and poor condition.

**Photo 4:** View of asbestos-containing wall plaster observed to be in poor condition, at the top of the basement stairs.

- ACMs identified to be in poor condition must be repaired/removed immediately, following Type 1/2/3 asbestos abatement work procedures as detailed in O. Reg. 278/05 and disposed of as asbestos waste under O. Reg. 347;

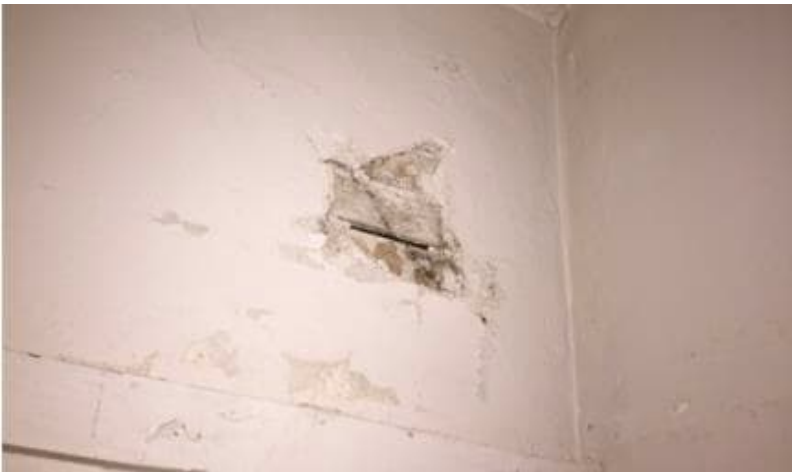
**Photo 5:** View of asbestos-containing wall plaster observed to be in poor condition in the closet across from the bathroom on the 2<sup>nd</sup> floor.

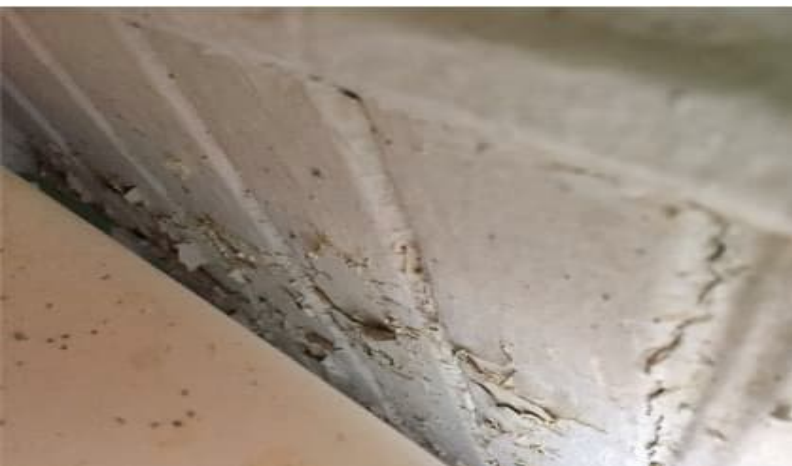
The paint finishes highlighted in pink in the above table are considered lead-containing paints or surface coatings with concentrations greater than 0.1% lead by weight. These paint finishes were observed to be in good condition, except for select areas, which were observed in poor condition.

**Photo 6:** View of lead-containing white paint observed to be in poor condition in the bathroom on the 2<sup>nd</sup> floor.

Paints identified to contain lead that is in poor condition must be immediately repaired and/or stabilized following a minimum Type 1/2 lead abatement procedures as per OMOL “Lead on Construction Project” dated April 2011.

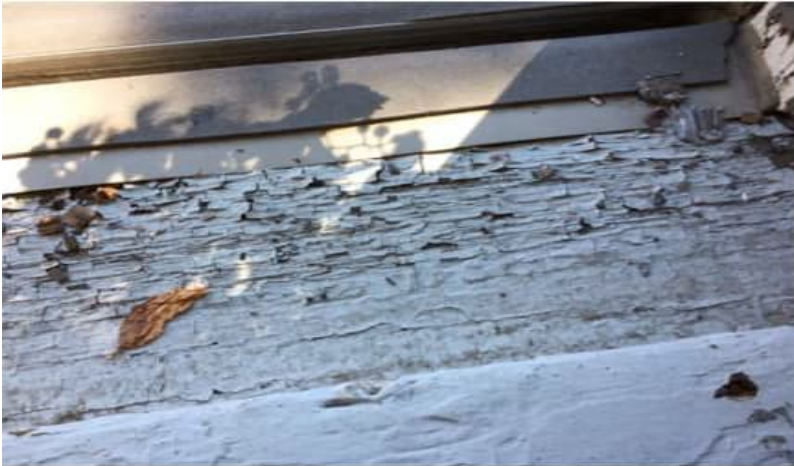
**Photo 7:** View of lead-containing white paint observed to be in poor condition in Room E on the 2<sup>nd</sup> floor.

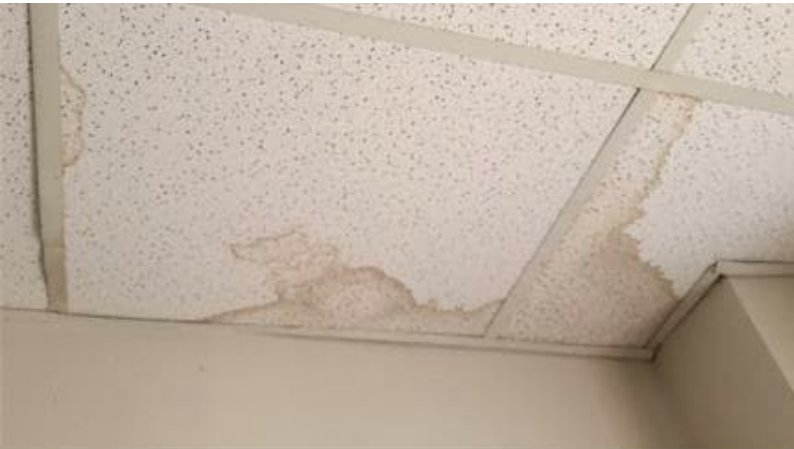
A visual survey of the subject building was conducted to determine if water damage was present. Select areas were identified throughout the subject building where materials were affected by water damage.

**Photo 8:** View of water-damaged suspended ceiling tiles observed in the 2<sup>nd</sup> floor hallway.

Water-stained/damaged ceiling tiles observed throughout the subject building should be replaced as part of regular maintenance, and the underlying cause of the water leakage should be identified and repaired;

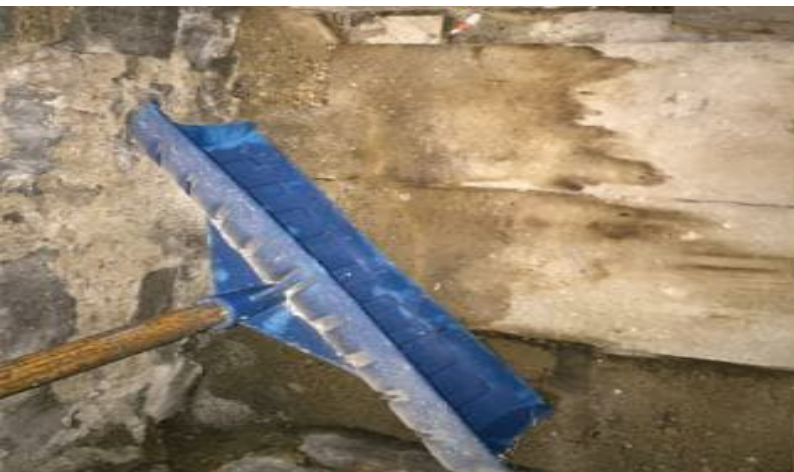
**Photo 9:** View of water-damaged wood stairs in the basement.

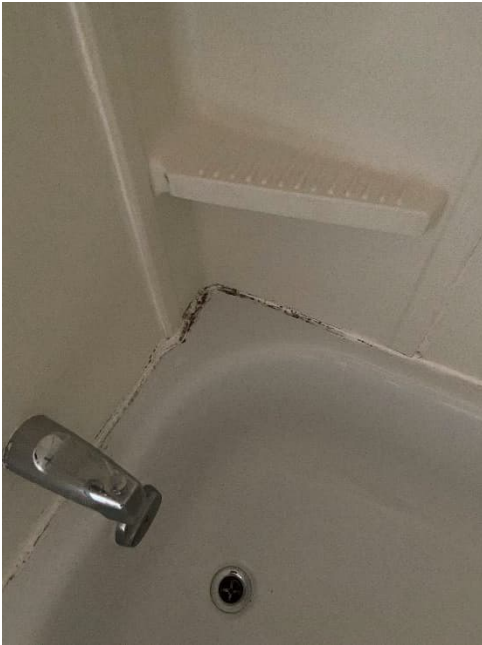
**Photo 10:** View of suspected mould growth in corner of bathtub in the second floor bathroom.

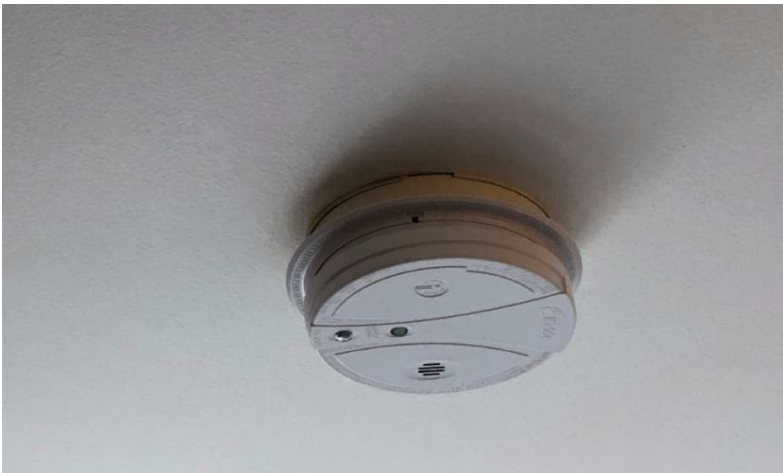
A visual assessment of the subject building was conducted to determine if any electrical components containing radioactive materials were present. Smoke detectors were observed throughout the subject building, which contained small quantities of radioactive material.

**Photo 11:** Typical view of smoke detectors containing radioactive materials.

The radioactive sources in smoke alarms are sealed and contained within a metal case inside the smoke detector and must not be damaged or tampered with. These materials do not pose a hazard as long as they remain contained and properly disposed of at the time of removal or replacement.
