HAZARDOUS MATERIALS SURVEY AND 2023 REASSESSMENT 122 HENDERSON AVENUE, OTTAWA, ON

Project No.: Z2021102HZ / CCC-230252-00

University of Ottawa

McIntosh Perry Limited (MPL)

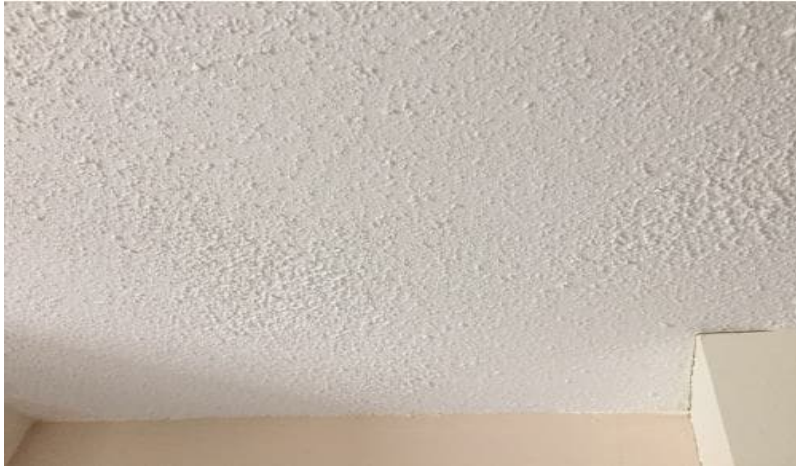
A ceiling texture coat was observed throughout the subject building. The laboratory analytical results of texture coat samples collected indicate that this material does not contain asbestos.

Photo 4: View of non-asbestos-containing ceiling texture coat observed in the 2nd-floor bathroom.

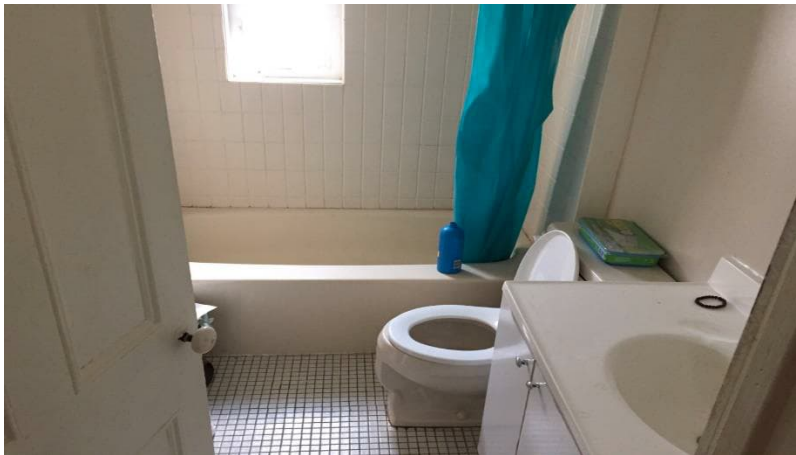
No bulk samples of the ceramic wall/floor tile grout were collected to avoid damage and compromise the structure's integrity. Prior to any renovation or demolition, ceramic wall/floor tile grout should be examined and tested for asbestos content. Ceramic wall/floor tile grout should therefore be considered to contain asbestos until bulk samples and analysis until proven otherwise.

Photo 5: Typical view of ceramic wall/floor tile grout suspected of containing asbestos.

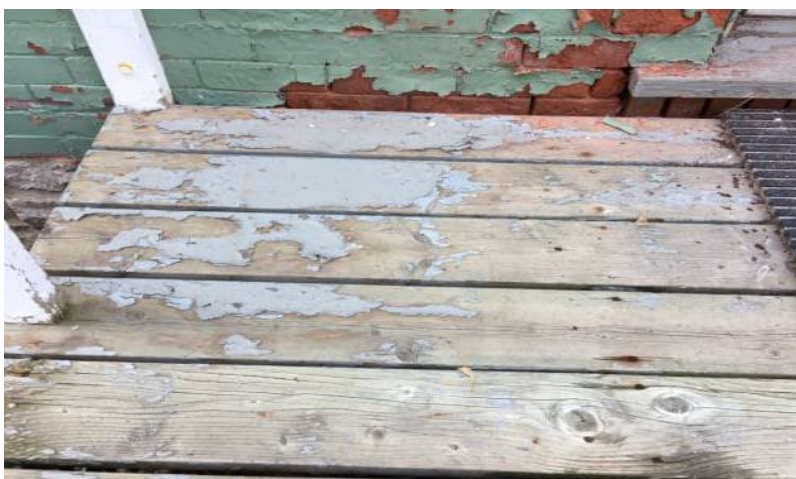
The paint finishes highlighted in pink in the above table are considered lead-containing paints or surface coatings with concentrations greater than 0.1% lead by weight. These paint finishes were in good condition except for the porch, which was observed to be in poor condition.

Photo 6: View of lead-containing grey and green paint observed to be in poor condition on the front deck.

Paints identified to contain lead that is in poor condition must be immediately repaired and/or stabilized following a minimum Type 1/2 lead abatement procedures as per OMOL “Lead on Construction Project” dated April 2011.

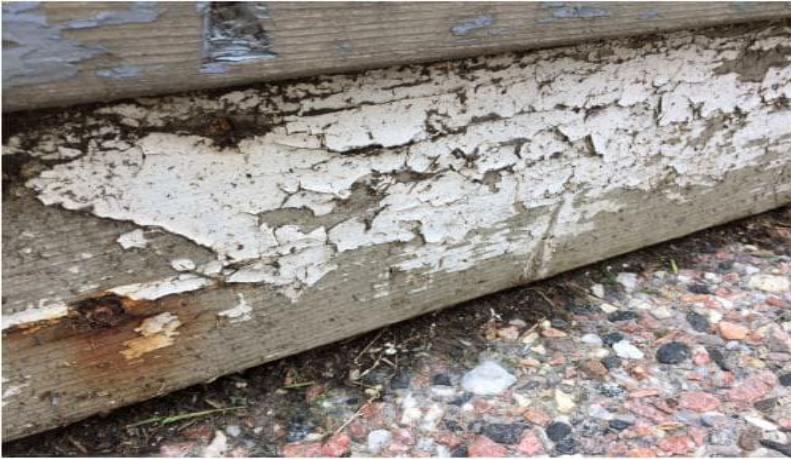
Photo 7: View of lead-containing white paint observed to be in poor condition on the front deck.

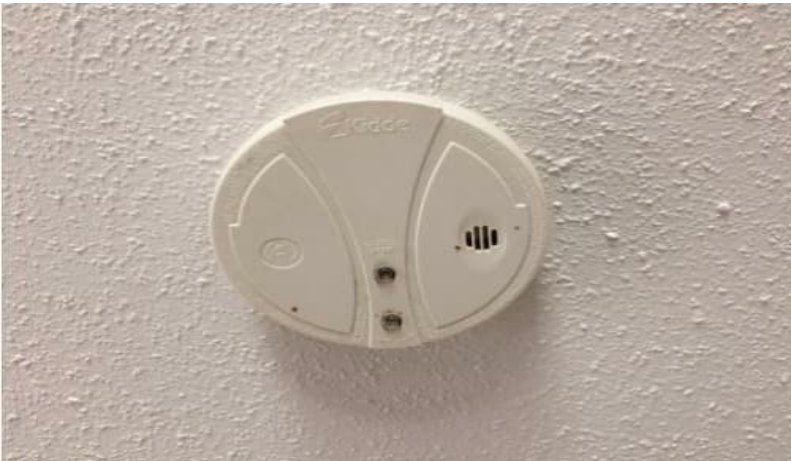
A visual assessment of the subject building was conducted to determine if any electrical components containing radioactive materials were present. Smoke detectors were observed throughout the subject building, which contained small quantities of radioactive material.

Photo 8: Typical view of smoke detectors containing radioactive materials.

The radioactive sources in smoke alarms are sealed and contained within a metal case inside the smoke detector and must not be damaged or tampered with. These materials do not pose a hazard as long as they remain contained and properly disposed of at the time of removal or replacement.
