HAZARDOUS MATERIALS SURVEY AND 2023 REASSESSMENT 128 HENDERSON AVENUE, OTTAWA, ON

Project No.: Z2021102HZ / CCC-230252-00

University of Ottawa

McIntosh Perry Limited (MPL)

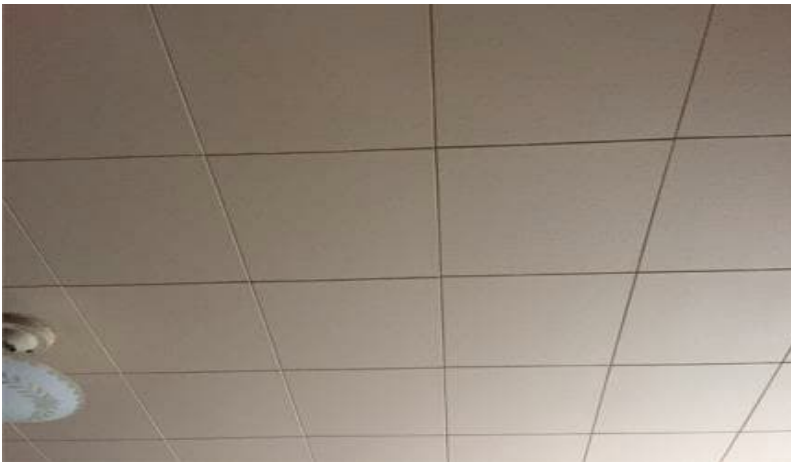
Photo 5: View of non-asbestos-containing acoustic ceiling tiles (1'x1') observed in Room D on the 1st floor.

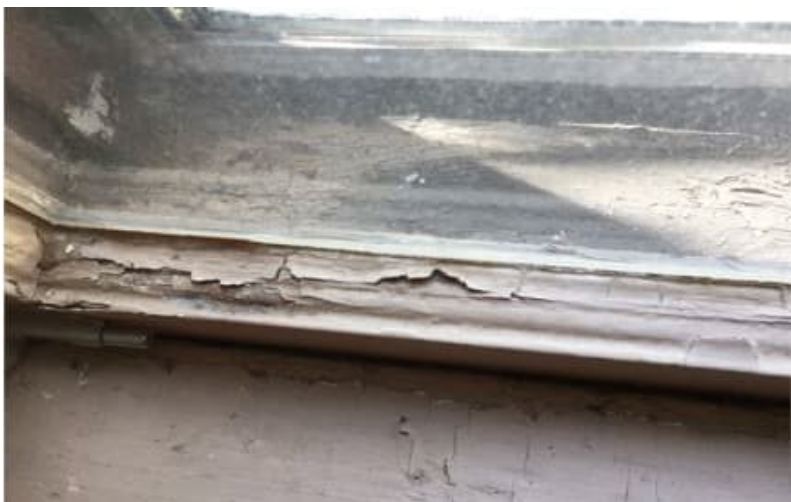
The paint finishes highlighted in pink in the above table are considered lead-containing paints or surface coatings with concentrations greater than 0.1% lead by weight. These paint finishes were observed to be in good condition except for select areas, which were observed in poor condition.

Photo 6: View of lead-containing beige paint observed to be in poor condition in Room C on the 2nd floor.

Paints identified to contain lead that are in good condition and do not pose a risk to workers or occupants can be managed in place.

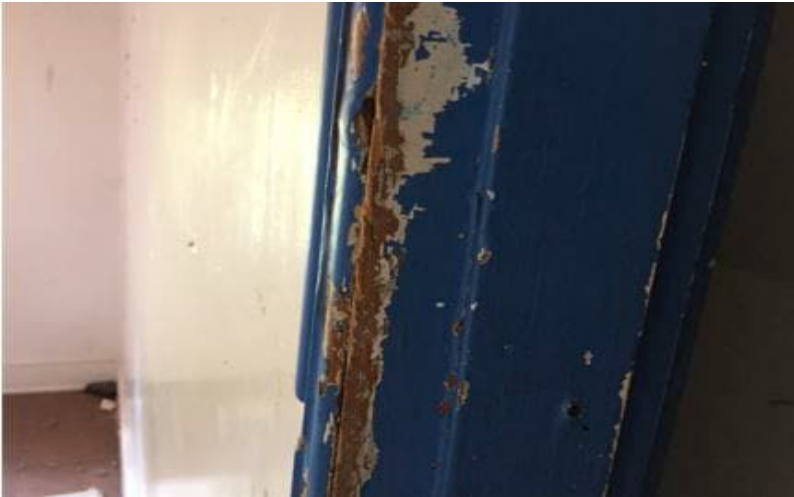
Photo 7: View of lead-containing blue paint observed to be in poor condition on the 3rd floor.

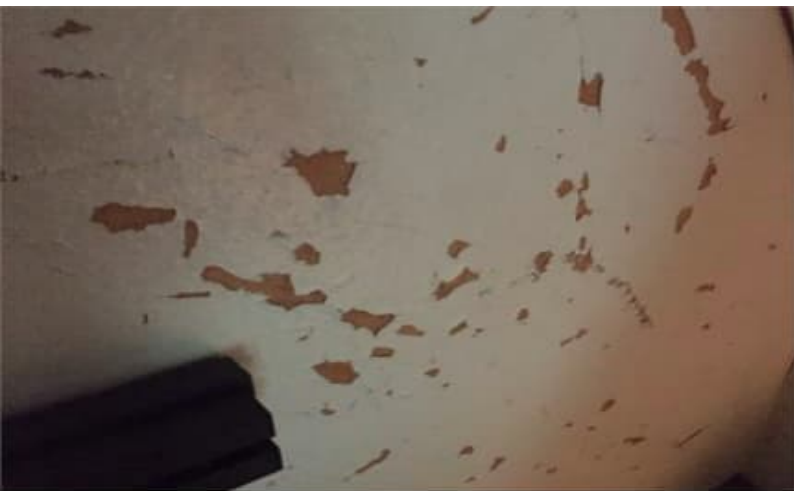
Photo 8: View of lead-containing white paint observed to be in poor condition on the wall near the stairs to the 3rd floor.

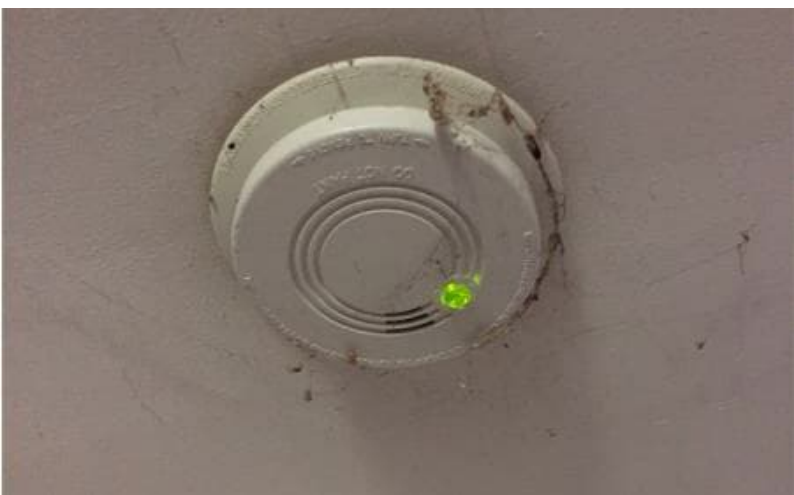
A visual assessment of the subject building was conducted to determine if any electrical components containing radioactive materials were present. Smoke detectors were observed throughout the subject building, which contained small quantities of radioactive material.

Photo 9: Typical view of smoke detectors containing radioactive materials.

The radioactive sources in smoke alarms are sealed and contained within a metal case inside the smoke detector and must not be damaged or tampered with. These materials do not pose a hazard as long as they remain contained and properly disposed of at the time of removal or replacement.

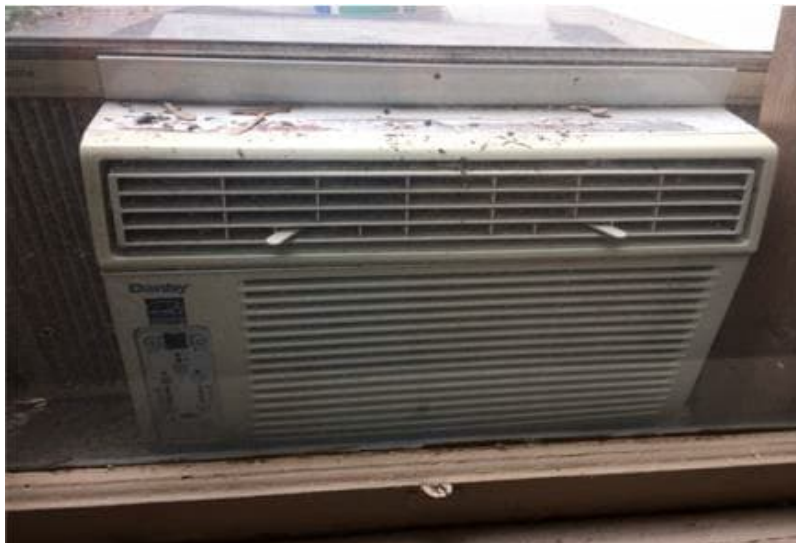
A visual assessment for equipment potentially containing ODSs and other halocarbons was conducted. MPL observed equipment such as refrigerators and air conditioners which contain or are suspected of containing ODSs or other halocarbons.

Photo 10: View of suspected ODS containing air-conditioning unit in Room D on the 1st floor.

Please refer to Appendix F – Hazardous Materials Checklist for equipment conditions, approximate quantities (where applicable), and recommended actions.
