# HAZARDOUS MATERIALS SURVEY AND 2023 REASSESSMENT 132 HENDERSON AVENUE, OTTAWA, ON

Project No.: Z2021102HZ / CCC-230252-00

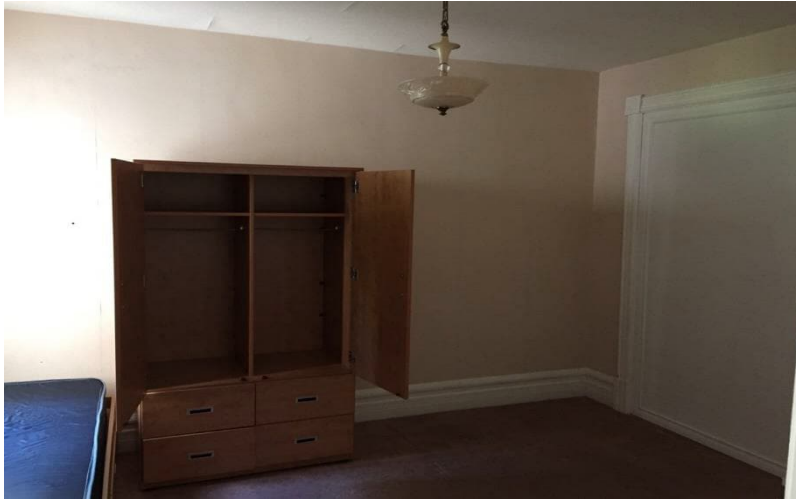
**Photo 1:** View of typical finishes observed at 132 Henderson Avenue.

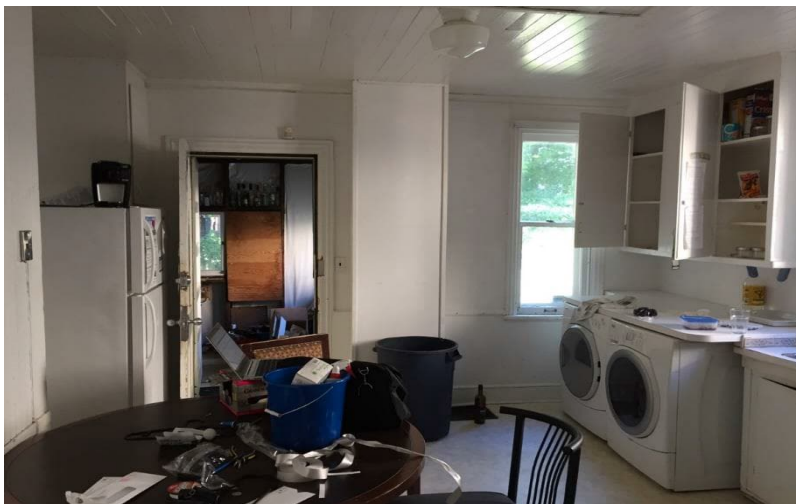
**Photo 2:** View of typical finishes observed at 132 Henderson Avenue.

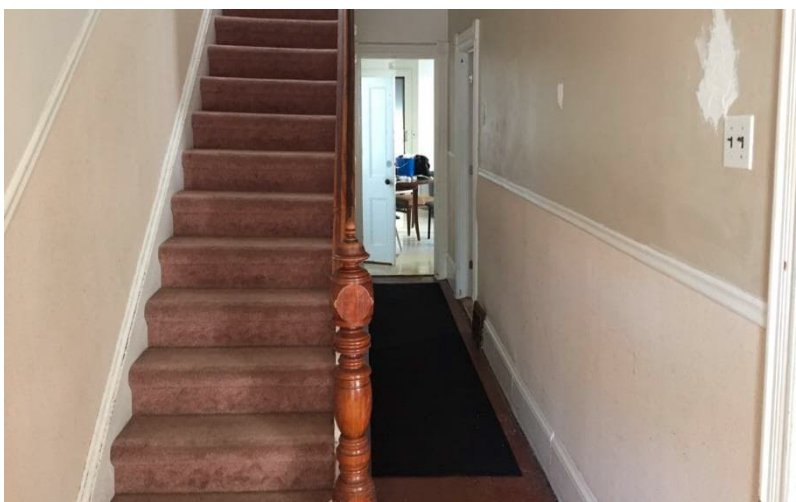
**Photo 3:** View of typical finishes observed at 132 Henderson Avenue.

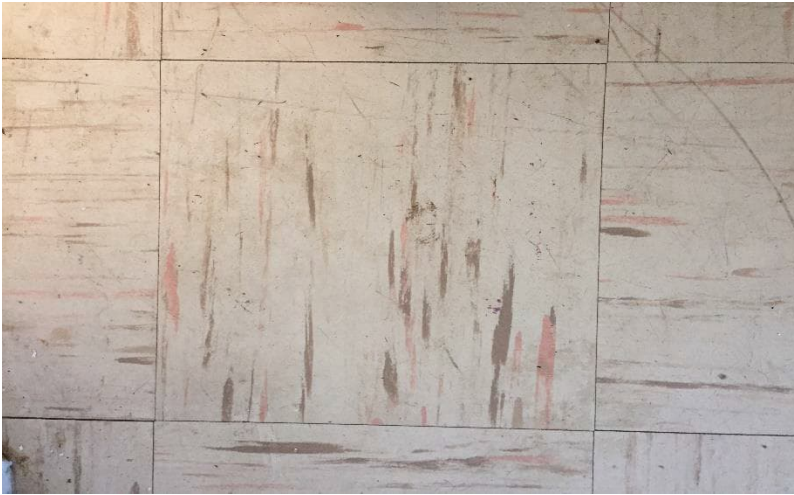
**Photo 4:** View of asbestos-containing vinyl floor tiles (9"x9"- Beige with Pink and Brown Streaks) observed in Room B on the 2<sup>nd</sup> Floor.

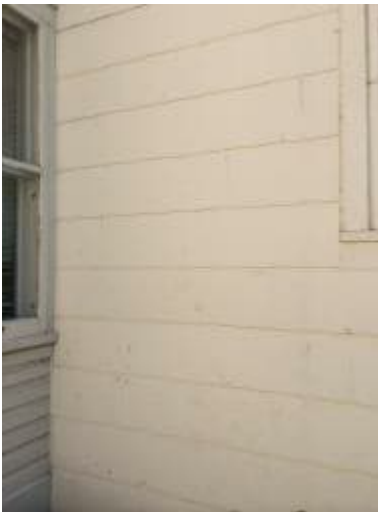
**Photo 5:** View of asbestos-containing transite siding observed on the exterior of the rear addition.

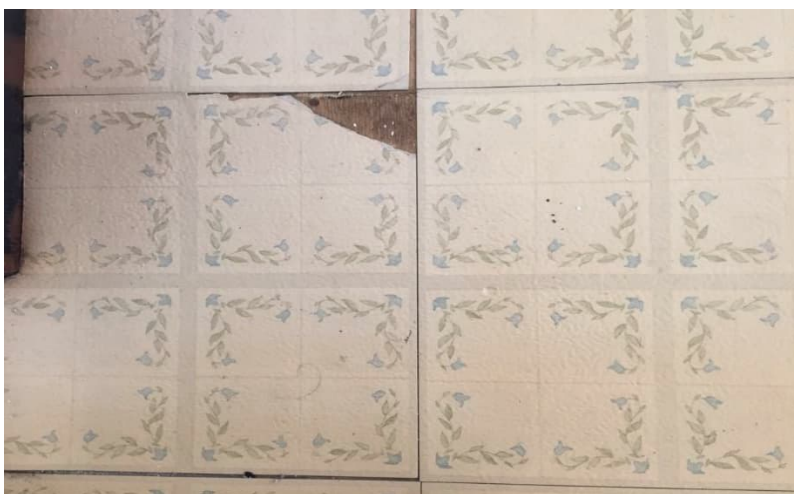
**Photo 6:** View of non-asbestos-containing vinyl floor tiles (12"x12"-Beige with Green/Blue Flowers) observed in Room D on the 2<sup>nd</sup> Floor.

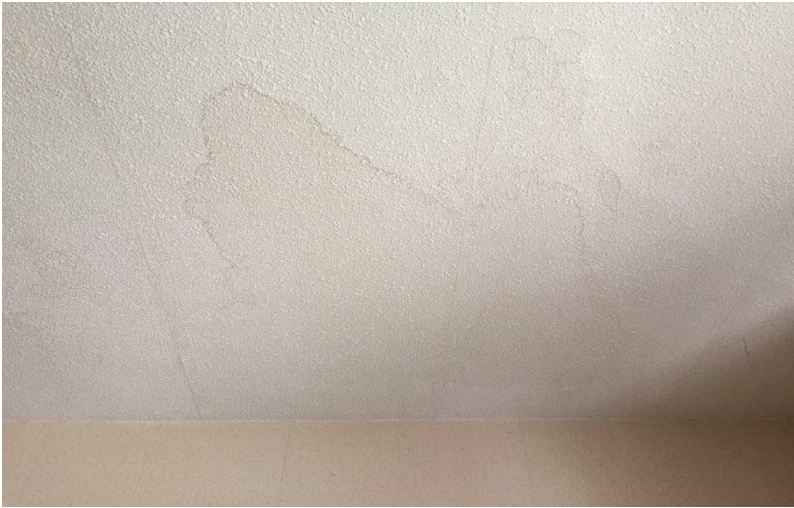
**Photo 7:** View of water-damaged texture coat observed in Room B on the 1<sup>st</sup> Floor.

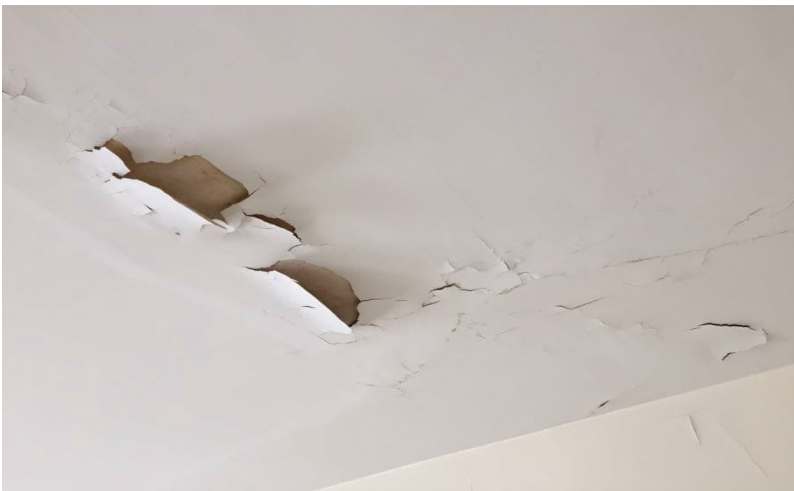
**Photo 8:** View of lead-containing white paint observed to be in poor condition in Room D on the 2<sup>nd</sup> floor.

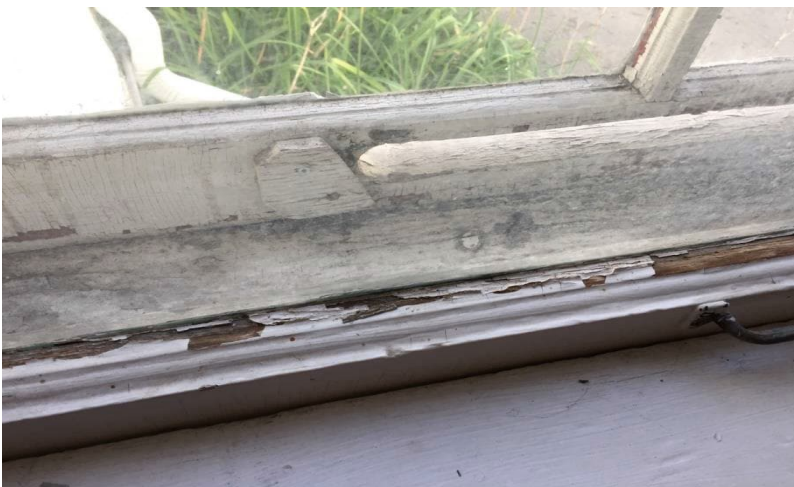
**Photo 9:** View of lead-containing white paint observed to be in poor condition in the kitchen on the 1<sup>st</sup> floor.

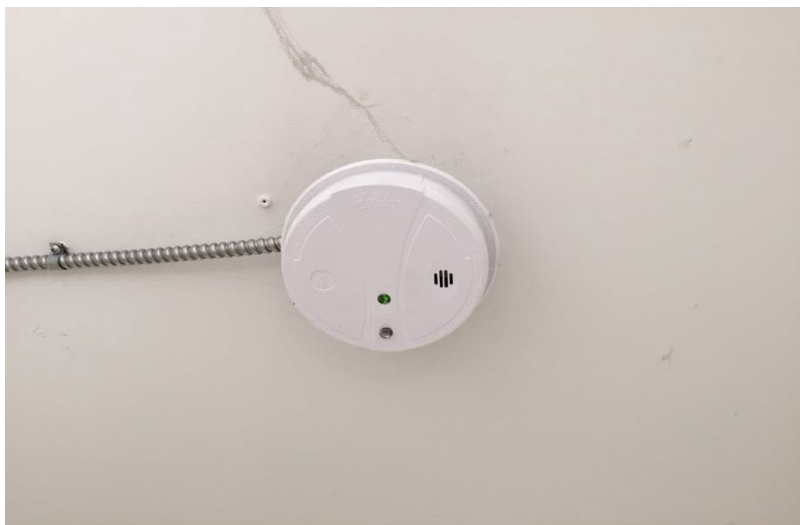
**Photo 10:** Typical view of smoke detectors containing radioactive materials.
