# HAZARDOUS MATERIALS SURVEY AND 2023 REASSESSMENT 134 HENDERSON AVENUE, OTTAWA, ON

Project No.: Z2021102HZ / CCC-230252-00

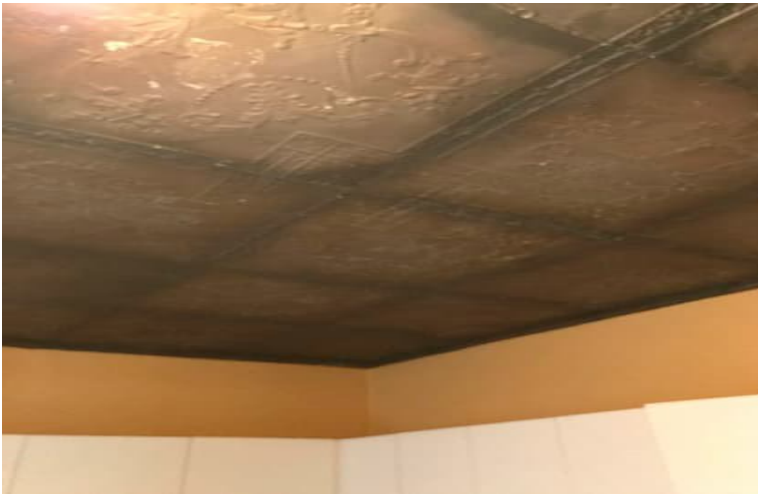
**Photo 1:** View of finishes observed in the kitchen at 134 Henderson Avenue.

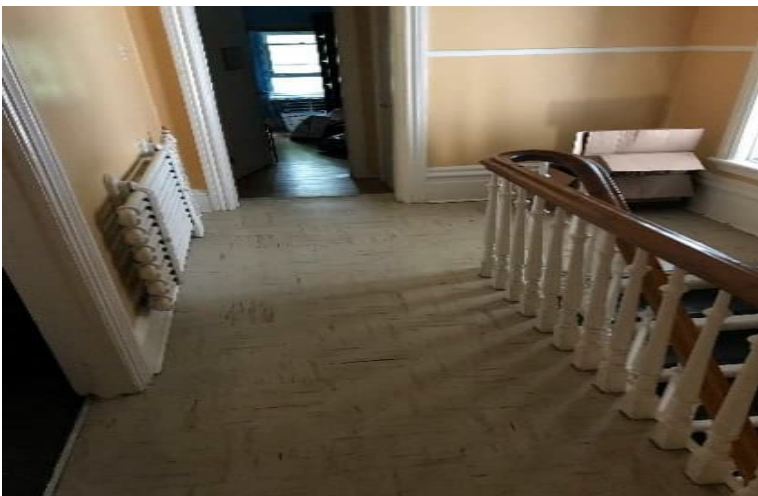
**Photo 2:** View of asbestos-containing vinyl floor tile observed in the 1<sup>st</sup> floor landing.

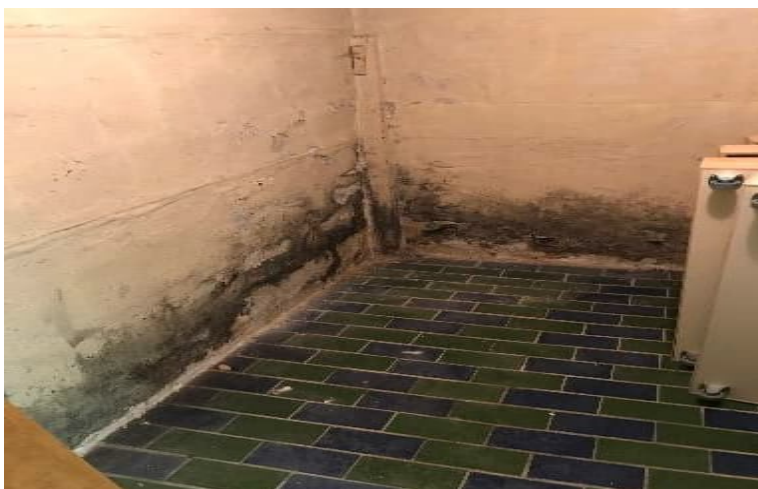
**Photo 3:** View of suspect mould growth observed on concrete walls in the basement of the subject building.
