# HAZARDOUS MATERIALS SURVEY AND 2023 REASSESSMENT 15-17 STEWART STREET, OTTAWA, ON

Project No.: Z2021101HZ / CCC-230252-00

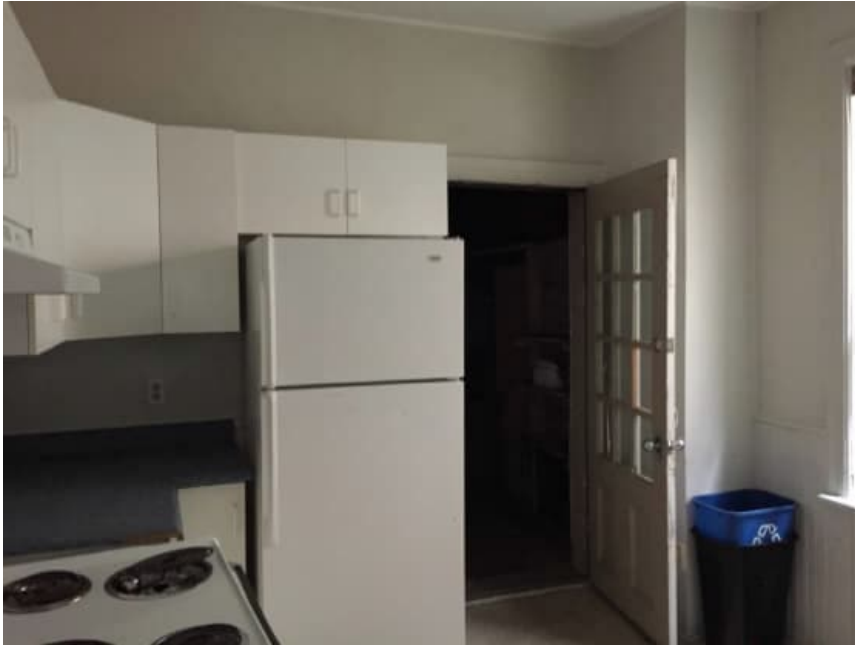
Photo 1: Representative view of the interior finishes observed at 17 Stewart Street.

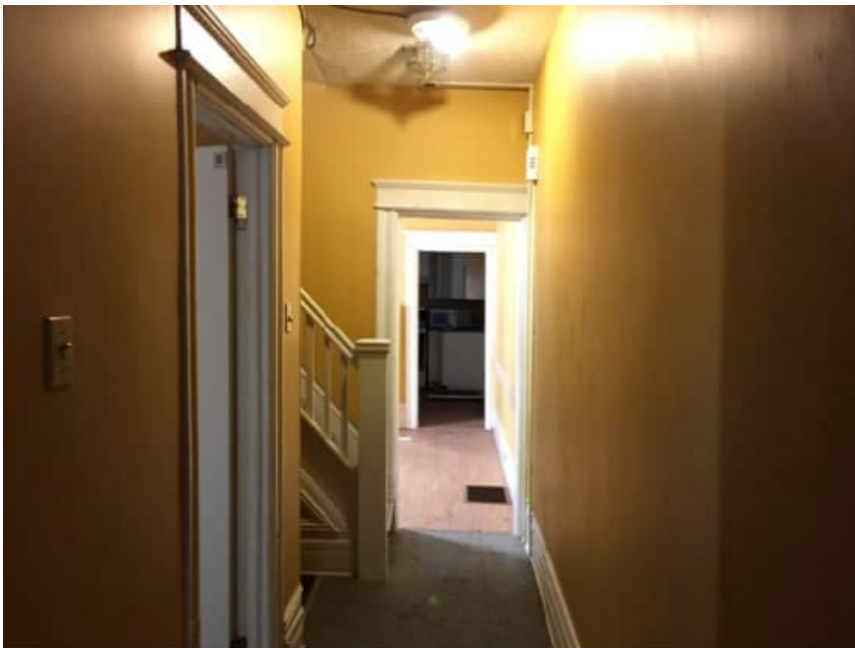
Photo 2: Representative view of the interior finishes observed at 15 Stewart Street.

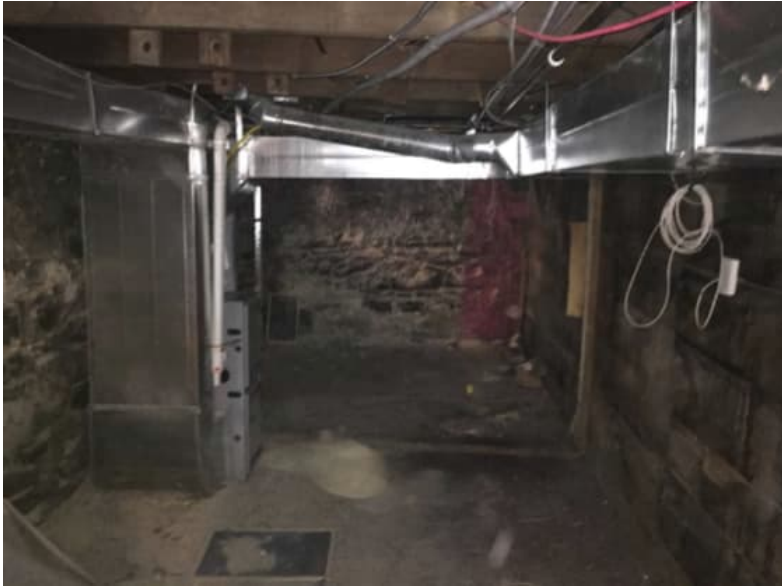
Photo 3: Representative view of the basement finishes observed at 15 Stewart Street.

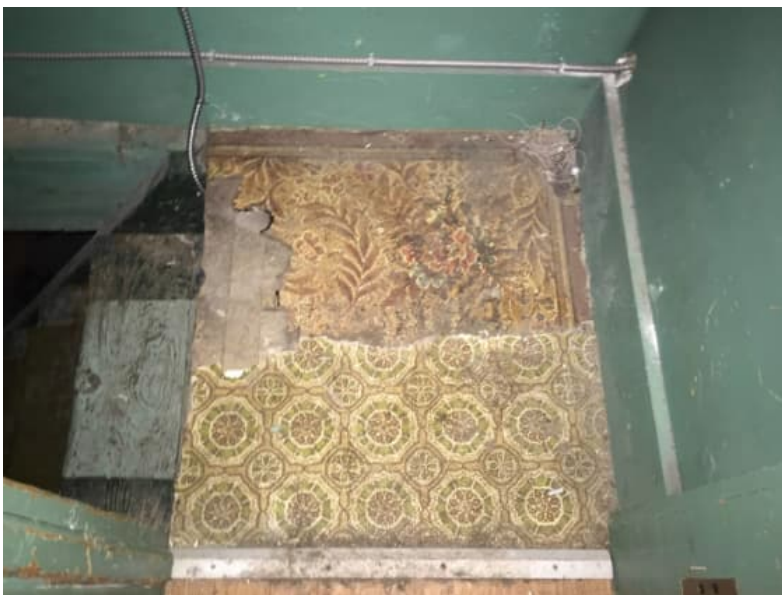
Photo 4: View of the poor condition asbestos-containing VSF observed in the basement stairway of 17 Stewart Street.

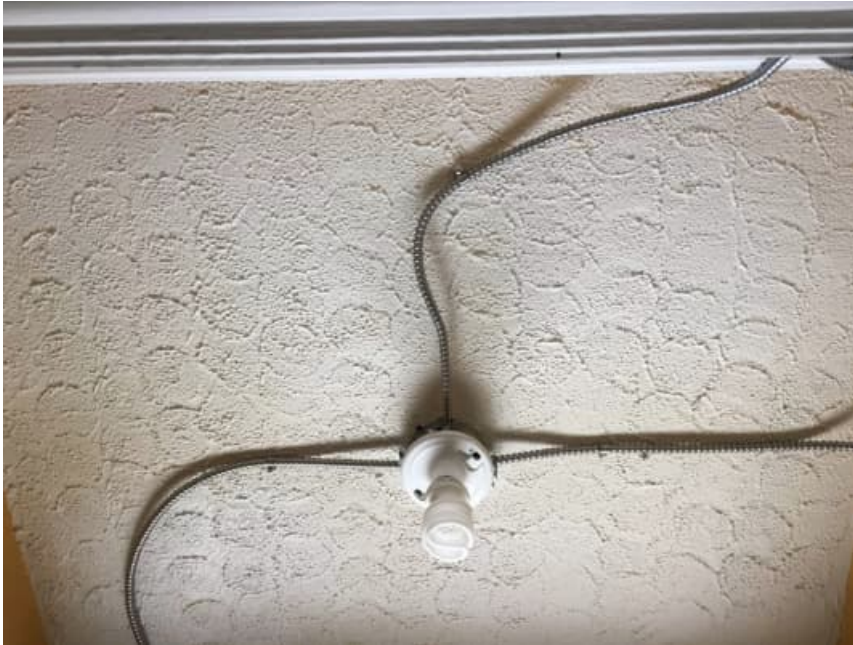
Photo 5: View of the asbestos-containing texture coat observed on the main floor of 15 Stewart Street.

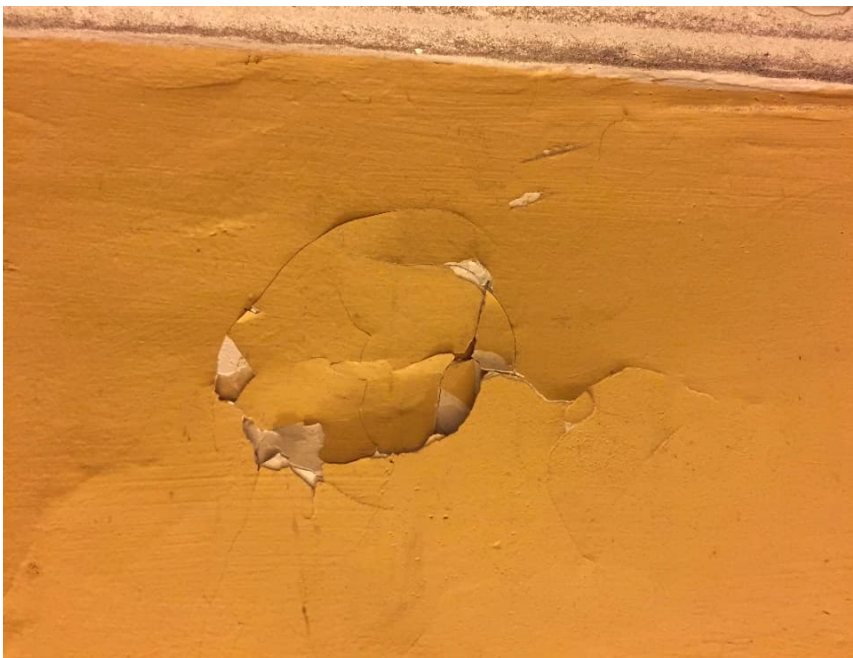
Photo 6: View of the poor condition asbestos-containing plaster and lead paint observed in Room 100A of 15 Stewart Street.

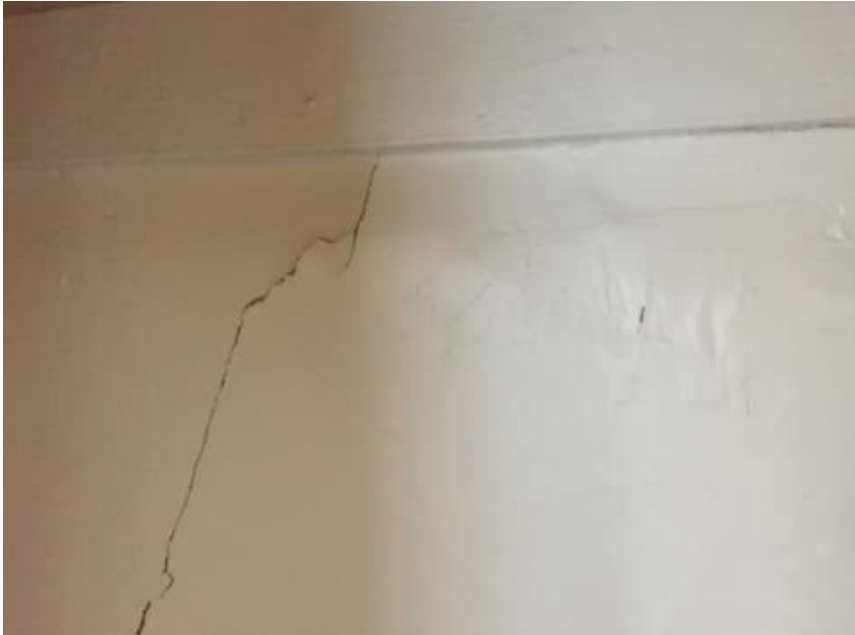
Photo 7: View of asbestos-containing plaster observed in poor condition in Room 209A of 15 Stewart Street.

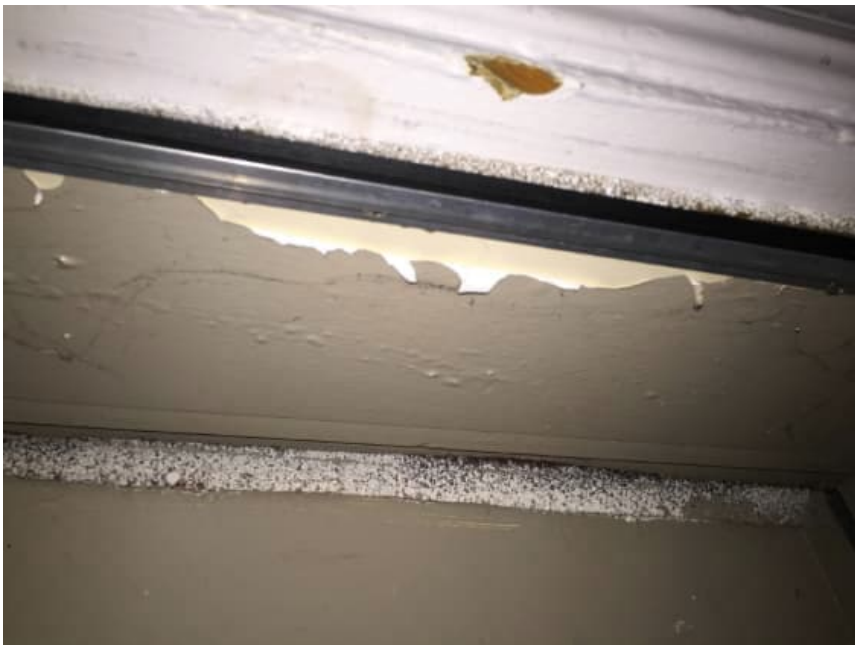
Photo 8: View of the poor condition lead-containing door frame paint observed in Room 108/112 of 17 Stewart Street.
