HAZARDOUS MATERIALS SURVEY AND 2023 REASSESSMENT 161 LAURIER AVE EAST, OTTAWA, ON

Project No.: CCC-221347-00 / CCC-230252-00

University of Ottawa

McIntosh Perry Limited (MPL)

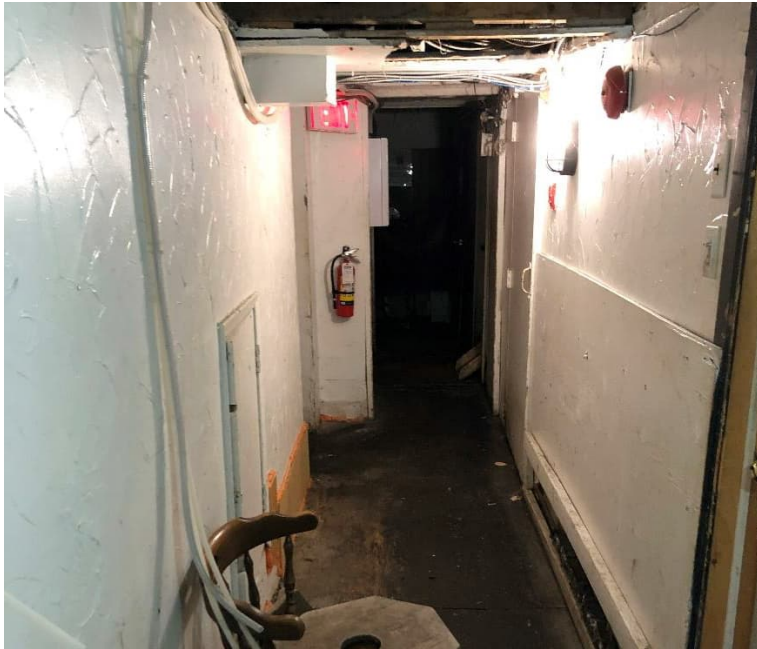
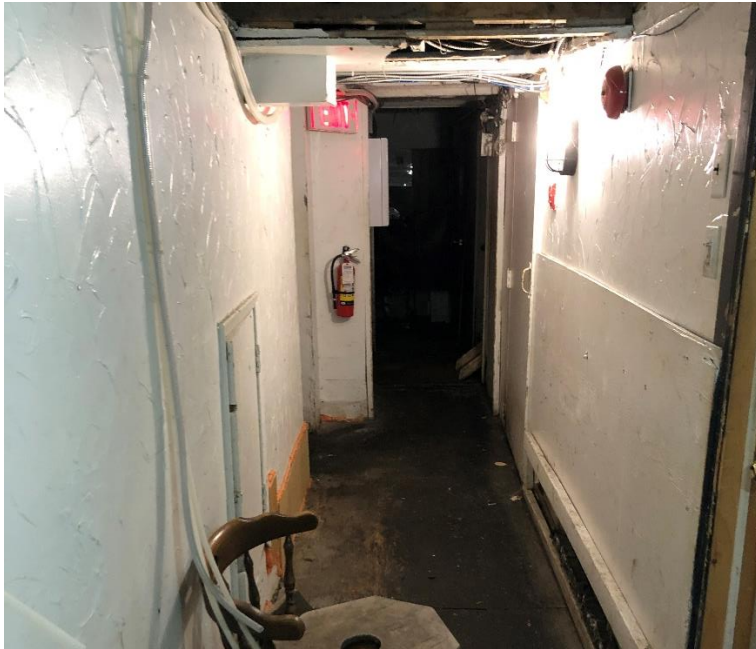
Drywall joint compounds were observed throughout the basement. The laboratory analytical results of drywall joint compound samples collected from the basement indicate that this material **contains 3% Chrysotile asbestos**. Since drywall joint compound is a homogeneous material, all areas must be treated as asbestos-containing unless additional bulk sampling and analysis until proven otherwise. This material was observed to be in good condition.

Photo 1: View of asbestos-containing drywall joint compound observed in the basement hallway

- Materials identified to contain asbestos that are in good condition and do not pose a risk to workers or occupants can be managed in place. Prior to any renovation or demolition activities that may disturb the ACMs, these materials must be removed following appropriate Type 1/2/3 asbestos abatement work procedures as detailed in O. Reg. 278/05 and disposed of as asbestos waste under O. Reg. 347;

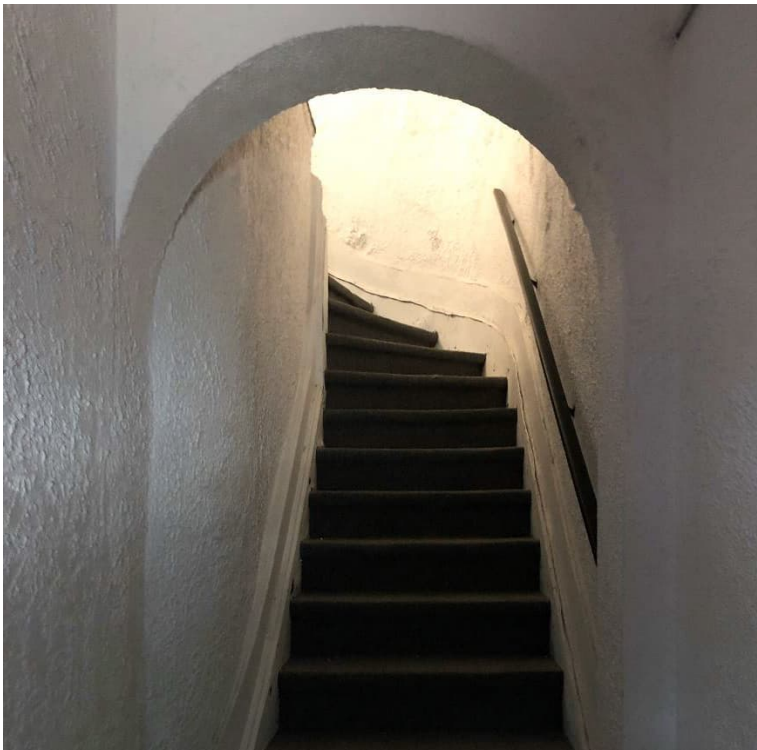
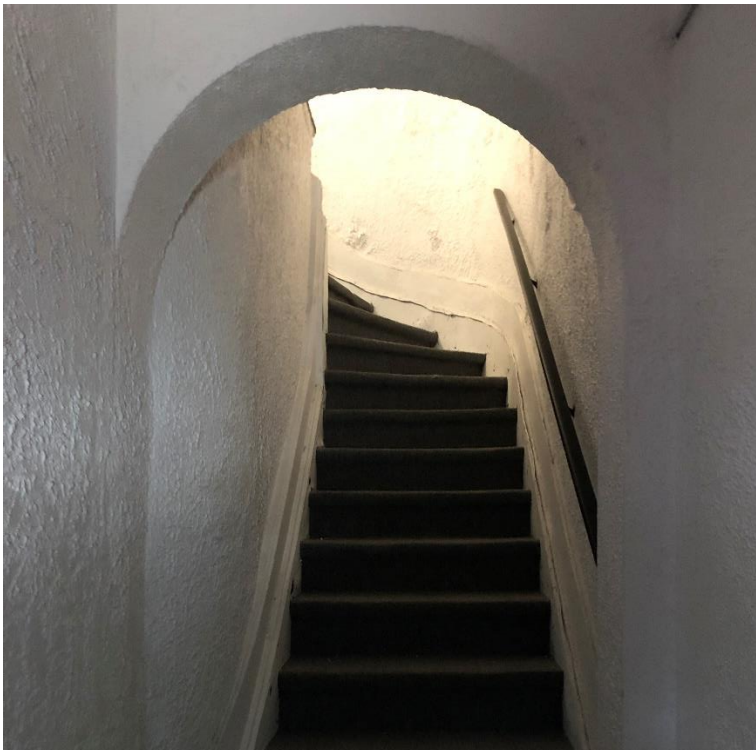
The ceiling/Wall texture finish was observed in Apartment Stairway. The laboratory analytical results of ceiling/wall texture coat samples collected from the Apartment Stairway indicate that this material **contains 5% Chrysotile asbestos**. This material is considered to be friable and was observed to be in good and fair condition.

Photo 2: View of asbestos-containing texture coat observed in the apartment stairway

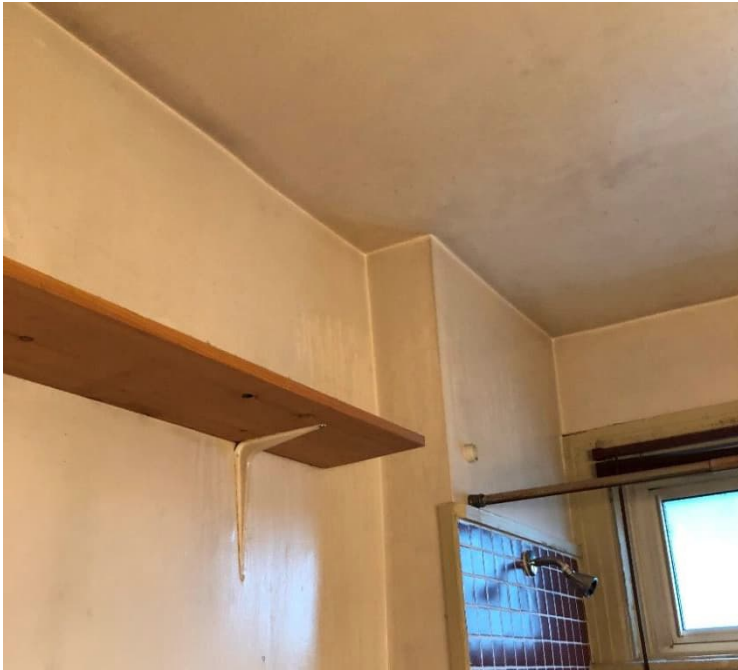
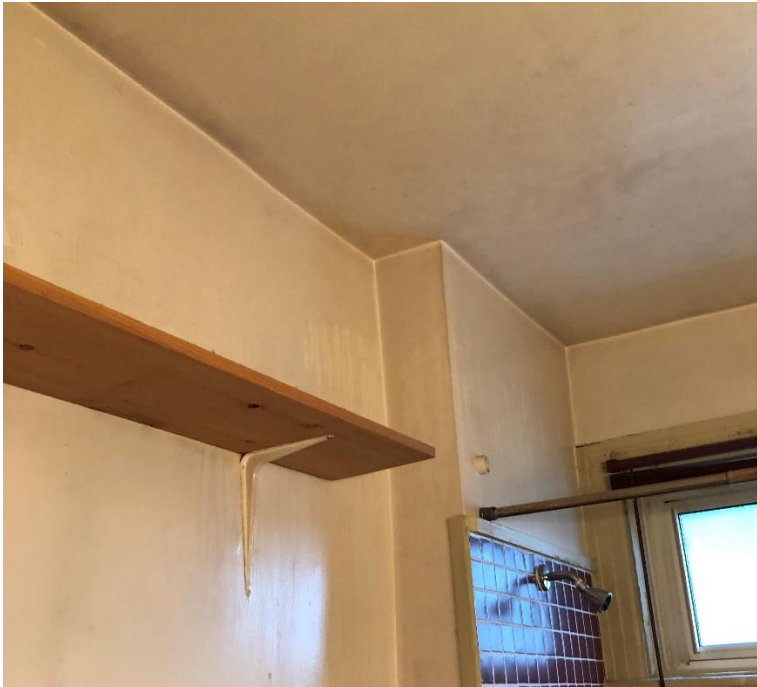
The paint finishes highlighted in pink in the above table are considered lead-containing paints or surface coatings with concentrations greater than 0.1% lead by weight. These paint finishes were observed to be in good condition, except for select areas that were observed in poor condition.

Photo 3: View of lead-containing white wall paint observed in the apartments

Photo 3: View of lead containing white wall paint observed in the apartments

Paints identified to contain lead that are in good condition and do not pose a risk to workers or occupants can be managed in place.

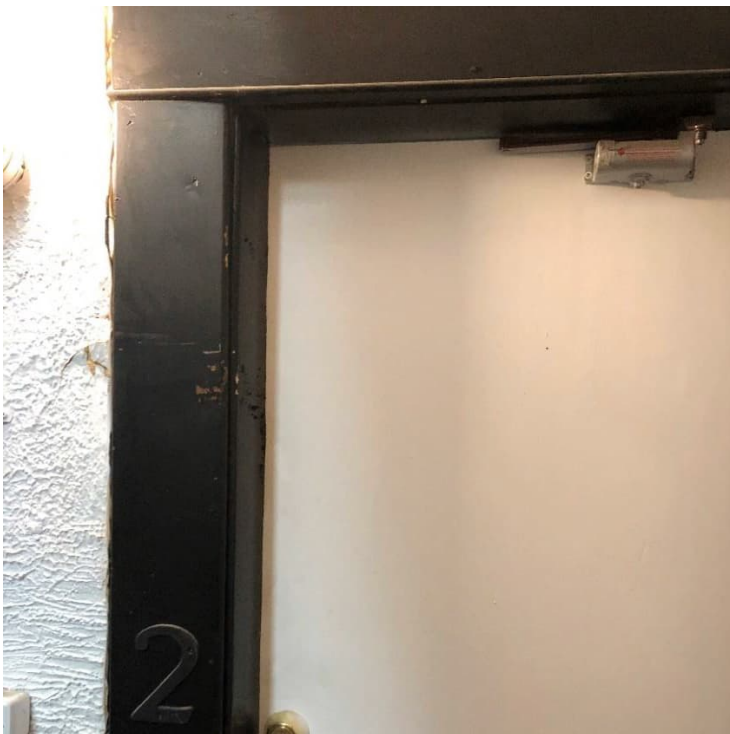
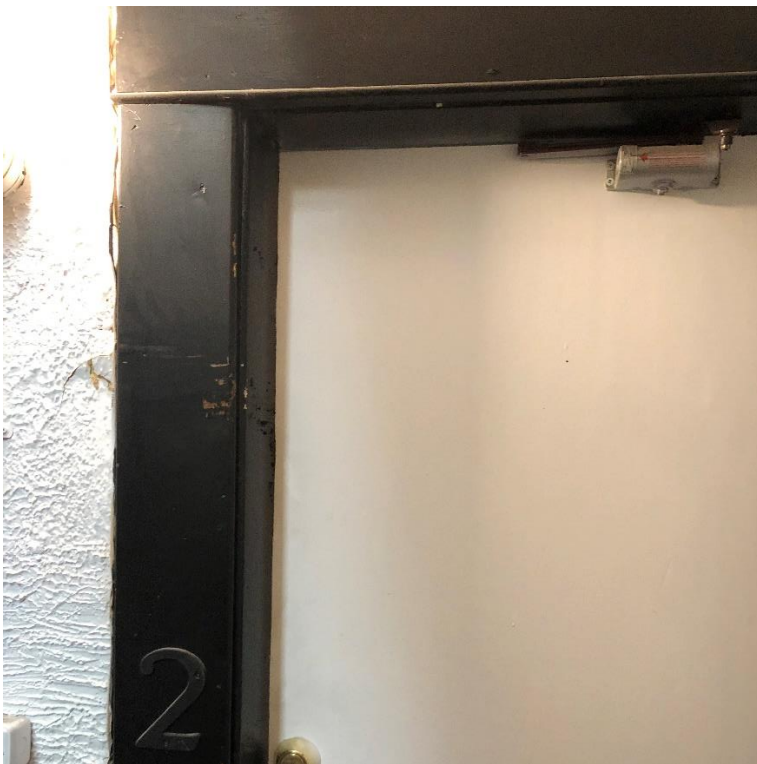
Photo 4: View of lead-containing black trim paint observed in the apartment stairwell

Photo 4: View of lead containing black trim paint observed in the apartment stairwell

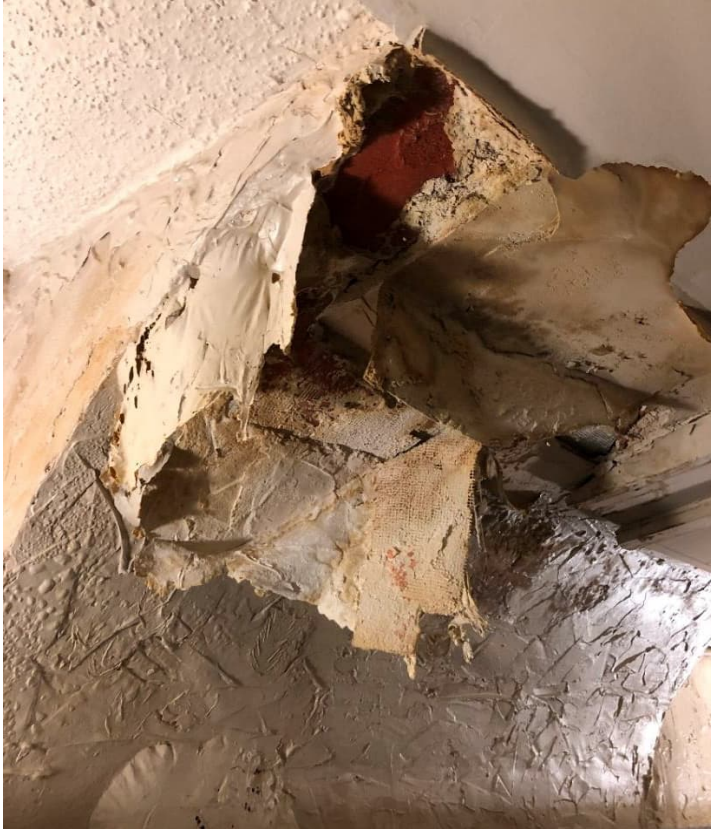
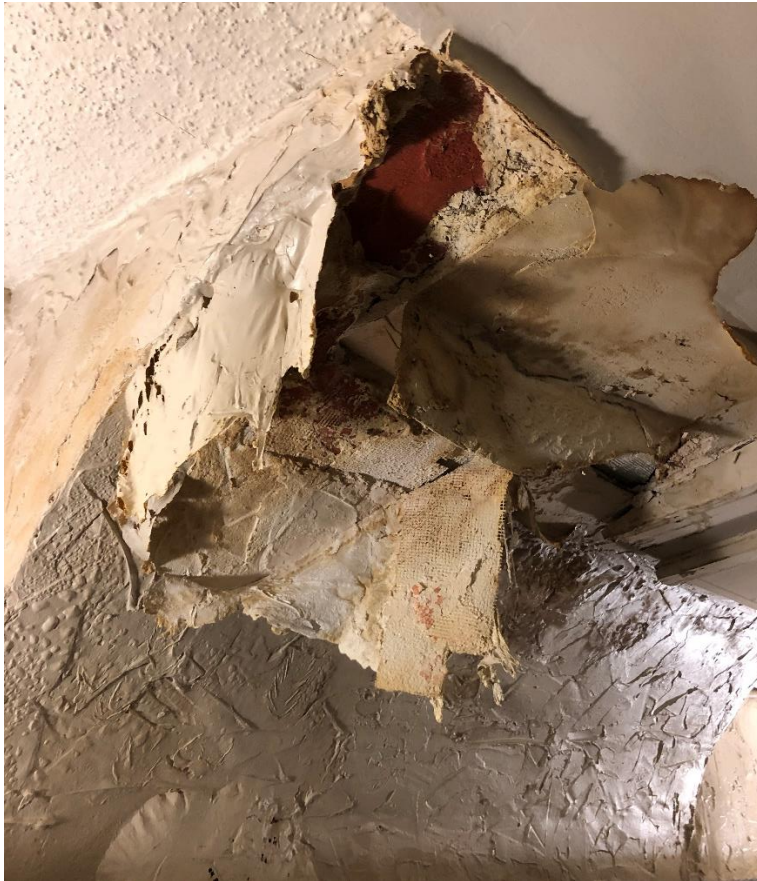
A visual survey of the subject building was conducted to determine if water damage was present. Select areas were identified throughout the subject building where materials were affected by water damage.

Photo 5: View of water-damaged plaster ceiling observed in the basement dining area

Photo 5: View of water damaged plaster ceiling observed in the basement dining area

Water stained/damaged ceiling observed throughout the basement of the subject building should be replaced as part of regular maintenance, and the underlying cause of the water leakage should be identified and repaired;

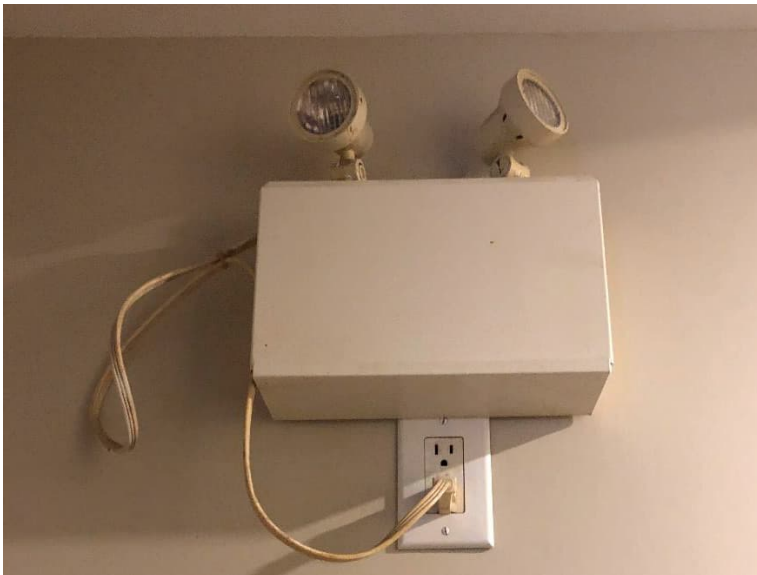
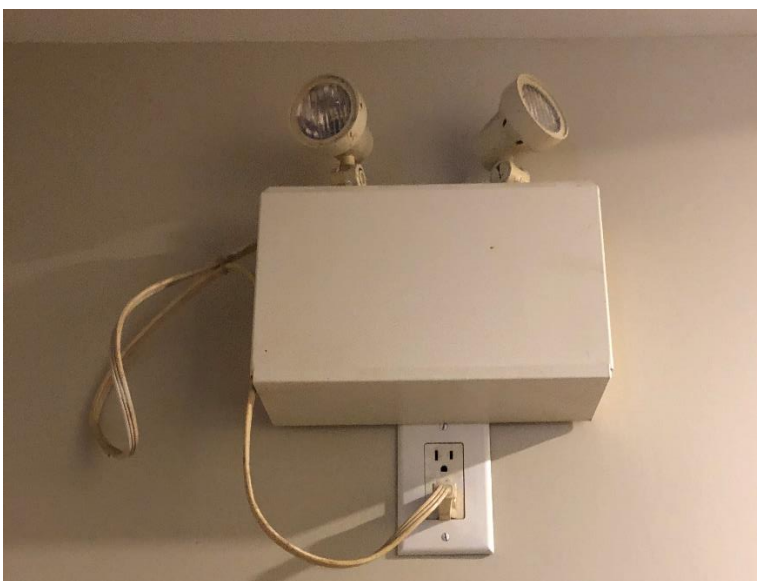
Lead-containing acid battery packs were observed throughout the subject building. These battery packs were observed on walls and above exits throughout the surveyed building.

Photo 6: View of lead acid battery pack observed throughout the building

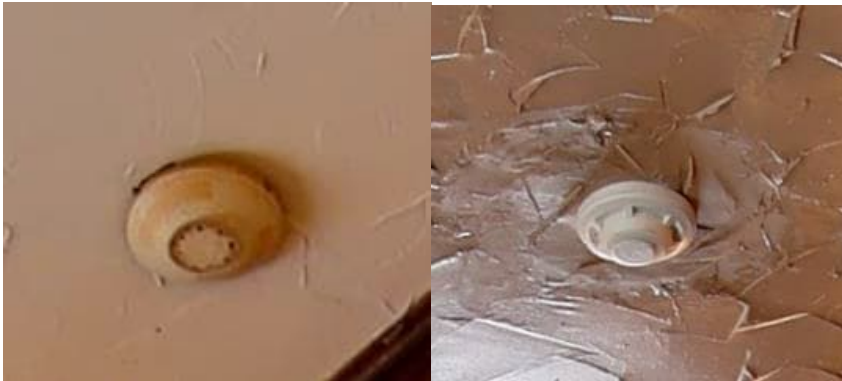
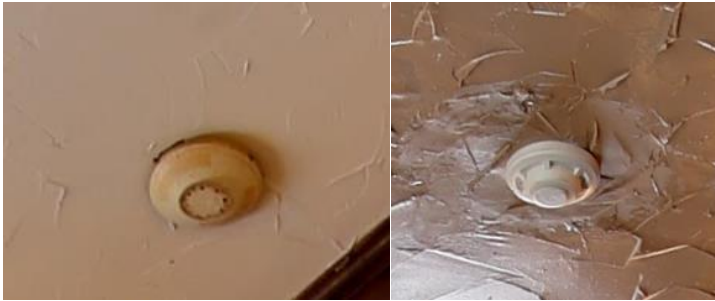
Smoke detectors of varying brands throughout the building were observed, which contained small quantities of radioactive material.

Photo 7: View of smoke detectors with radioactive material present throughout the building.

The radioactive sources in smoke alarms are sealed and contained within a metal case inside the smoke detector and must not be damaged or tampered with. These materials do not pose a hazard as long as they remain contained and properly disposed of at the time of removal or replacement.

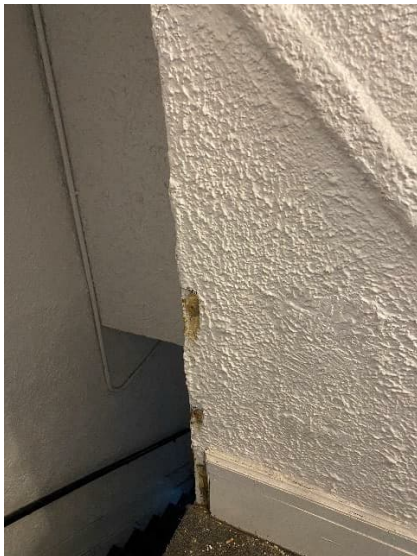
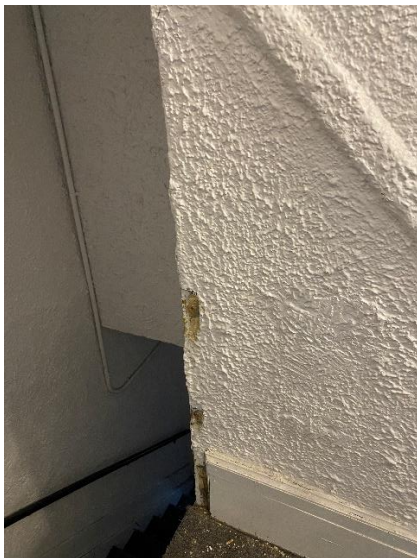
Photo 8: View of asbestos-containing texture coat present on walls observed in fair condition in the hallway of the subject building during the 2022 Reassessment.

- ACMs identified as in fair condition should be either repaired (where possible) and/or closely monitored for signs of further deterioration. Depending on the type of material and location, these materials should be scheduled for removal if there is a potential risk of exposure to workers and/or occupants;

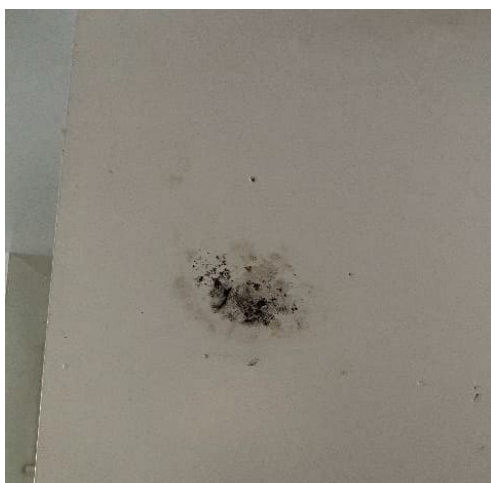
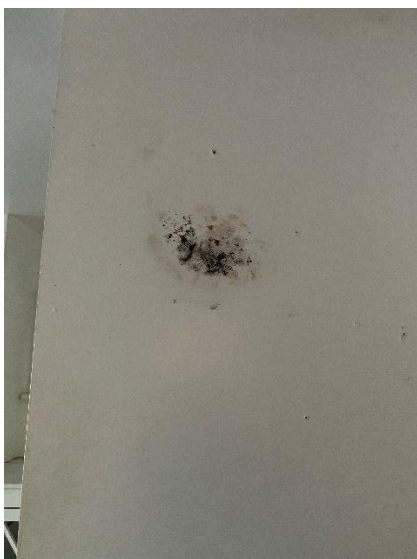
A visual survey of the subject building was conducted to determine if any mould was present. **Select areas affected by visible mould growth were observed during the 2022 Reassessment.**

Photo 9: View of suspect mould observed in Unit 2 of the subject building during the 2022 Reassessment.
