# HAZARDOUS MATERIALS SURVEY AND 2023 REASSESSMENT 19-21 STEWART STREET, OTTAWA, ON

Project No.: Z2021101HZ / CCC-230252-00

University of Ottawa

McIntosh Perry Limited (MPL)

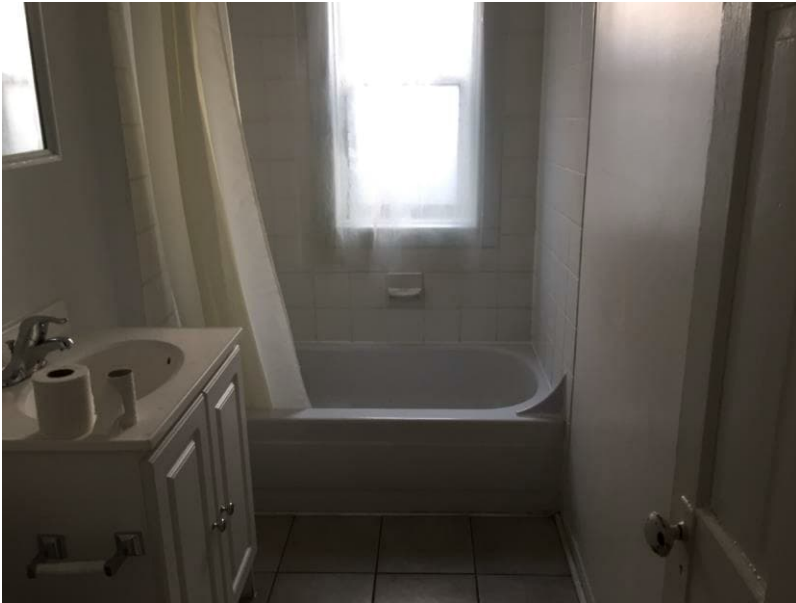
**Photo 3:** View of typical finishes observed at the building located at 19-21 Stewart Street.

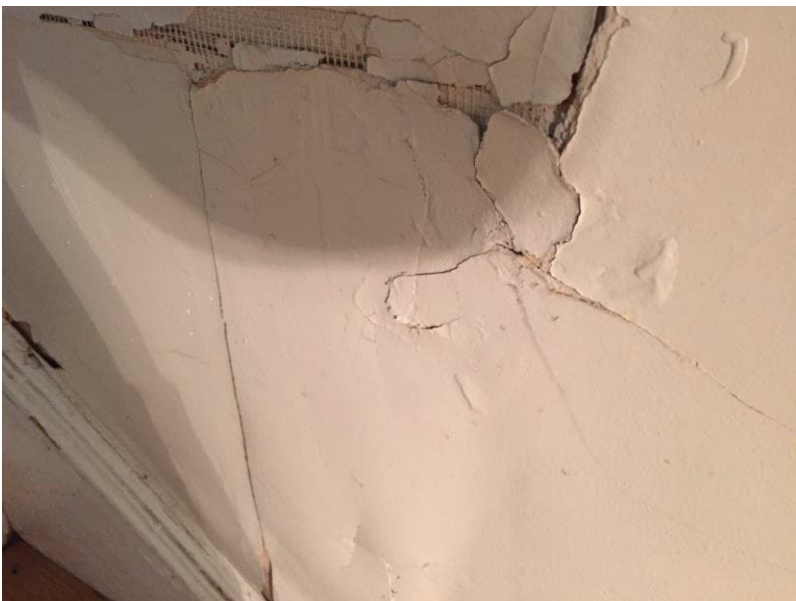
Ceiling/Wall plaster was previously observed and sampled throughout the building. The laboratory analytical results of plaster samples collected indicate that this material **contains 2% Chrysotile asbestos**. Since plaster is a homogeneous material, all areas must be treated as asbestos-containing unless additional bulk sampling and analysis until proven otherwise. This material is considered to be friable and was observed to be in good and poor condition.

**Photo 4:** View of poor-condition asbestos-containing plaster observed on the stairs to the second floor in 19 Stewart.

- ACMs identified to be in poor condition must be repaired/removed immediately, following Type 1/2/3 asbestos abatement work procedures as detailed in O. Reg. 278/05 and disposed of as asbestos waste under O. Reg. 347;

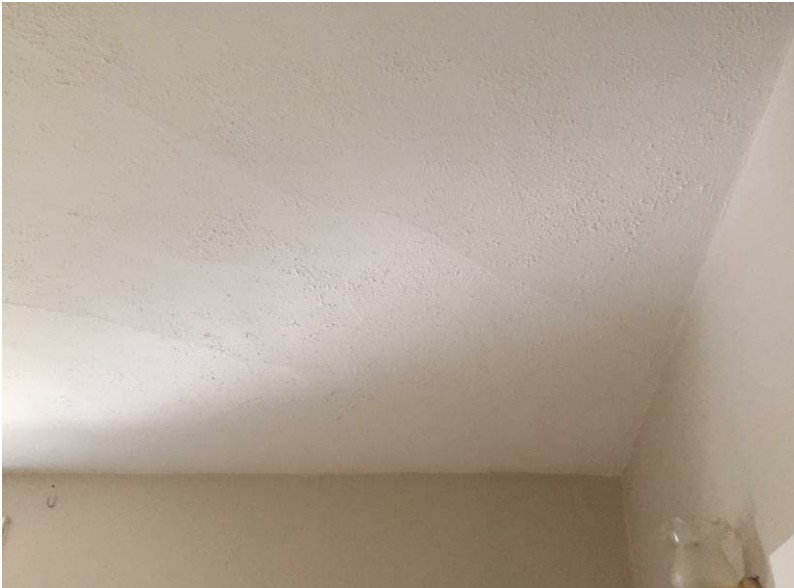
A texture coat was observed on the walls and ceiling in Rooms 217 and 219 at 19 Stewart Street. This material was found to **contain 3% Chrysotile asbestos**. This material is considered to be friable and observed to be in good condition.

**Photo 5:** View of asbestos-containing texture coat observed in Room F of 19 Stewart.

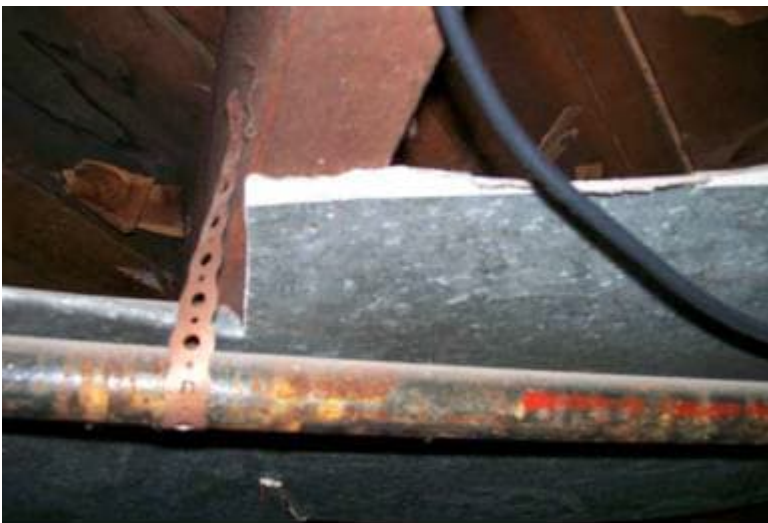
Previously identified asbestos-containing paper insulation was observed throughout the basement (B05) of 19 Stewart. This material **contains %35 Chrysotile asbestos**. This material is considered to be friable and was observed to be in good condition.

**Photo 6:** View of asbestos-containing paper insulation observed above the hot water tank in the basement of 19 Stewart.

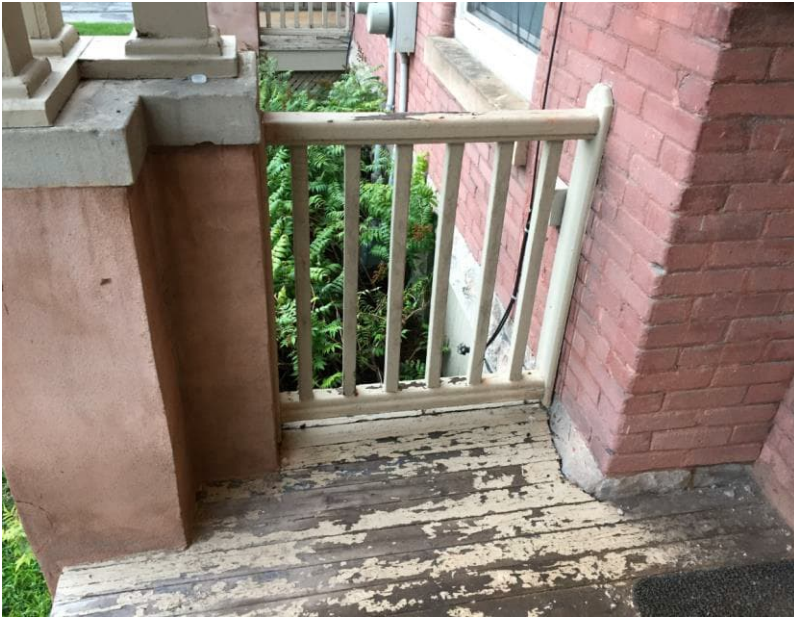
The paint finishes highlighted in pink in the above table are considered lead-containing paints or surface coatings with concentrations greater than 0.1% lead by weight. These paint finishes were observed to be in good condition, except for select areas that were observed in poor condition.

**Photo 7:** View of lead containing grey/brown paint observed on the porch and deck at 19-21 Stewart, observed in poor condition.

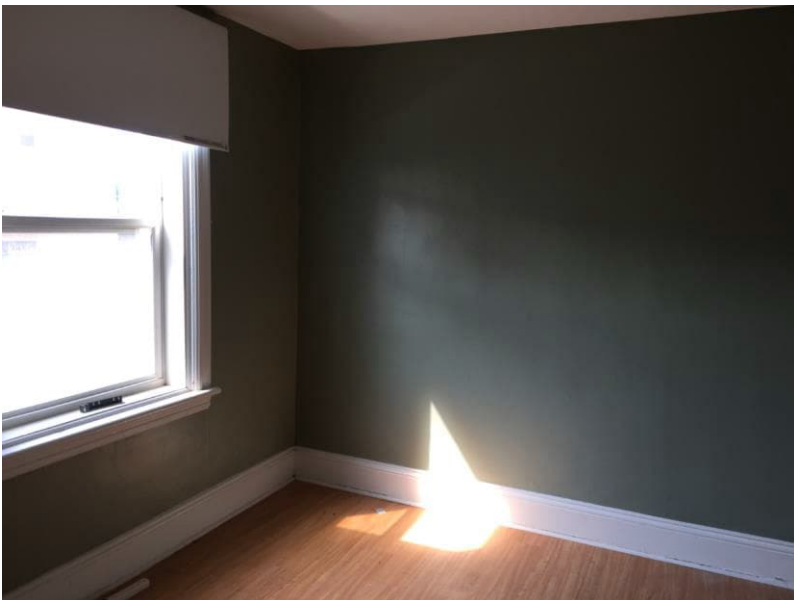
**Photo 8:** View of lead containing green paint observed in Room C at 19 Stewart.

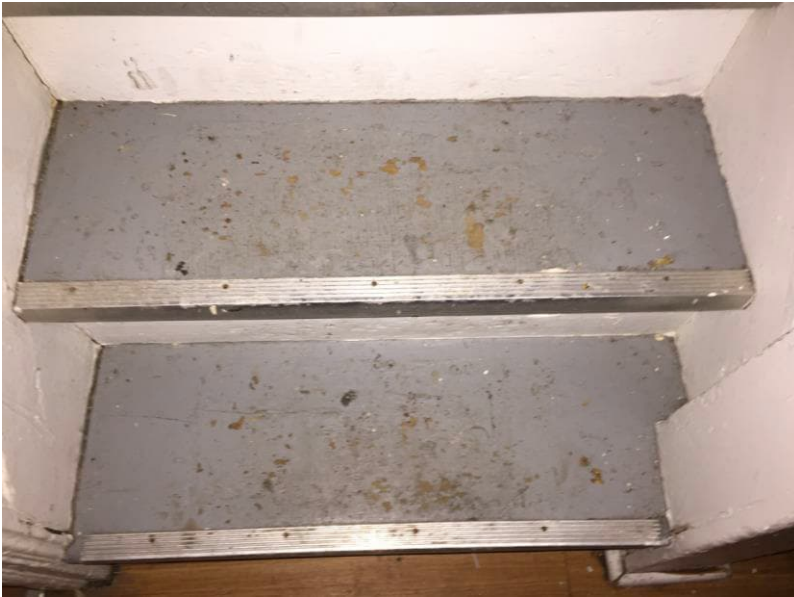
**Photo 9:** View of lead containing grey paint and previously identified lead containing blue paint observed on the staircase to the second floor at 21 Stewart.

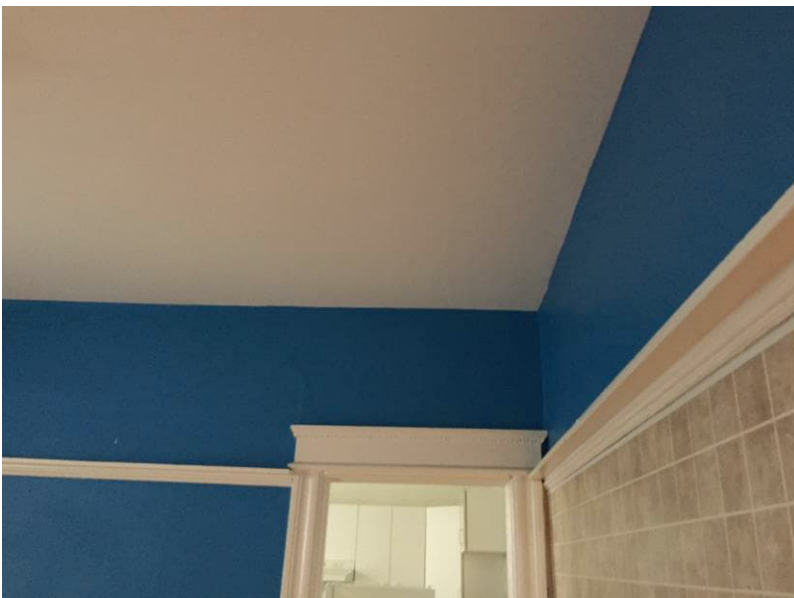
**Photo 10:** View of previously identified lead containing blue paint observed in the Living Room at 19 Stewart.

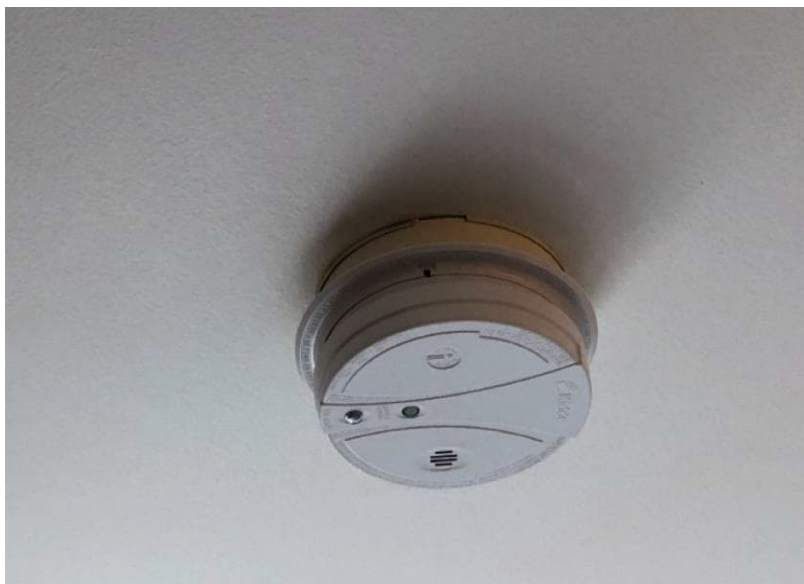
A visual assessment of the subject building was conducted to determine if any electrical components containing radioactive materials were present. Smoke detectors were observed throughout the subject building, which contained small quantities of radioactive material.

**Photo 11:** Typical view of smoke detectors containing radioactive materials.

The radioactive sources in smoke alarms are sealed and contained within a metal case inside the smoke detector and must not be damaged or tampered with. These materials do not pose a hazard as long as they remain contained and properly disposed of at the time of removal or replacement.
