HAZARDOUS MATERIALS SURVEY AND 2023 REASSESSMENT 200 LEES AVENUE, OTTAWA, ONTARIO

Project No.: Z1920014HZ / CCC-230252-00

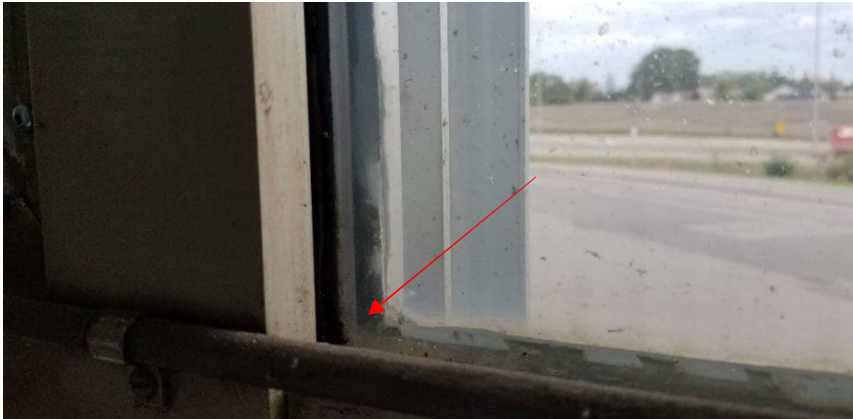
Photo 1: View of asbestos-containing interior window caulking (black) observed to be in good condition in Room 139.

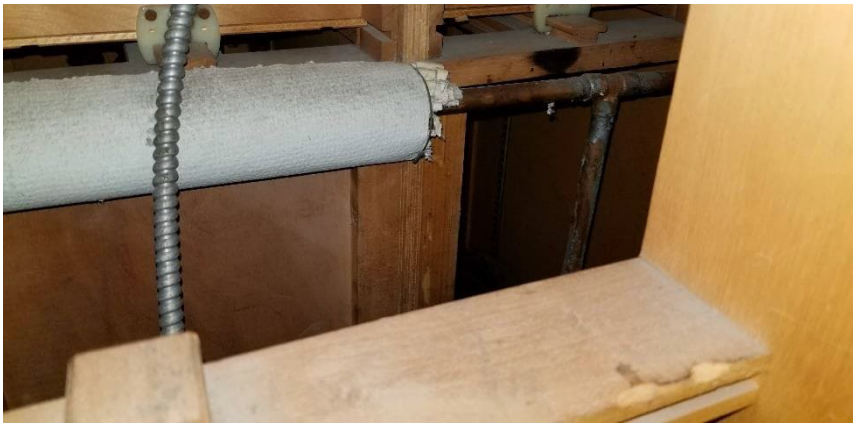
Photo 2: View of asbestos-containing mechanical pipe straight insulation observed to be in poor condition in cabinet 510 in Room A 105.

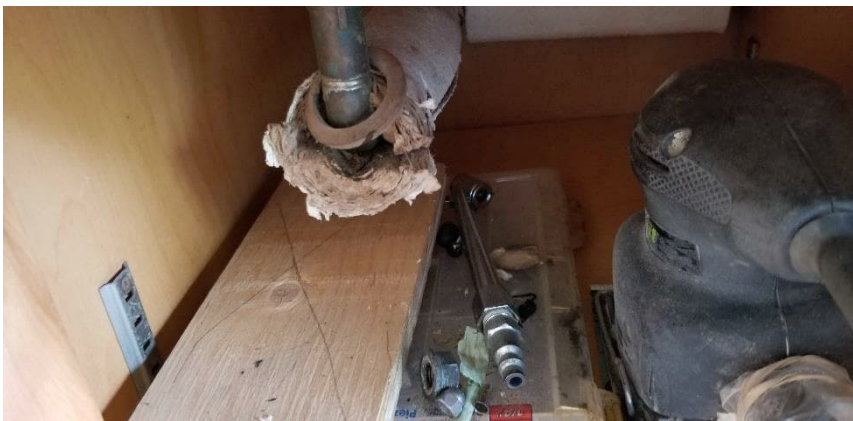
Photo 3: View of asbestos-containing mechanical pipe straight insulation observed to be in poor condition on the 2nd work bench outside the bike shop office in Room A 105.

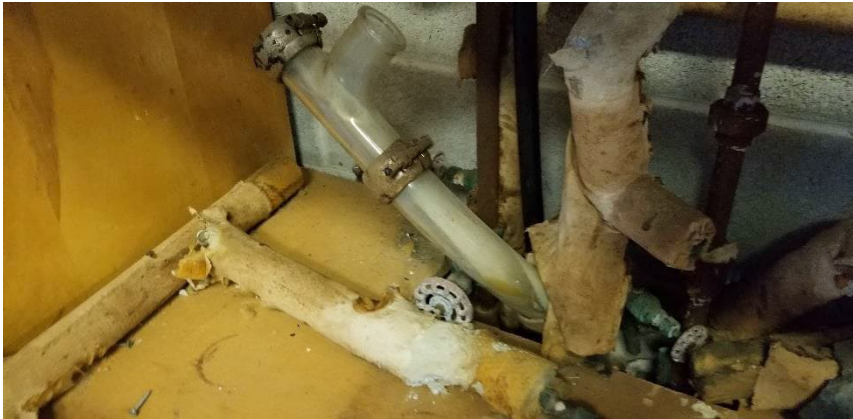
Photo 4: View of asbestos-containing mechanical pipe fittings observed to be in poor condition in Room A104.

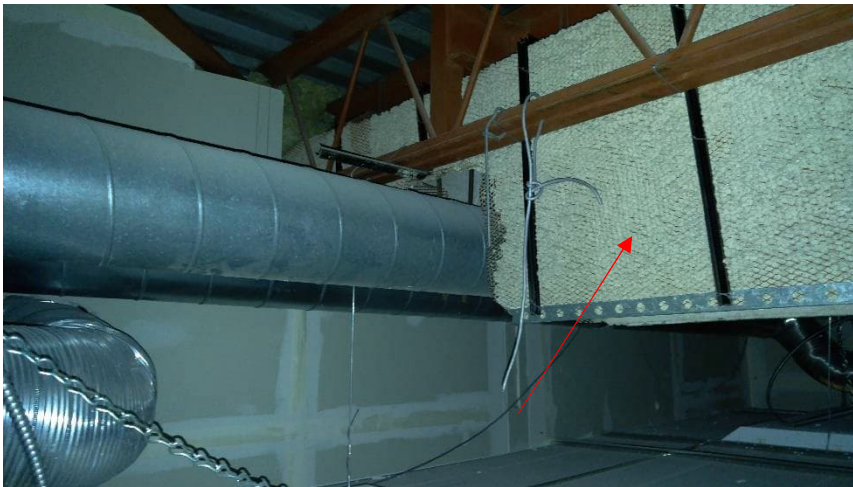
Photo 5: View of asbestos-containing plaster on steel mesh observed in Room B 215N.

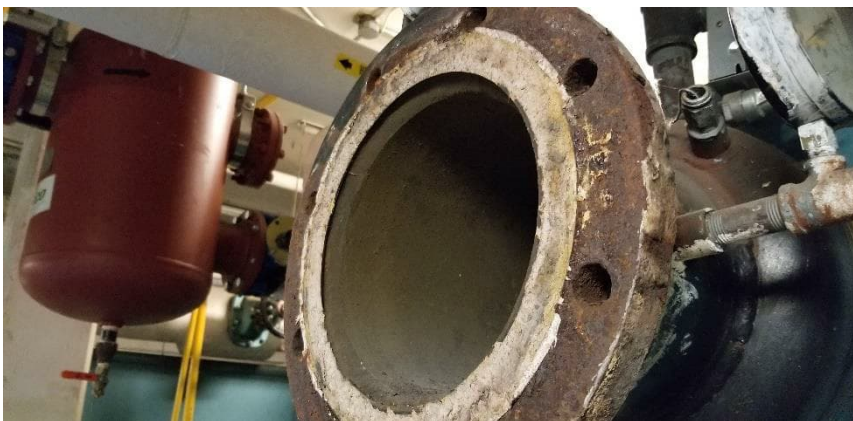
Photo 6: View of asbestos-containing pipe gasket observed on the Unilux Boiler in Mechanical Room A02.

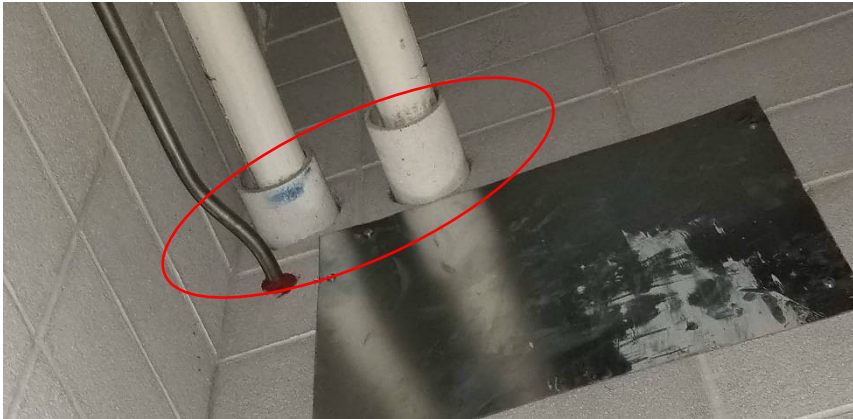
Photo 7: View of asbestos-containing transite pipe (highlighted in red) observed to be in good condition Mechanical Room A138C.

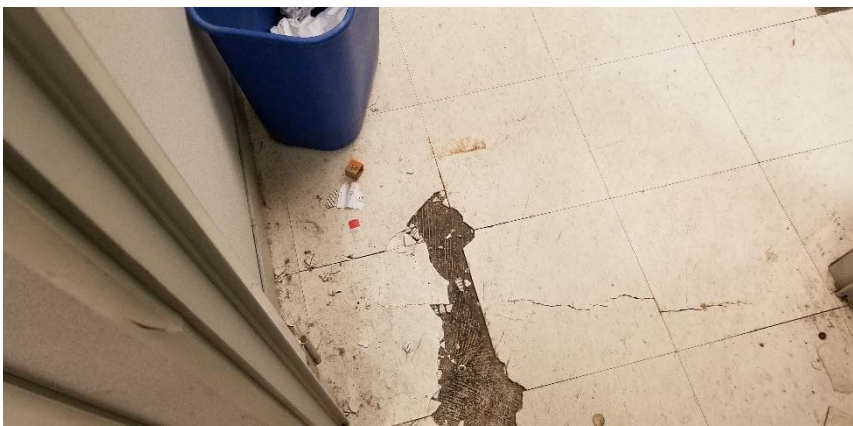
Photo 8: View of asbestos-containing vinyl floor tile (12"x12"-White with beige spots) observed to be in poor condition in Room C144.

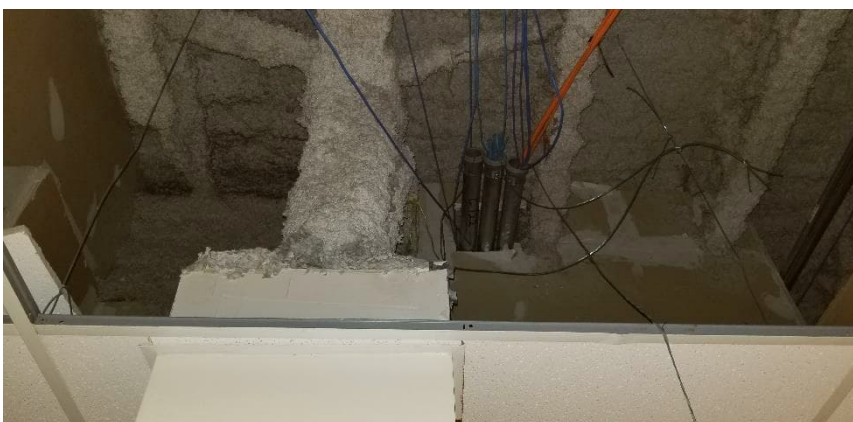
Photo 9: View of non-asbestos-containing fireproofing observed above the suspended ceiling tiles in Room C141C.

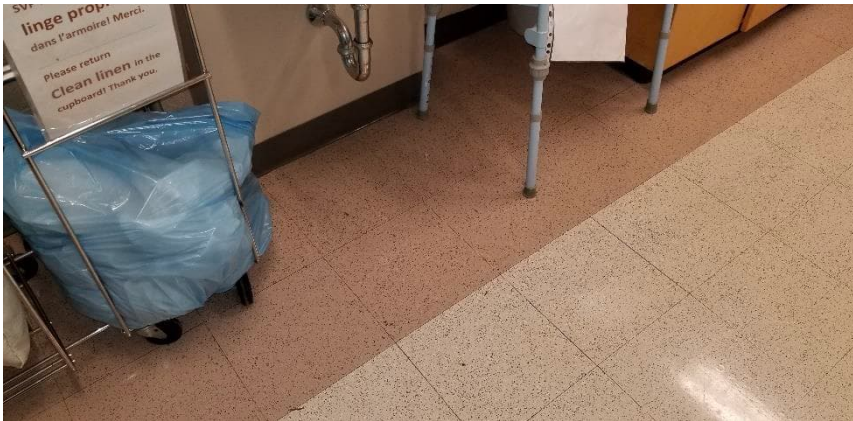
Photo 10: View of non-asbestos-containing vinyl floor tiles (12"x12"-Pink with dots) and vinyl floor tiles (12"x12"-Offwhite with dots) observed in RoomC115.

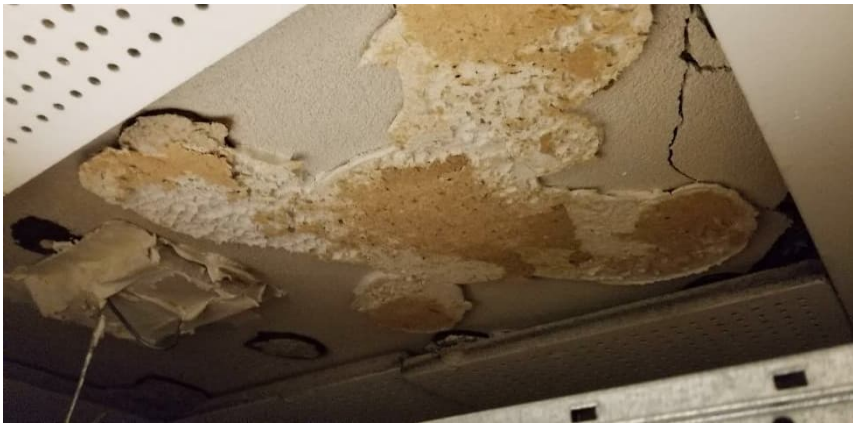
Photo 11: View of non-asbestos-containing glued-on acoustic tile (12"x12"-Uniform Holes) and adhesive mastic (brown) observed in the Men's Change Room in D108.

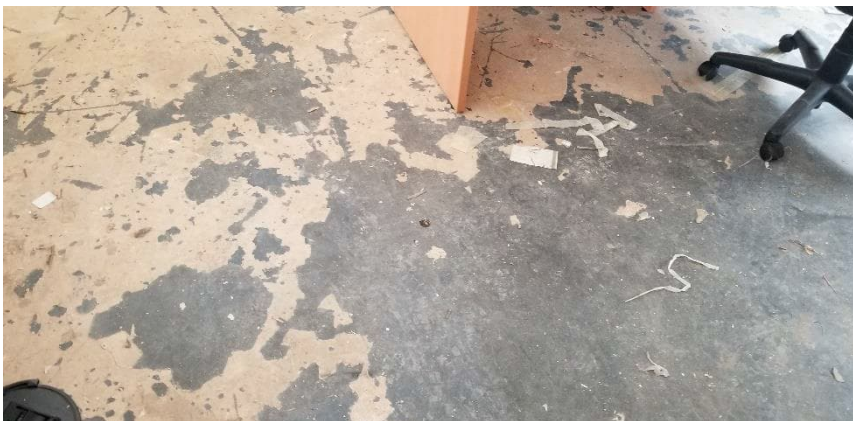
Photo 12: View of low-level lead paint observed to be in poor condition in Room A144.

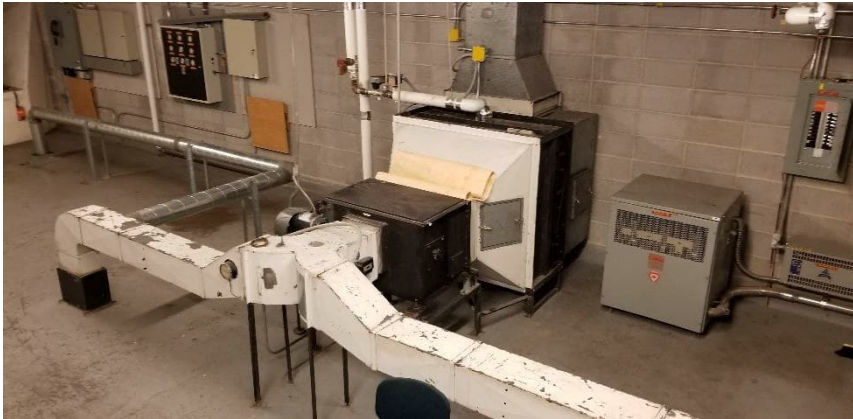
Photo 13: View lead containing white paint was observed to be in poor condition in Mechanical Room D201.

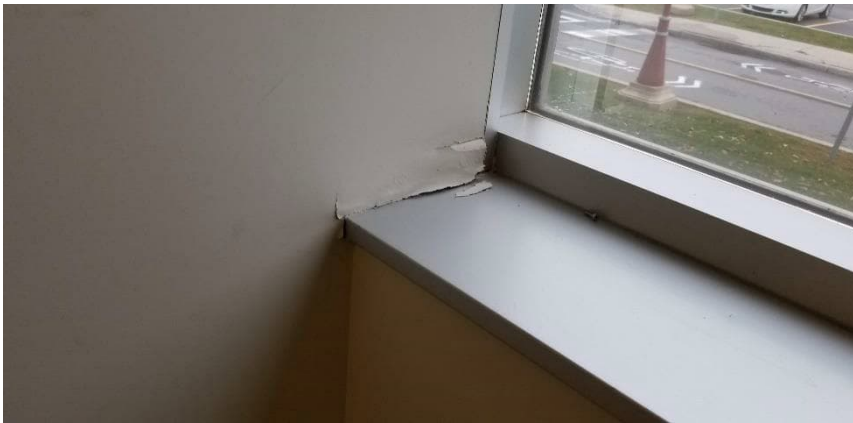
Photo 14: View of water damage on drywall observed in Room E117.

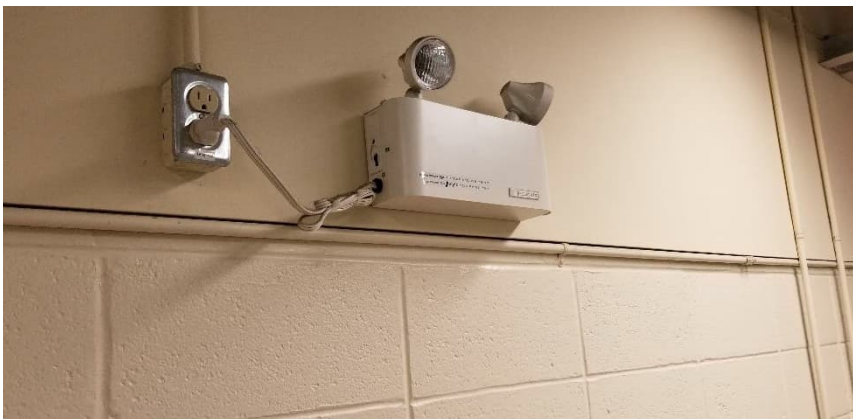
Photo 15: View of lead acid battery pack observed outside of D201.

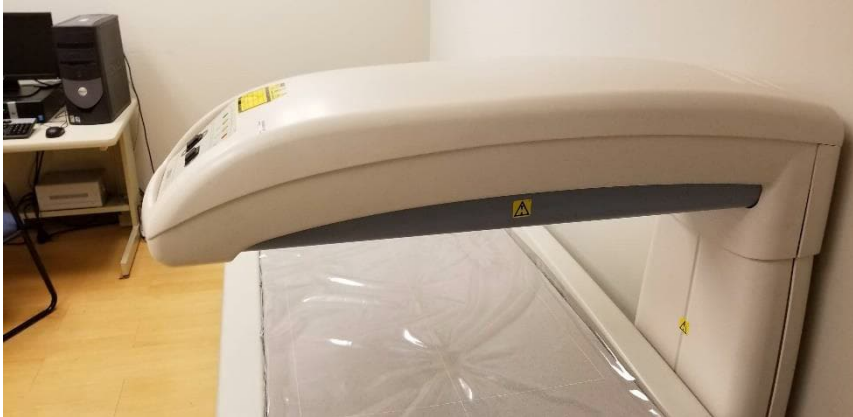
Photo 16: View of a diagnostic machine suspected to contain radioactive materials observed in Room E029.

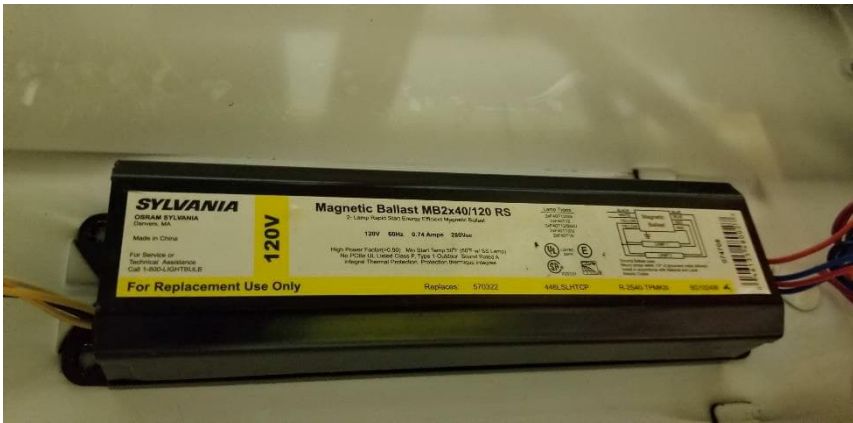
Photo 17: Typical view of non-PCB containing light ballast observed throughout the surveyed building.

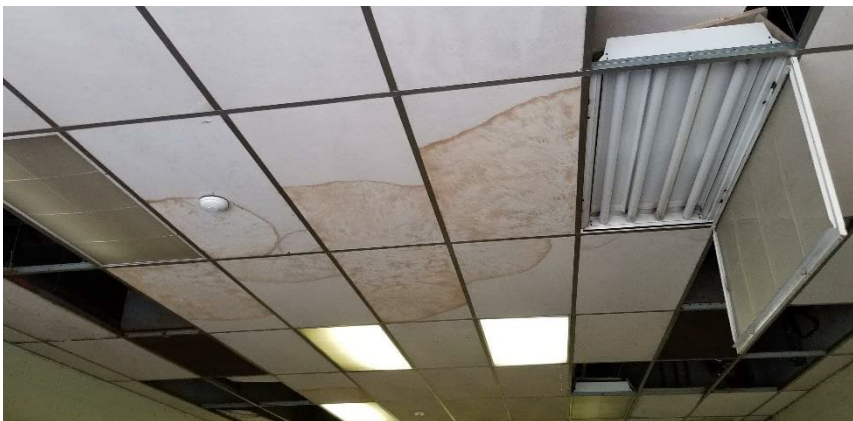
Photo 18: View of water-stained suspended ceiling tiles in Room A104C.
