HAZARDOUS MATERIALS SURVEY AND 2023 REASSESSMENT ADVANCED RESEARCH COMPLEX (ARC), OTTAWA, ON

Project No.: Z2021101HZ / CCC-230252-00

University of Ottawa

The reassessment survey was completed on September 20, 2023.

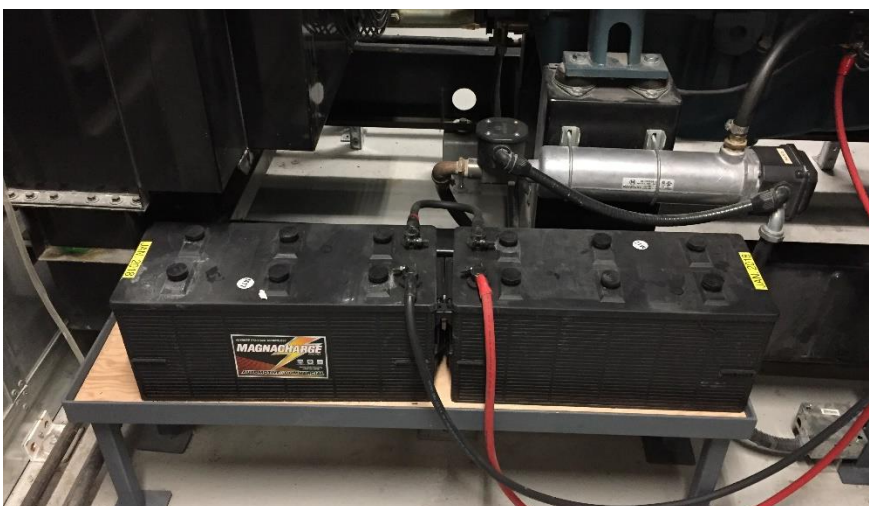
Lead-containing acid battery packs were observed in Room 532C.

Photo 6: View of the lead-acid batteries present in Room 532C.

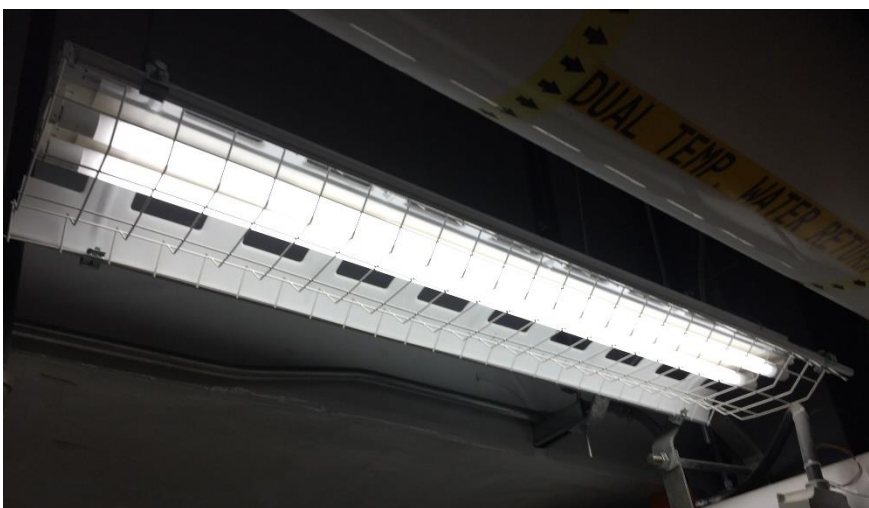
Fluorescent light fixtures containing 2 to 4 fluorescent light tubes per fixture were observed throughout the building. Mercury is likely to be present in vapour form in fluorescent light tubes.

Photo 9: Representative view of the fluorescent light fixtures containing mercury vapour observed throughout the subject building.
