HAZARDOUS MATERIALS SURVEY AND 2023 REASSESSMENT 30 MARIE CURIE PRIVATE (BIOSCIENCE-PH II), OTTAWA, ON

Project No.:0Z2021101HZ / CCC-230252-00

University of Ottawa

McIntosh Perry Limited (MPL)

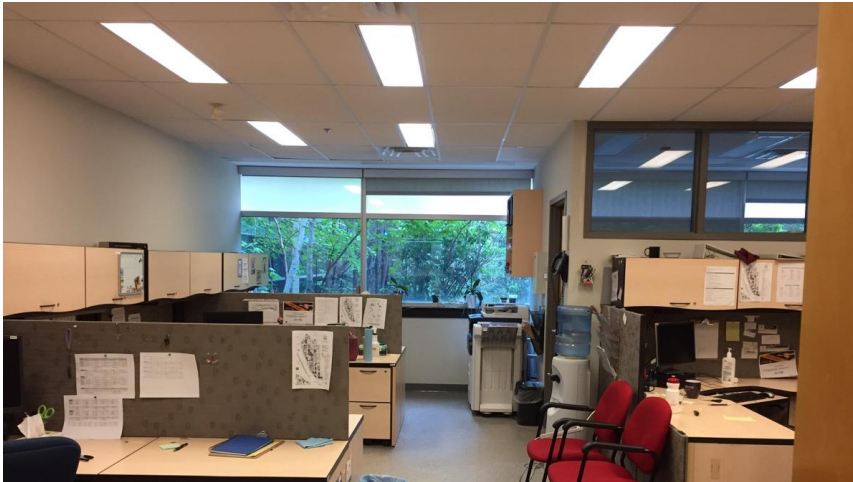
Photo 1: A representative view of the building finishes is observed throughout the subject building.

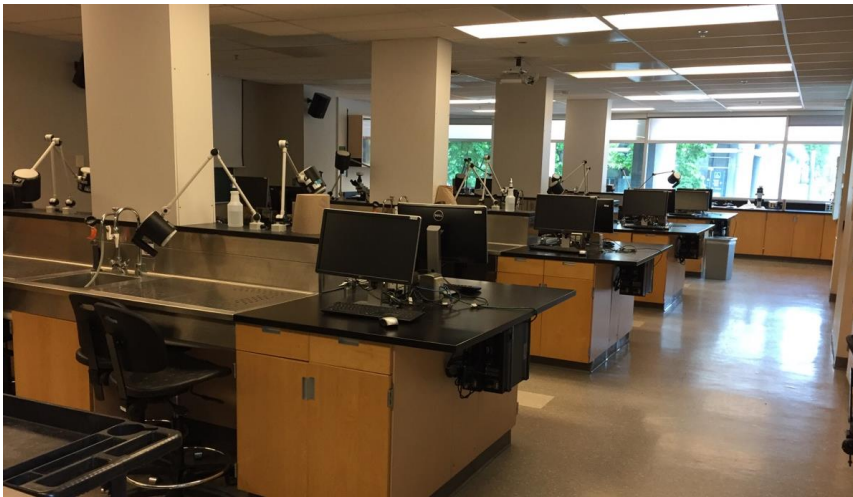
Photo 2: A representative view of the building finishes is observed throughout the subject building.

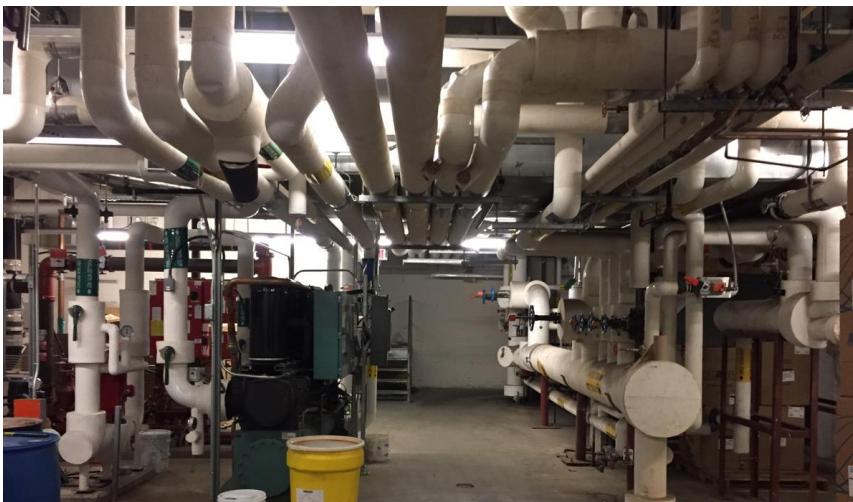
Mechanical pipe straight insulation was observed throughout the subject building. MPL made several incisions throughout to investigate its composition, and it was visually identified as fibreglass and, therefore, not suspected of containing asbestos.

Photo 3: Representative view of the non-asbestos-containing mechanical insulation observed throughout the subject building.

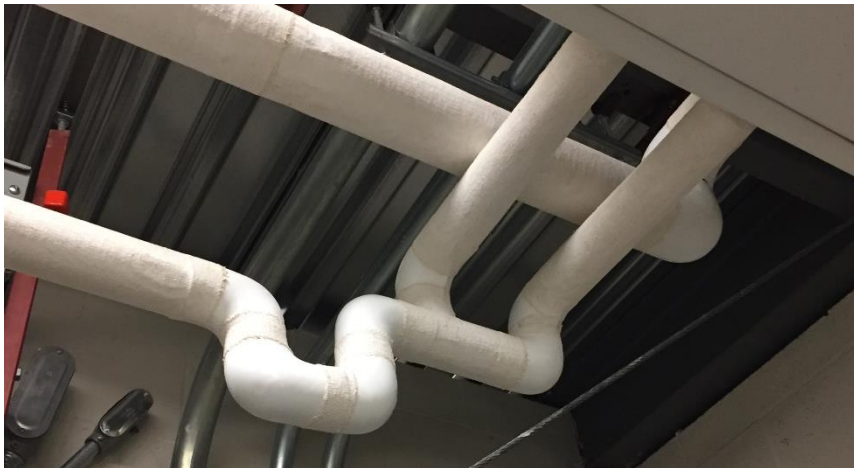
Mechanical pipe elbows/fittings insulation was observed throughout the subject building. MPL made several incisions throughout to investigate its composition, and it was visually identified as fibreglass and, therefore, not suspected of containing asbestos.

Photo 4: Representative view of the non-asbestos-containing mechanical insulation observed throughout the subject building.

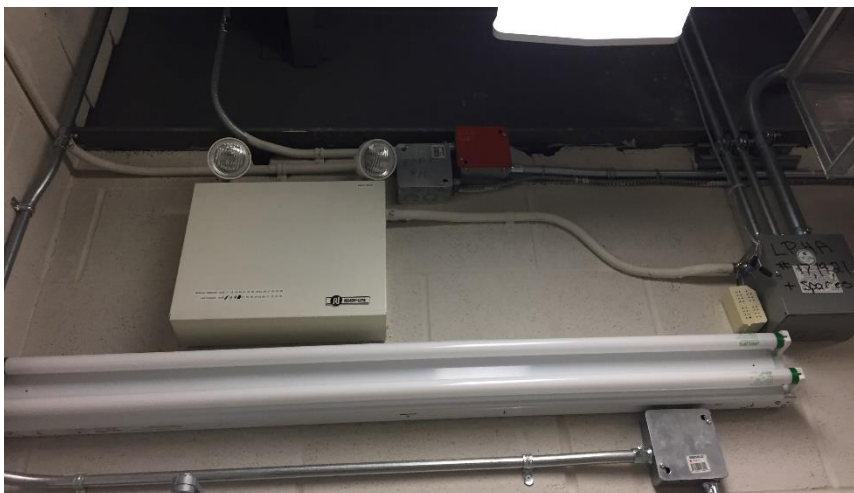
Lead-containing acid battery packs were observed in Rooms 001, 133, 234, 433, 505, 528, 529, and 530.

Photo 5: View of the lead-containing battery packs and mercury-containing fluorescent light fixtures observed throughout Room 528.

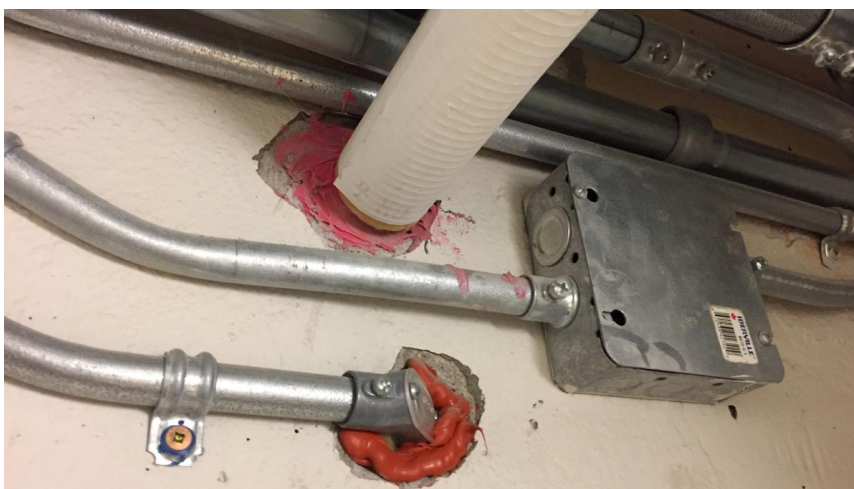
Firestop caulking (Red) was observed and previously sampled in Room 133. The analytical results of the samples collected in the laboratory indicate that this material does not contain asbestos.

Photo 6: View of the non-asbestos-containing firestop caulking (Red) observed throughout the subject building.

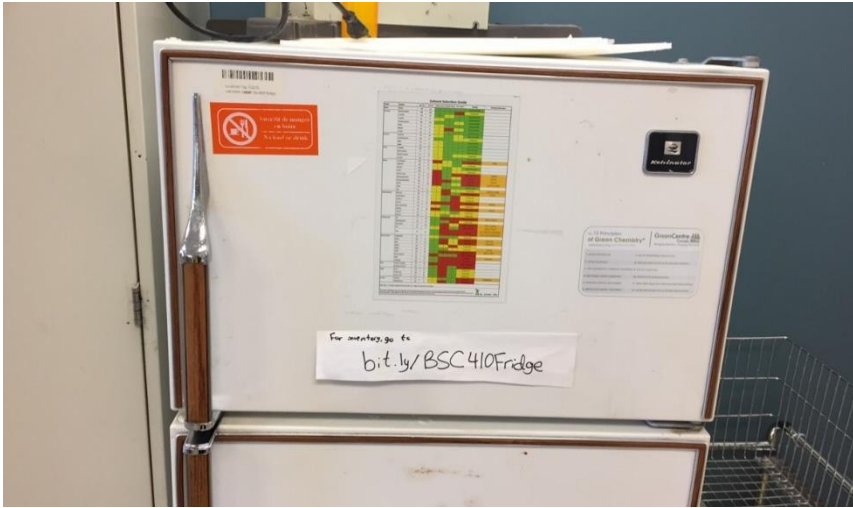
A visual assessment was conducted for equipment potentially containing ODSs and other halocarbons. Equipment containing ODSs or other halocarbons was observed throughout the subject building.

Photo 7: A representative view of the equipment containing ODSs was observed throughout the subject building.

Please refer to Appendix F – Hazardous Materials Checklist for equipment conditions, approximate quantities (where applicable), and recommended actions.

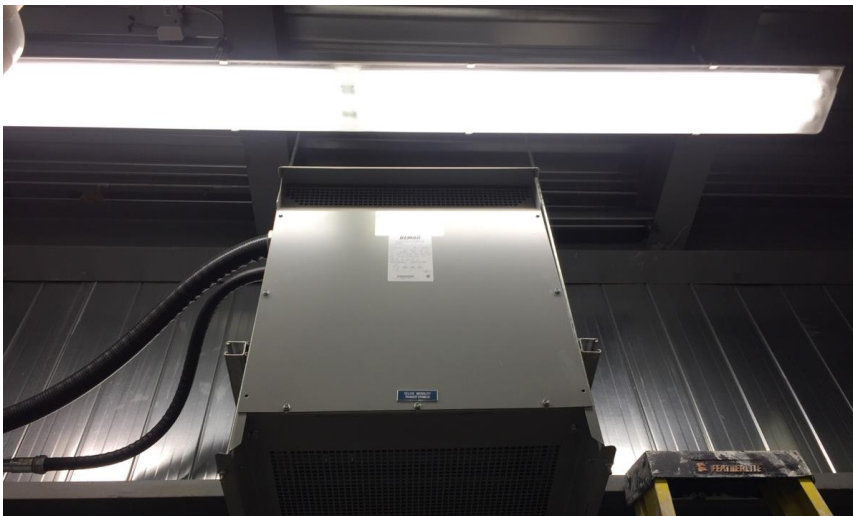
No PCBs containing electrical transformers were observed throughout the subject building. Transformers that could be assessed were observed to be dry-type and manufactured by Siemens.

Photo 8: Representative view of the non-PCB dry-type transformers observed throughout the subject building.

Since no PCB-containing equipment was observed or suspected to be present during the site survey, no further action is required.
